**Slope Upgrading Works at
Feature No. 11SW-A/R526,
King's College,
Bonham Road, Hong Kong**

Project Profile for Slope Upgrading Works at
Feature No. 11SW-A/R526, King's College

May 2018

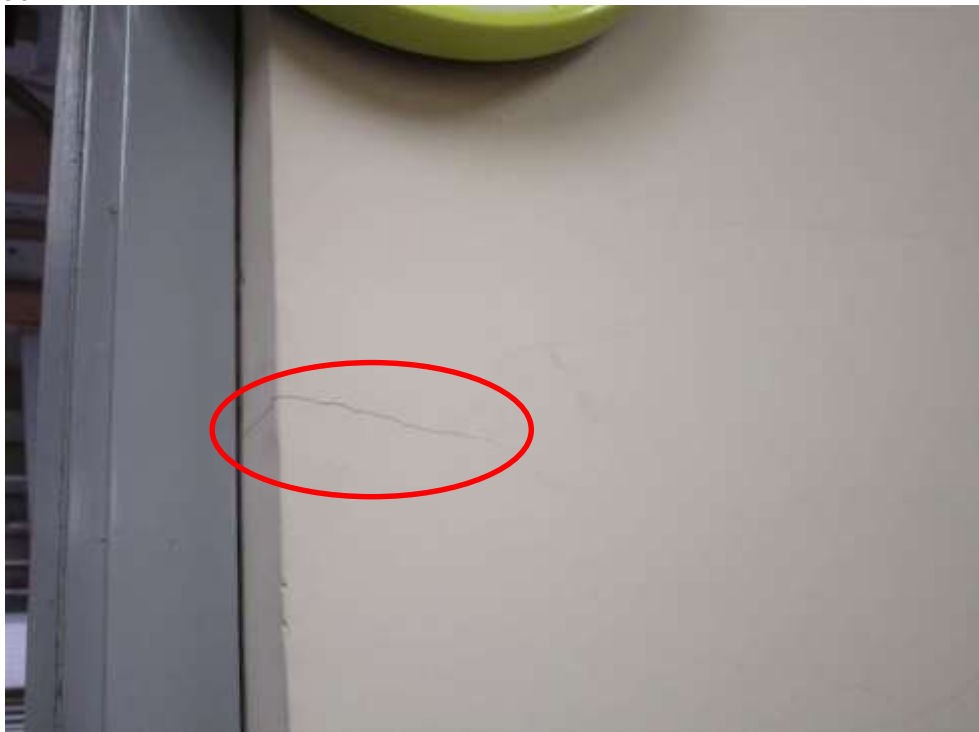
Photo No. 1504

Defect No. 252 **Location** LG/F North wing, Staff quarter **Component** wall

Description An area of medium cracks was observed on wall finishing

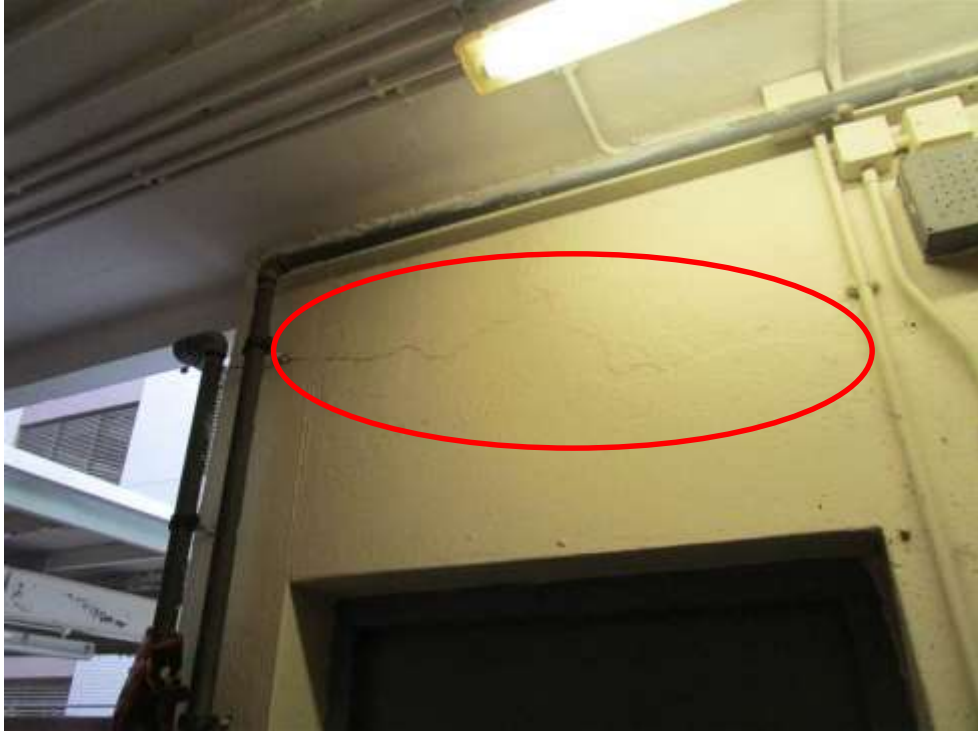
Photo No. 1505

Defect No. 252 **Location** LG/F North wing, Staff quarter **Component** wall

Description An area of medium cracks was observed on wall finishing

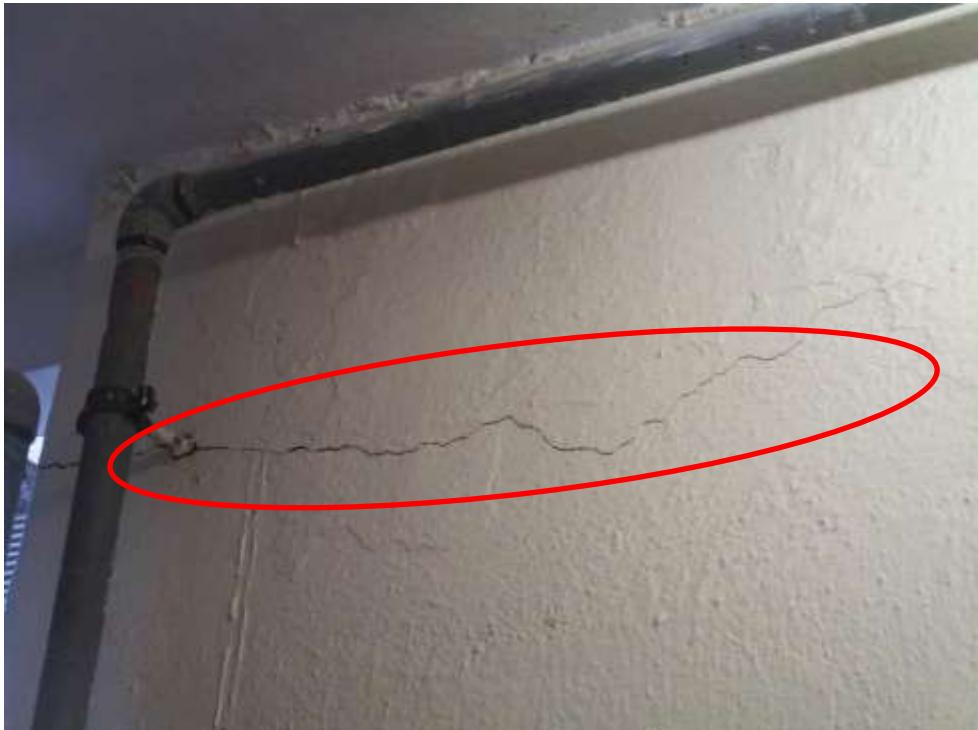
Photo No. 1506

Defect No. 253 **Location** LG/F North wing, Staff quarter **Component** wall

Description A wide crack was observed on wall finishing

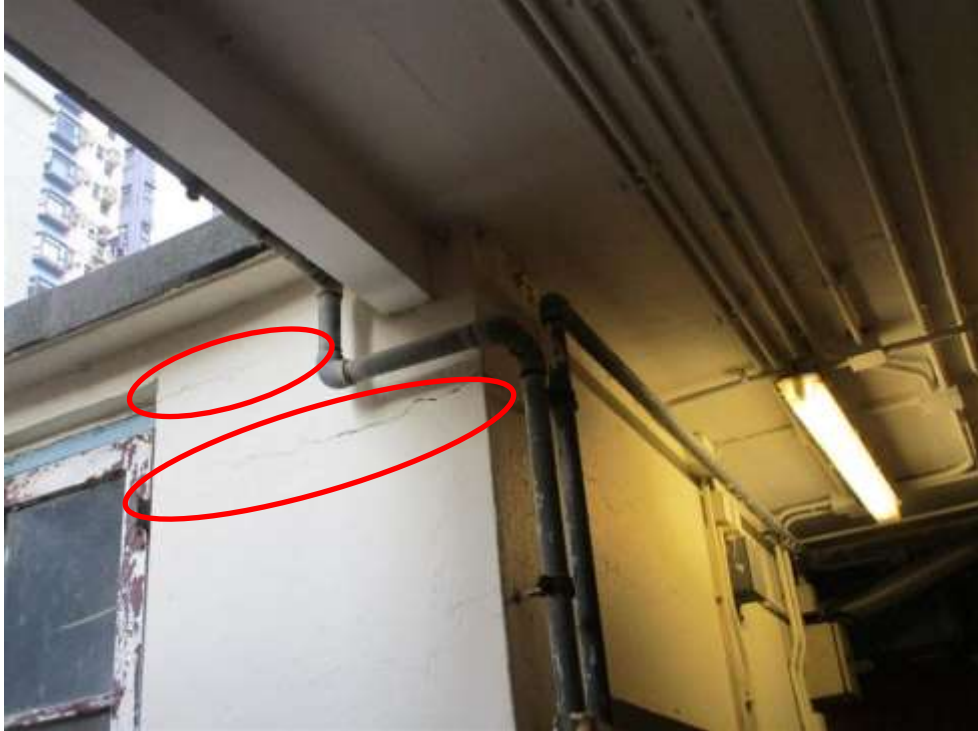
Photo No. 1507

Defect No. 253 **Location** LG/F North wing, Staff quarter **Component** wall

Description A wide crack was observed on wall finishing

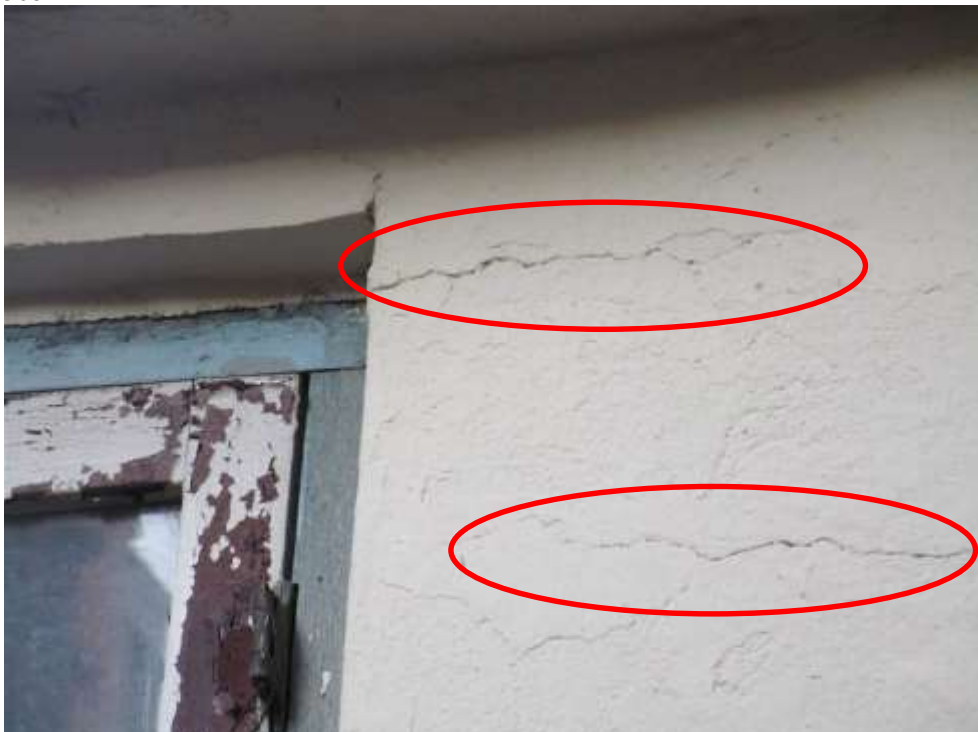
Photo No. 1508

Defect No. 254 **Location** LG/F North wing, Staff quarter **Component** wall

Description 2 wide cracks were observed on wall finishing

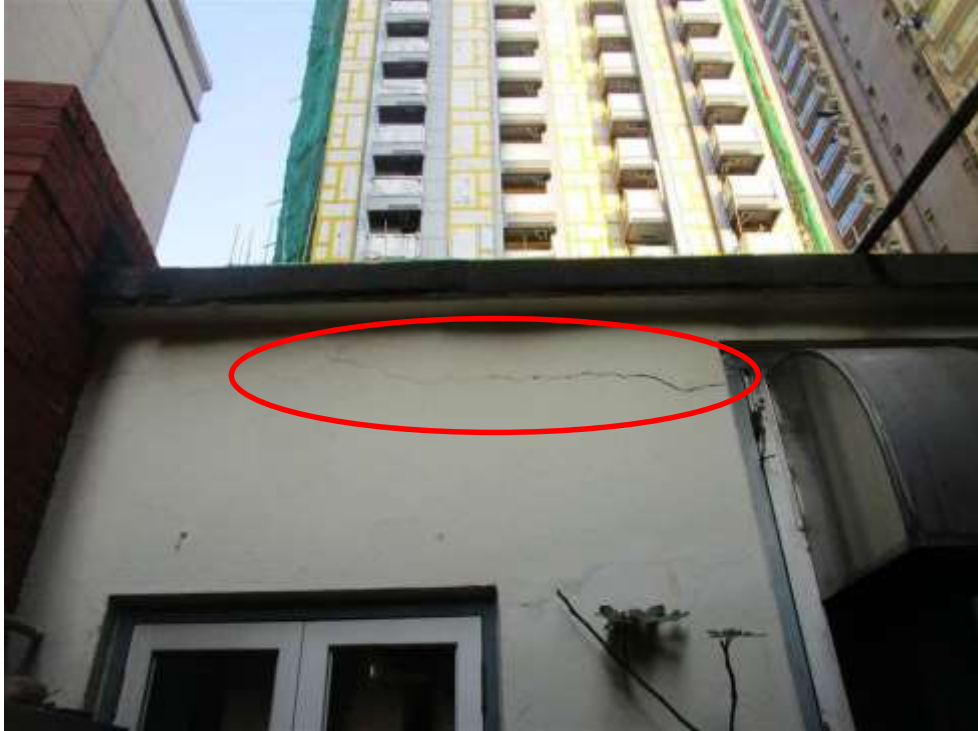
Photo No. 1509

Defect No. 254 **Location** LG/F North wing, Staff quarter **Component** wall

Description 2 wide cracks were observed on wall finishing

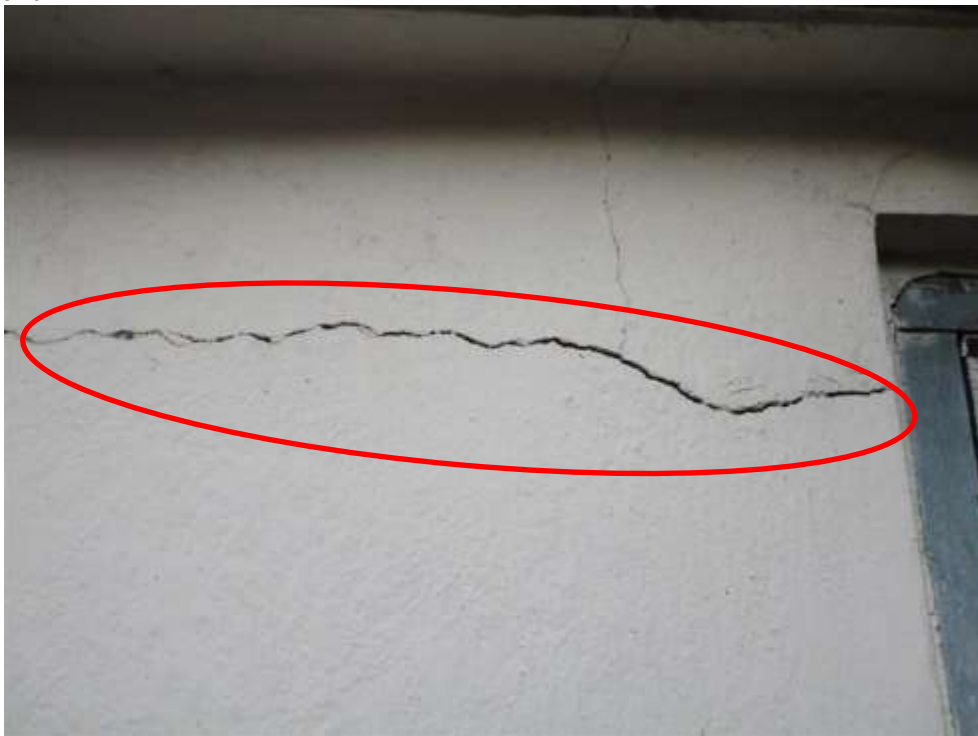
Photo No. 1510

Defect No. 255 **Location** LG/F North wing, Staff quarter **Component** wall

Description A wide crack was observed on wall finishing

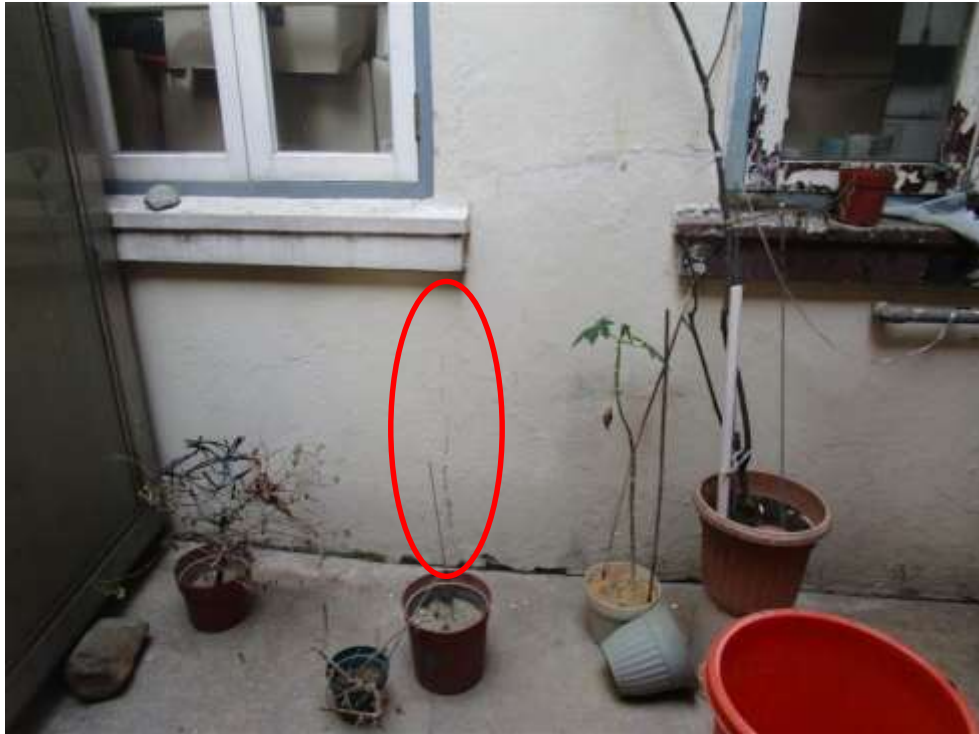
Photo No. 1511

Defect No. 255 **Location** LG/F North wing, Staff quarter **Component** wall

Description A wide crack was observed on wall finishing

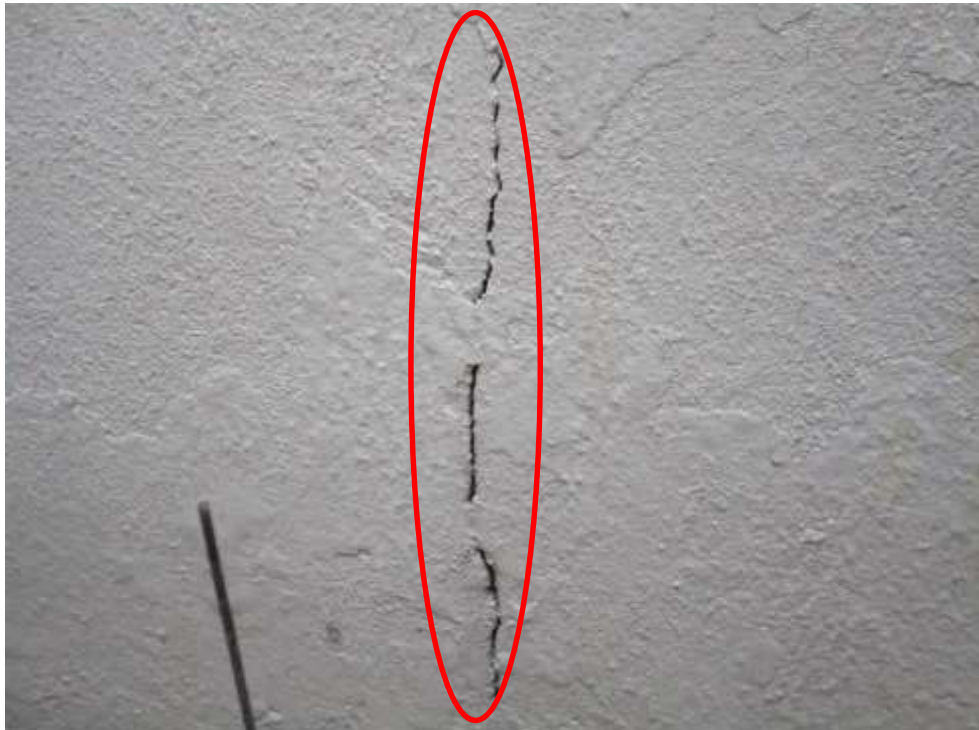
Photo No. 1512

Defect No. 256 **Location** LG/F North wing, Staff quarter **Component** wall

Description A wide crack was observed on wall finishing

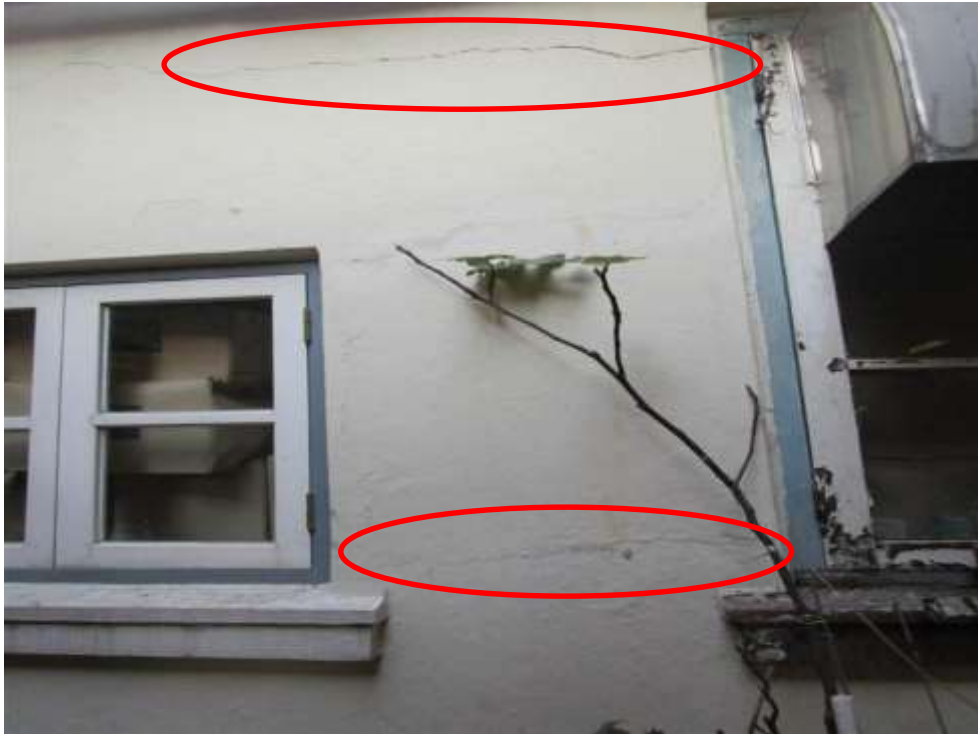
Photo No. 1513

Defect No. 256 **Location** LG/F North wing, Staff quarter **Component** wall

Description A wide crack was observed on wall finishing

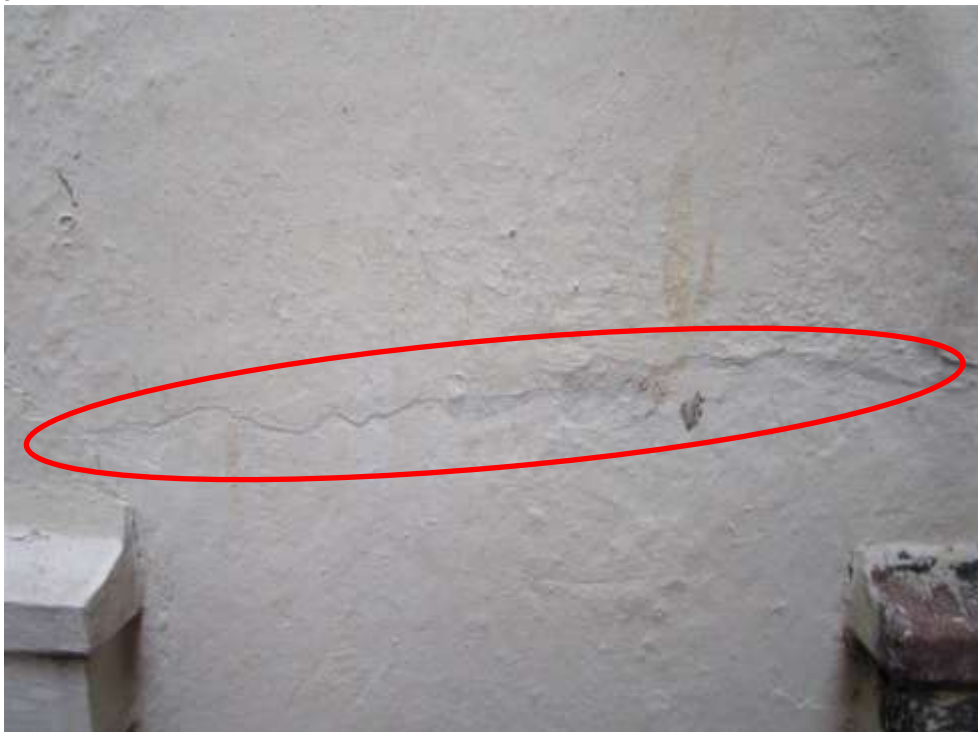
Photo No. 1514

Defect No.	257	Location	LG/F North wing, Staff quarter	Component	wall
-------------------	-----	-----------------	--------------------------------	------------------	------

Description	2 medium cracks were observed on wall finishing				
--------------------	-------------------------------------------------	--	--	--	--

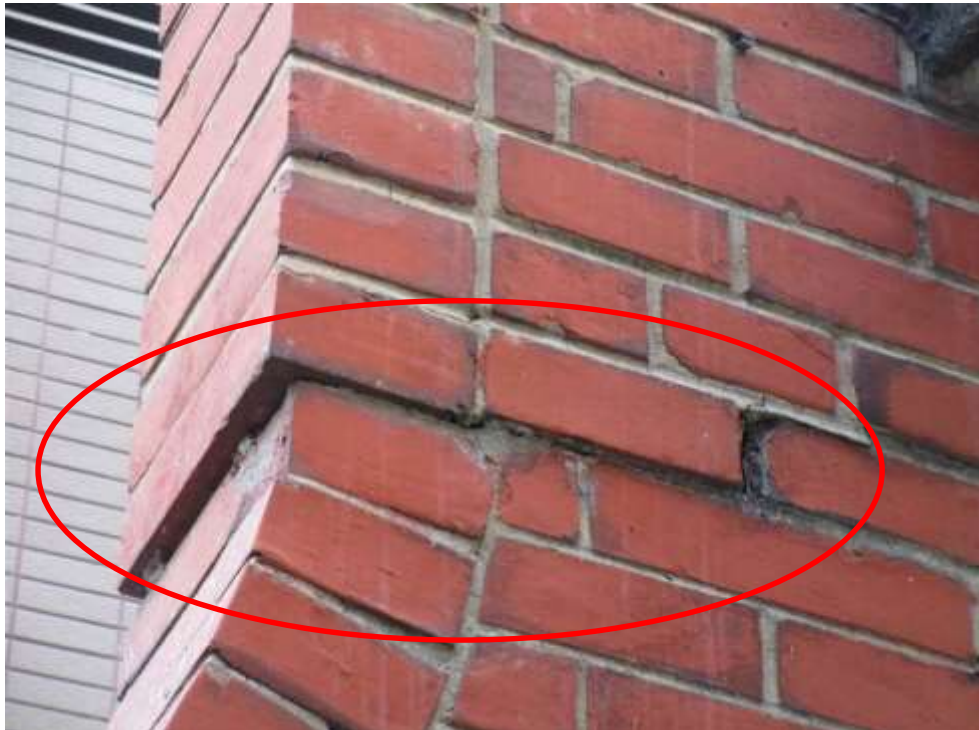
Photo No. 1516

Defect No. 258 **Location** LG/F North wing, Staff quarter **Component** wall

Description 2 areas of slightly misaligned bricks were observed on the wall

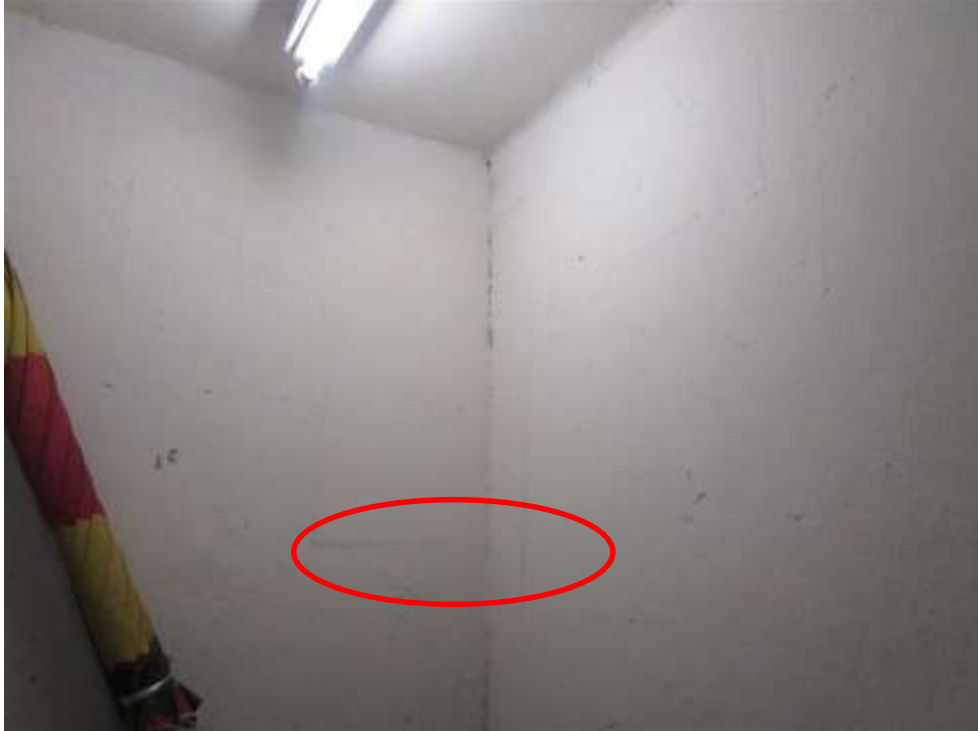
Photo No. 1517

Defect No. 258 **Location** LG/F North wing, Staff quarter **Component** wall

Description 2 areas of slightly misaligned bricks were observed on the wall

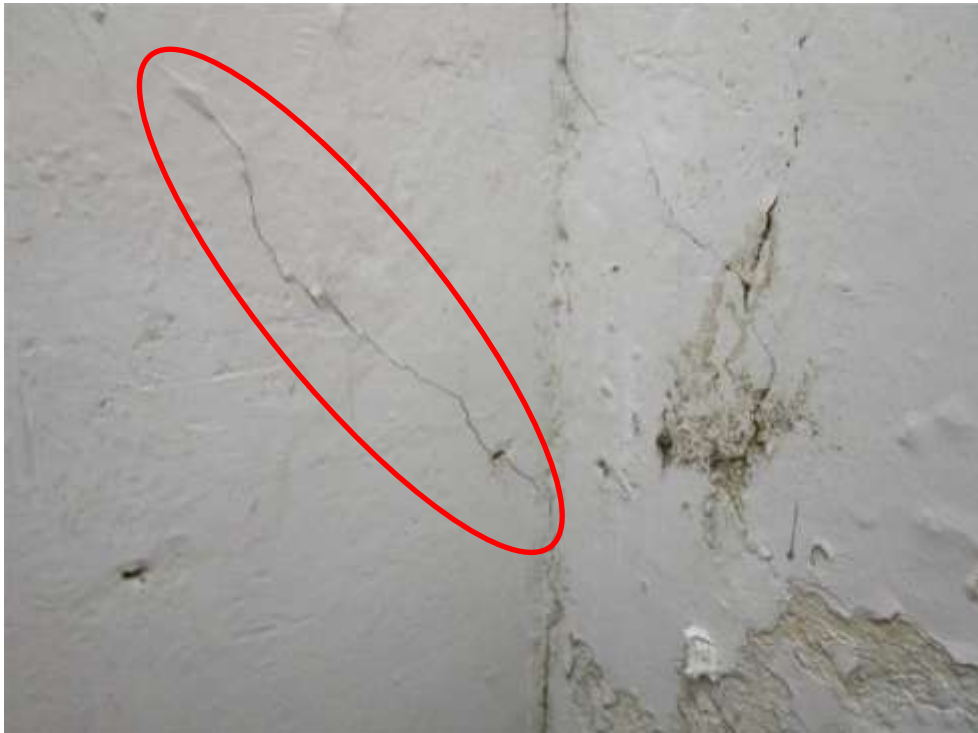
Photo No. 1518

Defect No. 259	Location LG/F North wing, Store room under stairs	Component wall
-----------------------	----------------------------------------------------------	-----------------------

Description An area of medium cracks was observed on wall finishing

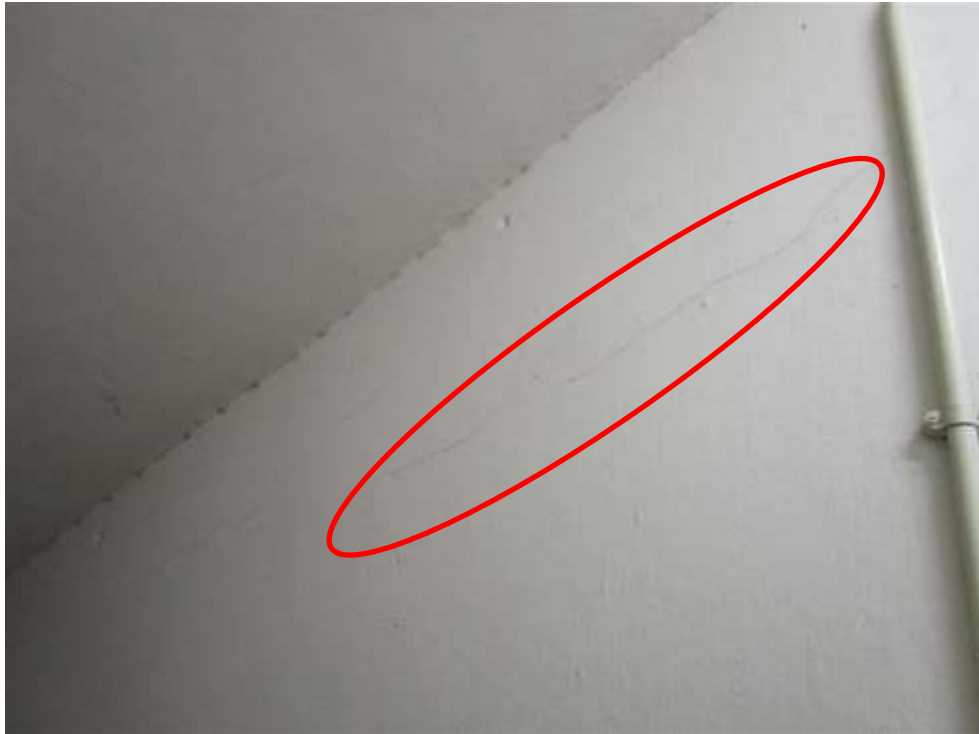
Photo No. 1519

Defect No. 259	Location LG/F North wing, Store room under stairs	Component wall
-----------------------	----------------------------------------------------------	-----------------------

Description An area of medium cracks was observed on wall finishing

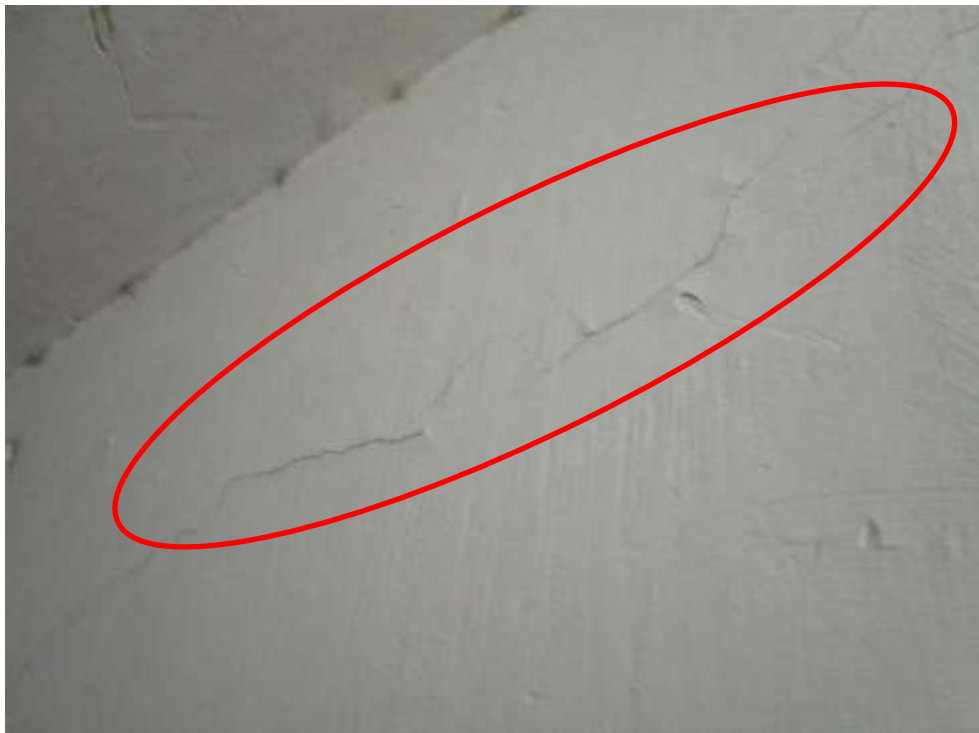
Photo No. 1520

Defect No. 260	Location LG/F North wing, Store room under stairs	Component wall
-----------------------	----------------------------------------------------------	-----------------------

Description A medium crack was observed on wall finishing

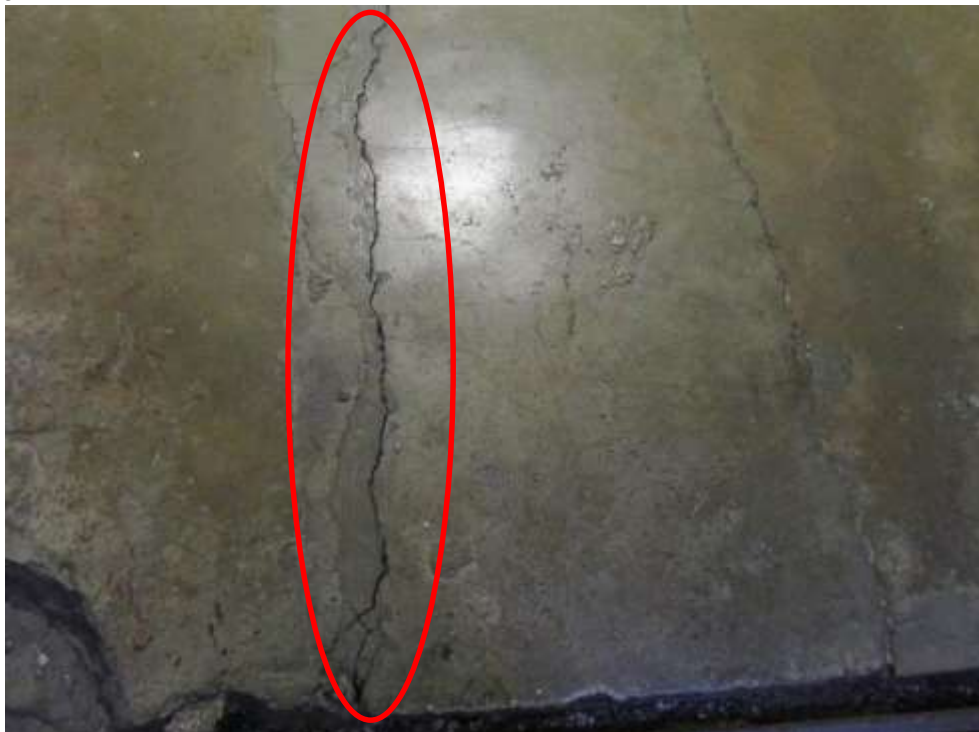
Photo No. 1522

Defect No.	261	Location	LG/F South wing, Corridor	Component	slab
-------------------	-----	-----------------	---------------------------	------------------	------

Description	A wide crack was observed on slab				
--------------------	-----------------------------------	--	--	--	--

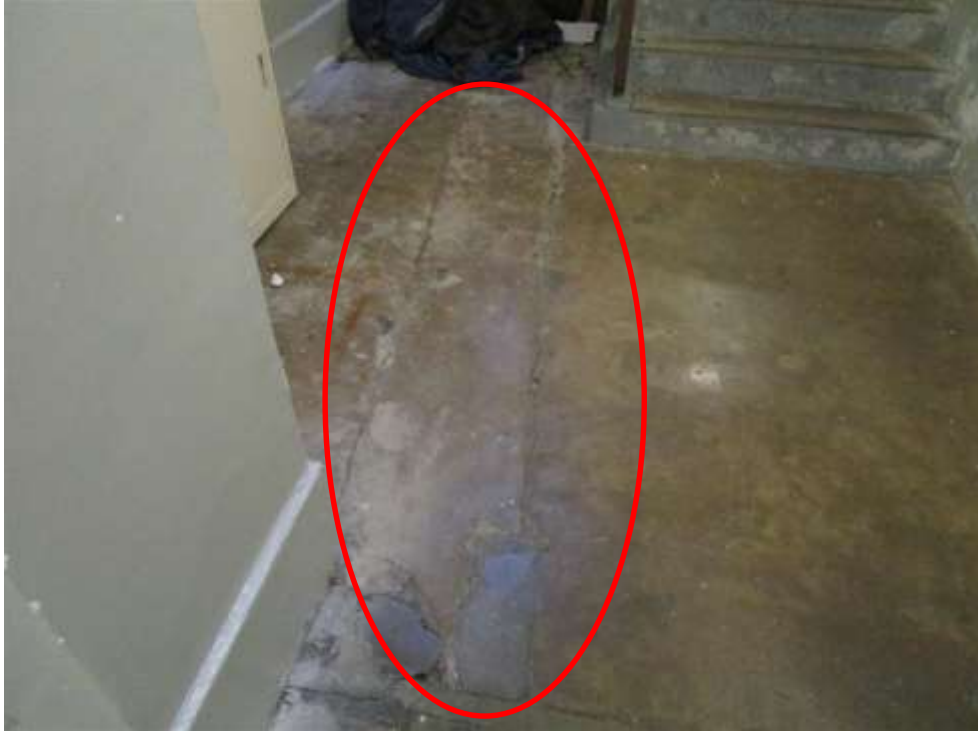
Photo No. 1523

Defect No.	261	Location	LG/F South wing, Corridor	Component	slab
-------------------	-----	-----------------	---------------------------	------------------	------

Description	A wide crack was observed on slab				
--------------------	-----------------------------------	--	--	--	--

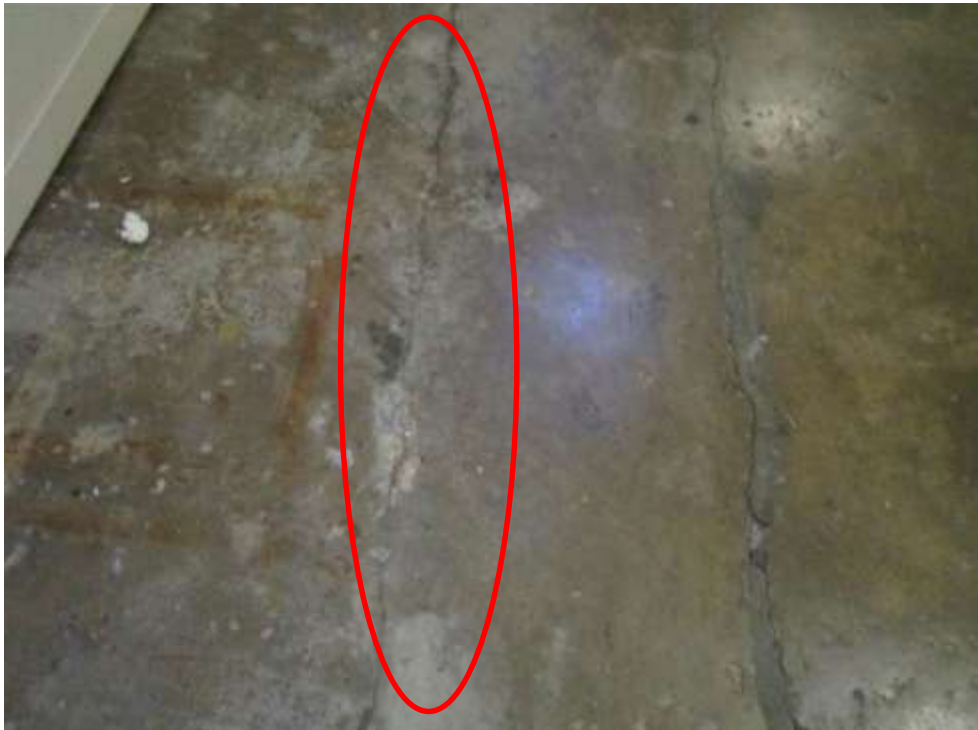
Photo No. 1524

Defect No.	262	Location	LG/F South wing, Corridor	Component	slab
-------------------	-----	-----------------	---------------------------	------------------	------

Description	A wide crack was observed on slab				
--------------------	-----------------------------------	--	--	--	--

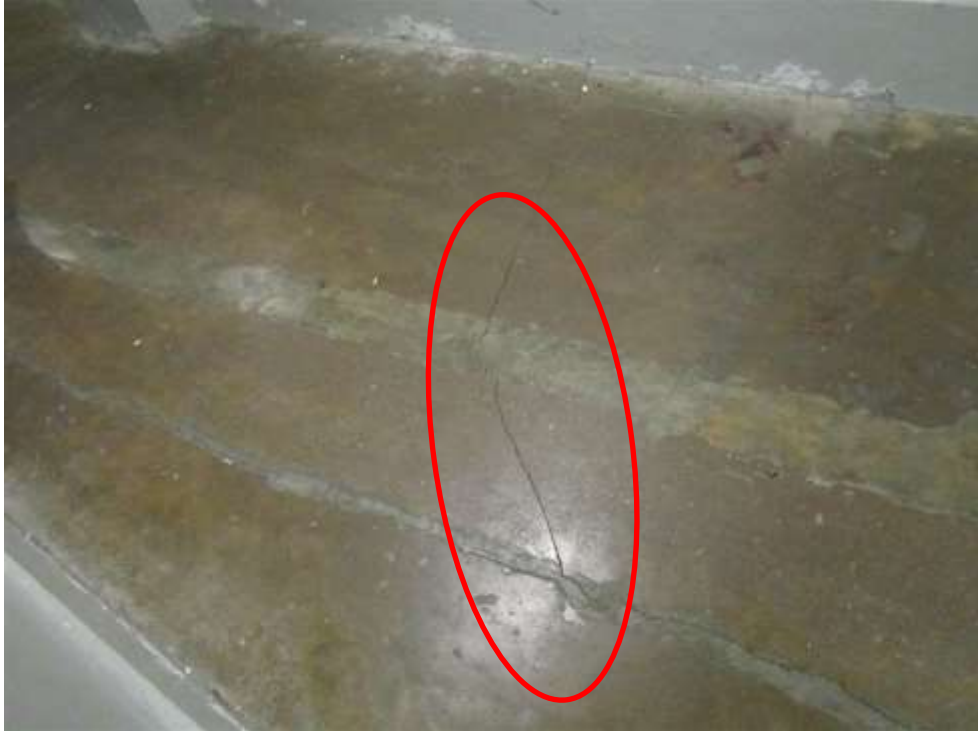
Photo No. 1525

Defect No.	262	Location	LG/F South wing, Corridor	Component	slab
-------------------	-----	-----------------	---------------------------	------------------	------

Description	A wide crack was observed on slab				
--------------------	-----------------------------------	--	--	--	--

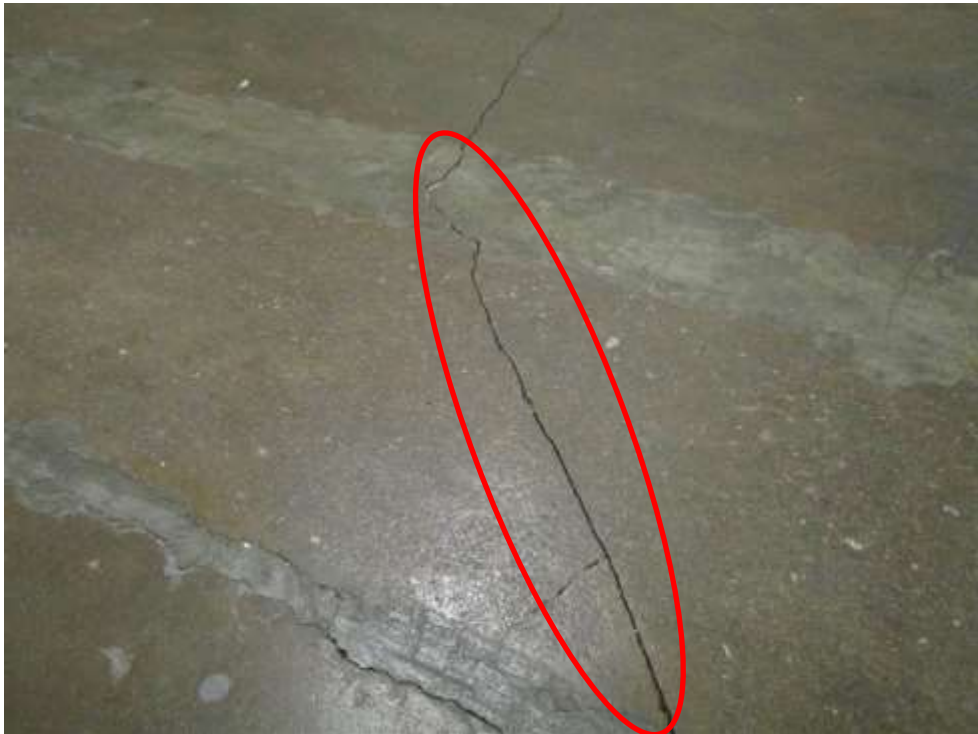
Photo No. 1526

Defect No. 263	Location LG/F South wing, Corridor	Component slab
-----------------------	-------------------------------------------	-----------------------

Description A wide crack was observed on slab

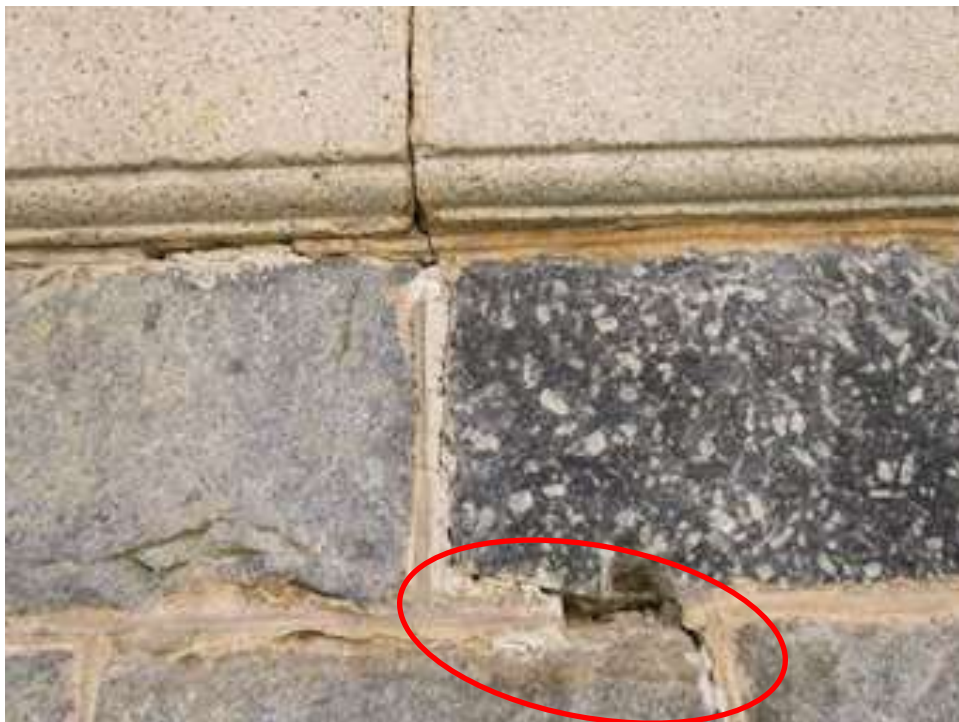
Photo No. 1528

Defect No. 264	Location LG/F South wing, Retaining wall under building	Component retaining wall
-----------------------	----------------------------------------------------------------	---------------------------------

Description A wide crack on joint mortar was observed on retaining wall

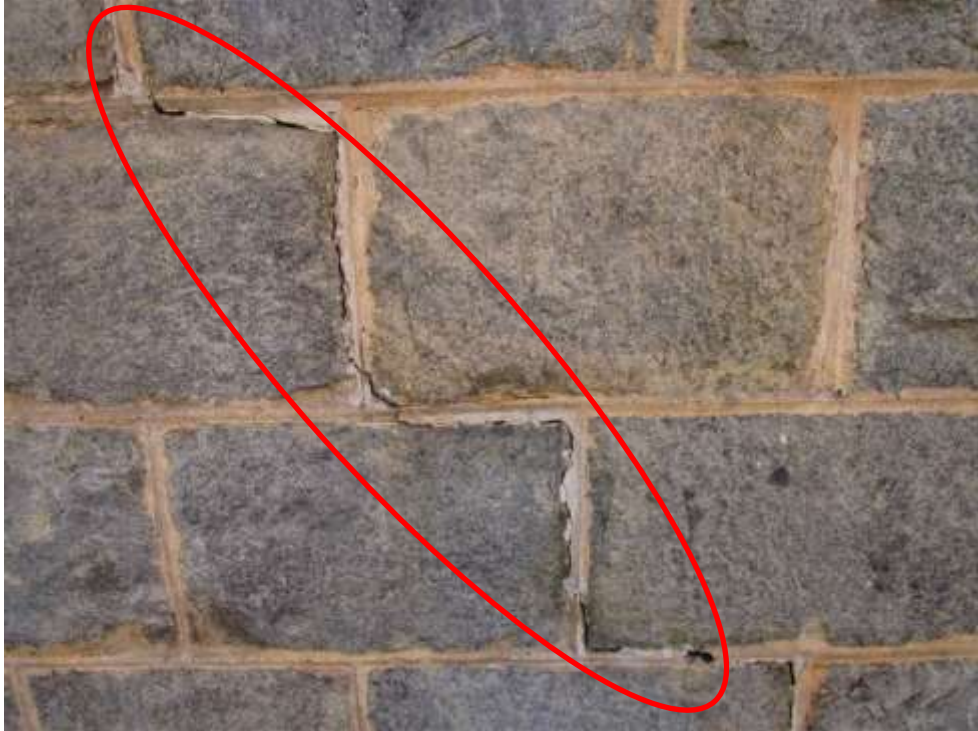
Photo No. 1529

Defect No. 264	Location LG/F South wing, Retaining wall under building	Component retaining wall
-----------------------	----------------------------------------------------------------	---------------------------------

Description A wide crack on joint mortar was observed on retaining wall

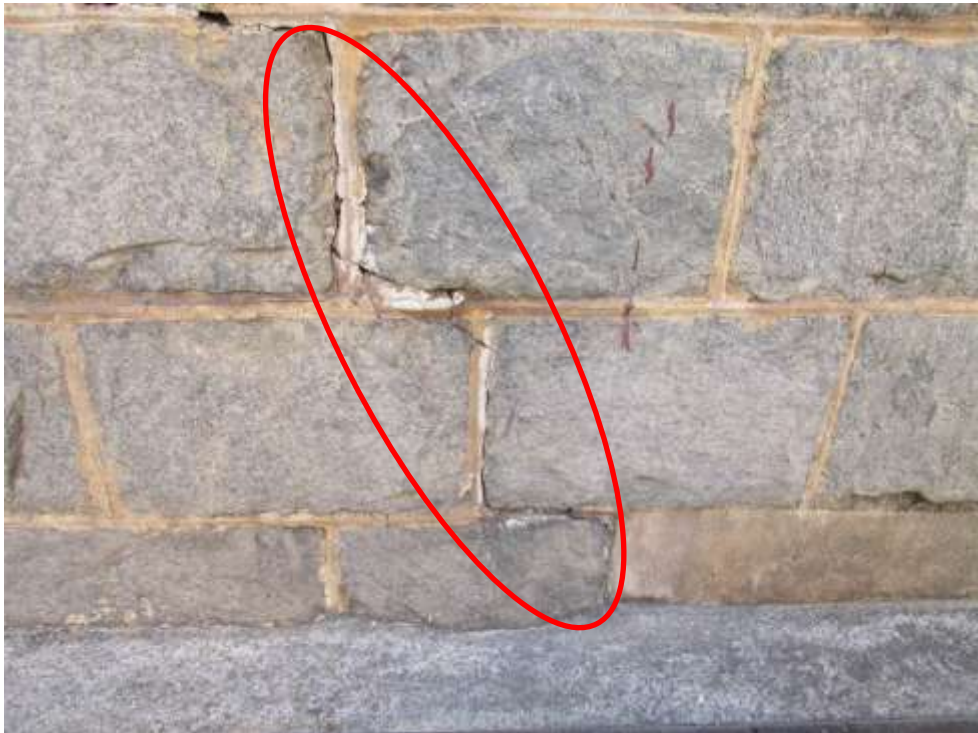
Photo No. 1530

Defect No. 265	Location LG/F South wing, Retaining wall under building	Component retaining wall
-----------------------	----------------------------------------------------------------	---------------------------------

Description A wide crack on joint mortar was observed on retaining wall

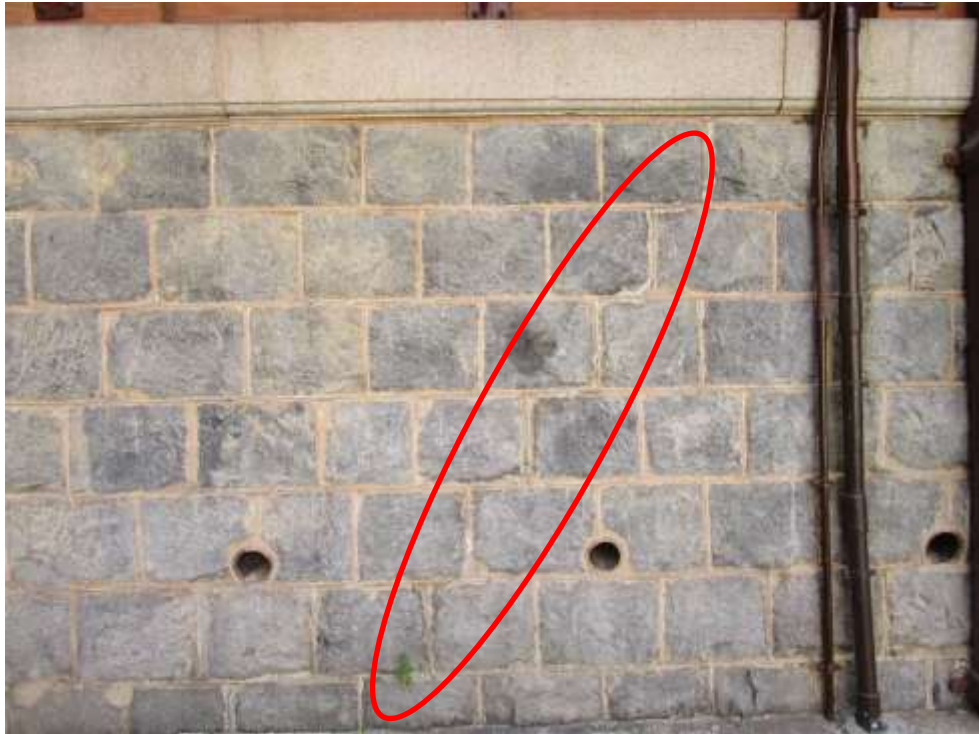
Photo No. 1531

Defect No. 265	Location LG/F South wing, Retaining wall under building	Component retaining wall
-----------------------	----------------------------------------------------------------	---------------------------------

Description A wide crack on joint mortar was observed on retaining wall

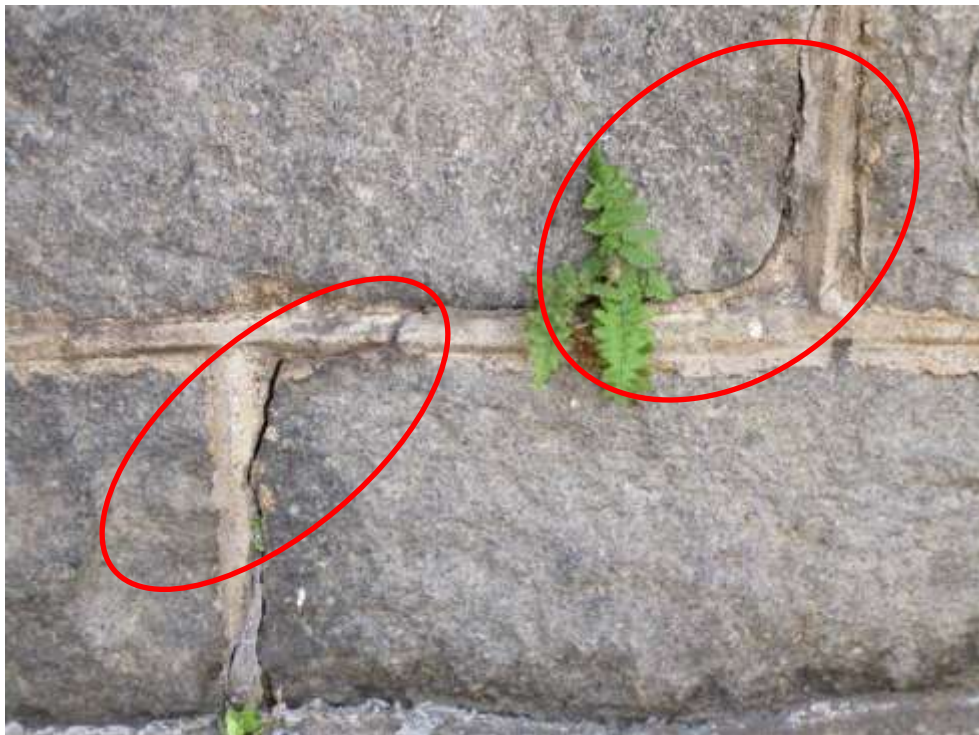
Photo No. 1532

Defect No. 266	Location LG/F South wing, Retaining wall under building	Component retaining wall
-----------------------	----------------------------------------------------------------	---------------------------------

Description A wide crack on joint mortar with vegetation growth was observed on retaining wall

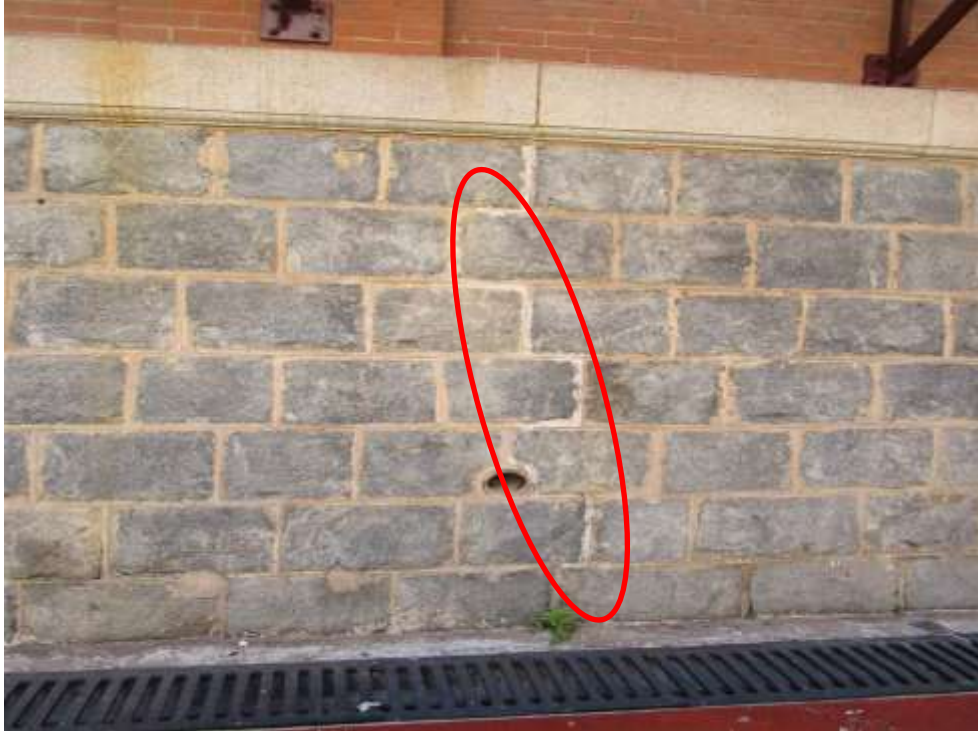
Photo No. 1533

Defect No. 266	Location LG/F South wing, Retaining wall under building	Component retaining wall
-----------------------	----------------------------------------------------------------	---------------------------------

Description A wide crack on joint mortar with vegetation growth was observed on retaining wall

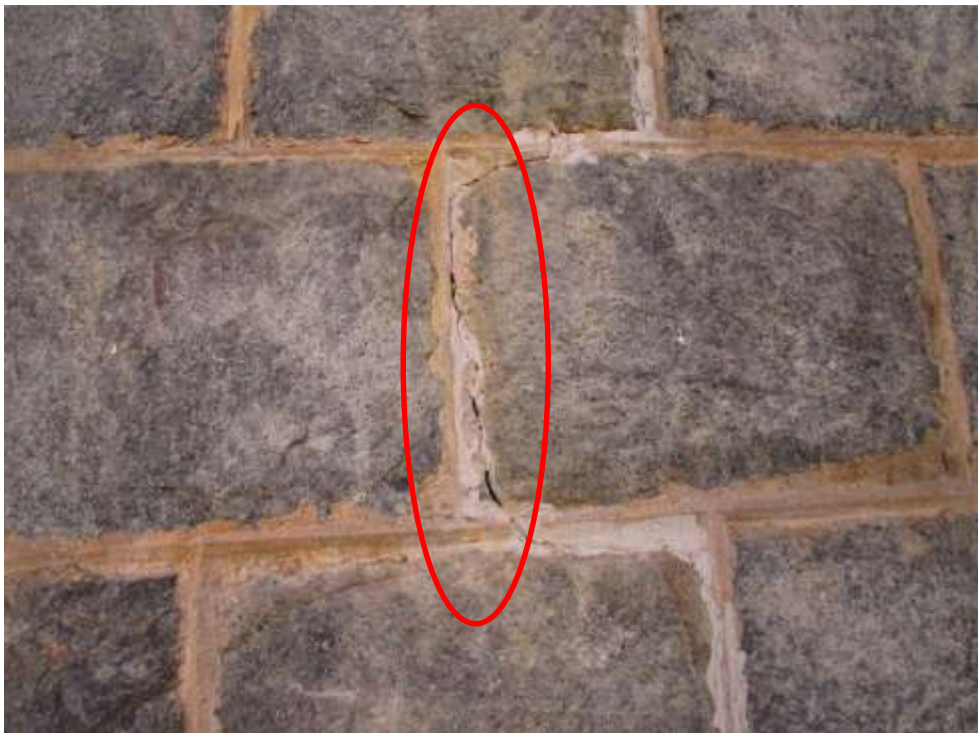
Photo No. 1534

Defect No. 267	Location LG/F South wing, Retaining wall under building	Component retaining wall
-----------------------	----------------------------------------------------------------	---------------------------------

Description A wide crack was observed on mortar joint of retaining wall with sign of previous repair

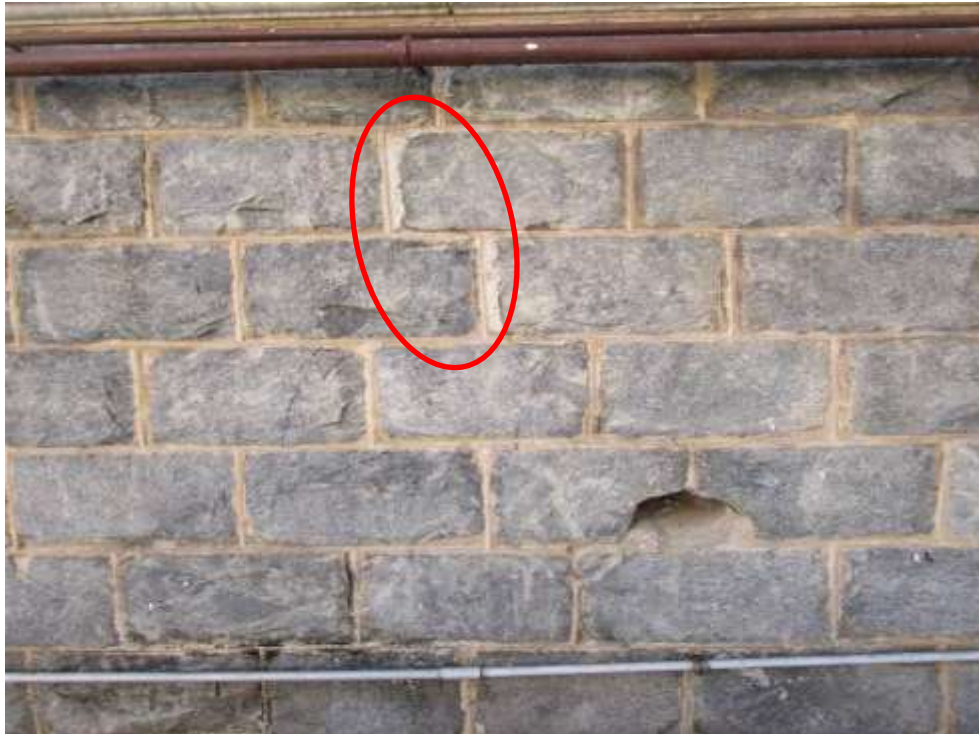
Photo No. 1535

Defect No. 267	Location LG/F South wing, Retaining wall under building	Component retaining wall
-----------------------	----------------------------------------------------------------	---------------------------------

Description A wide crack was observed on mortar joint of retaining wall with sign of previous repair
