**Slope Upgrading Works at
Feature No. 11SW-A/R526,
King's College,
Bonham Road, Hong Kong**

Project Profile for Slope Upgrading Works at
Feature No. 11SW-A/R526, King's College

May 2018

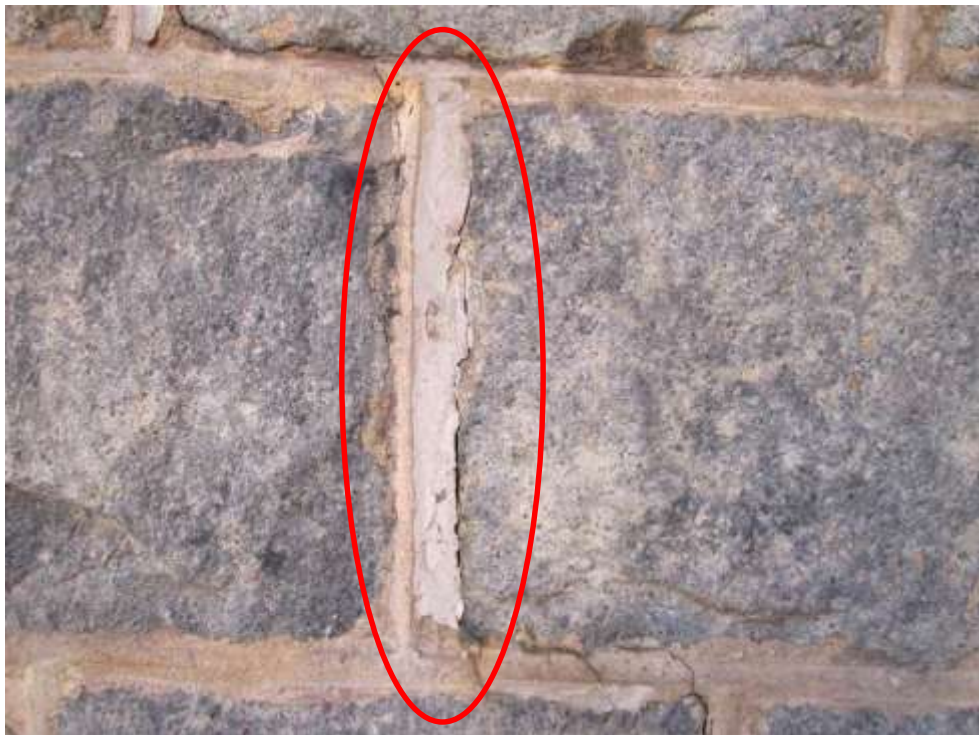
Photo No. 1536

Defect No.	268	Location	LG/F South wing, Retaining wall under building	Component	retaining wall
-------------------	-----	-----------------	------------------------------------------------	------------------	----------------

Description A wide crack was observed on mortar joint of retaining wall with sign of previous repair

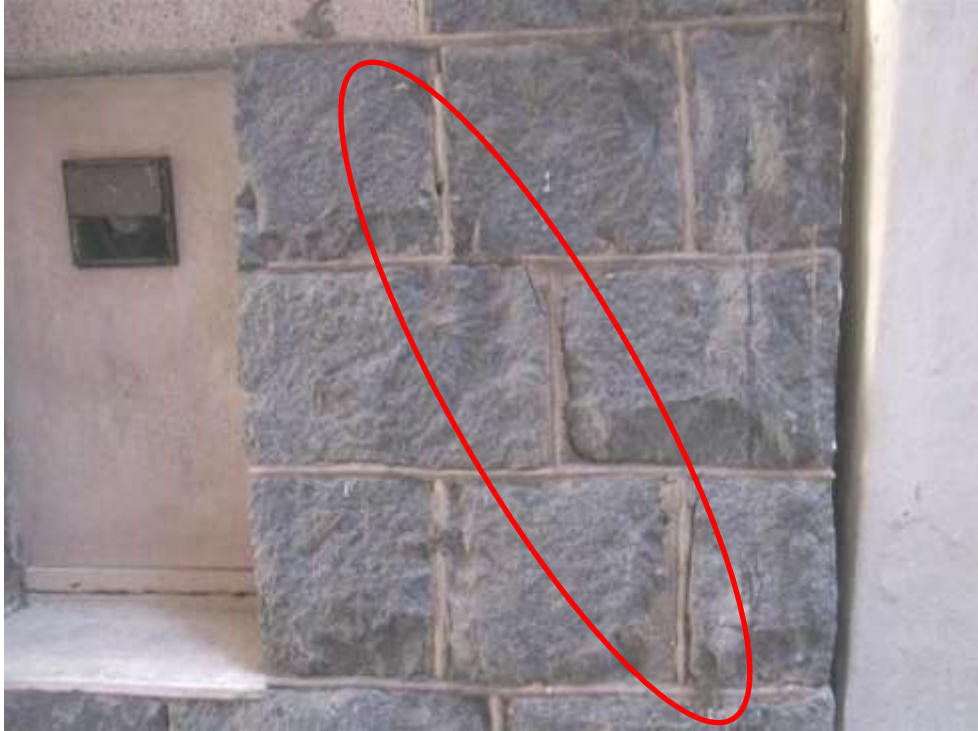
Photo No. 1537

Defect No.	268	Location	LG/F South wing, Retaining wall under building	Component	retaining wall
-------------------	-----	-----------------	------------------------------------------------	------------------	----------------

Description A wide crack was observed on mortar joint of retaining wall with sign of previous repair

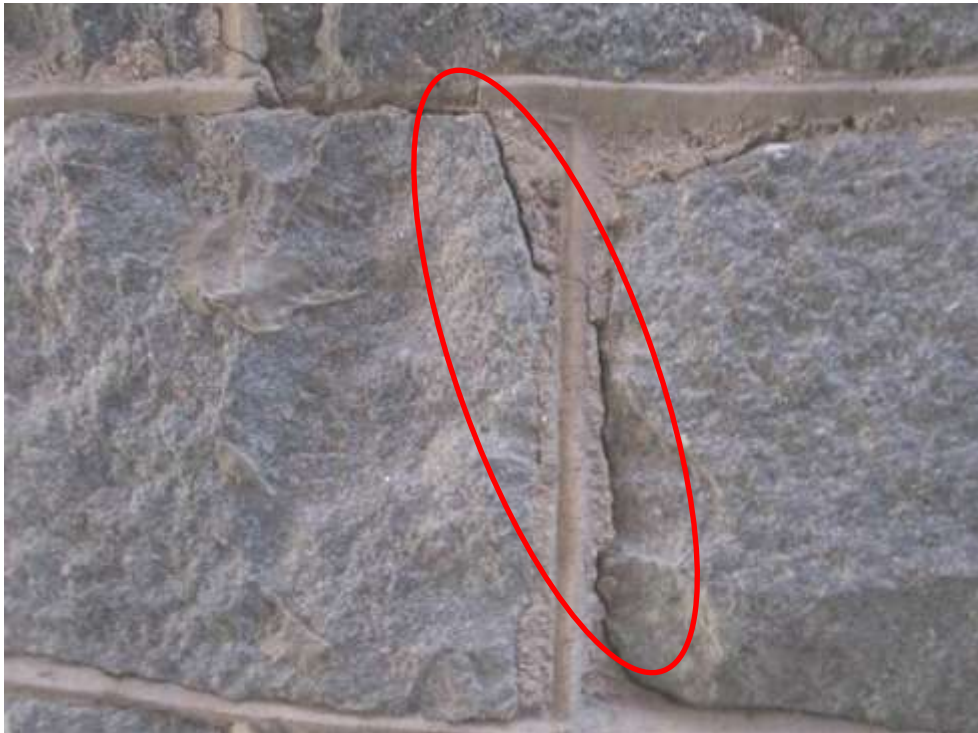
Photo No. 1538

Defect No. 269	Location LG/F South wing, Retaining wall under building	Component retaining wall
-----------------------	----------------------------------------------------------------	---------------------------------

Description A wide crack was observed on retaining wall mortar joint

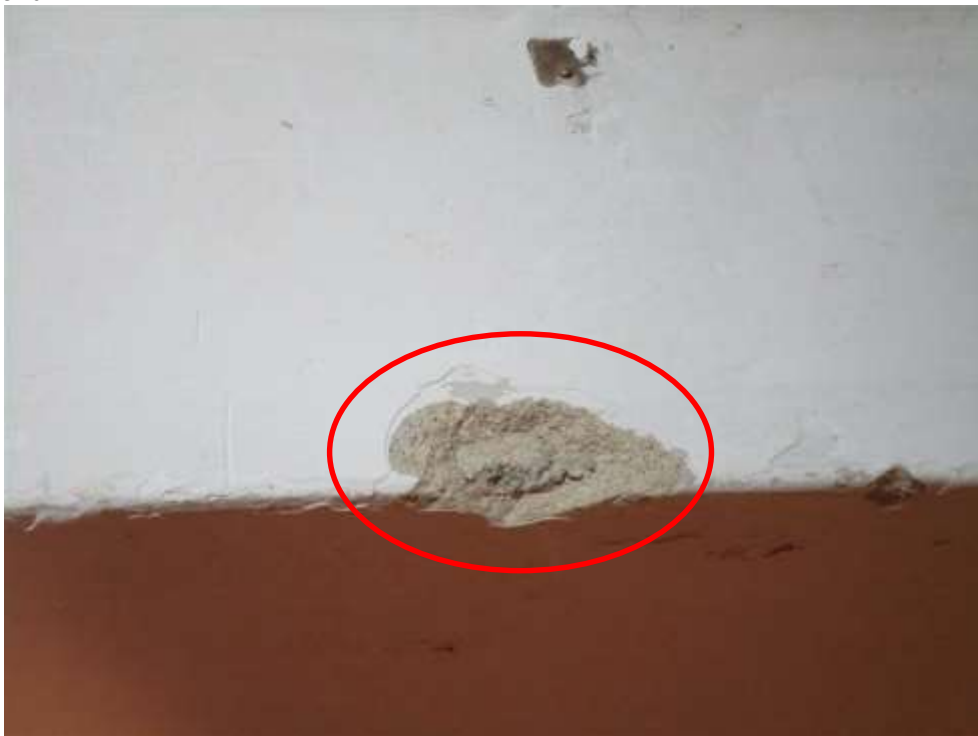
Photo No. 1540

Defect No.	270	Location	LG/F South wing, Scout room	Component	beam
-------------------	-----	-----------------	-----------------------------	------------------	------

Description	Minor chipped edge of beam finishing				
--------------------	--------------------------------------	--	--	--	--

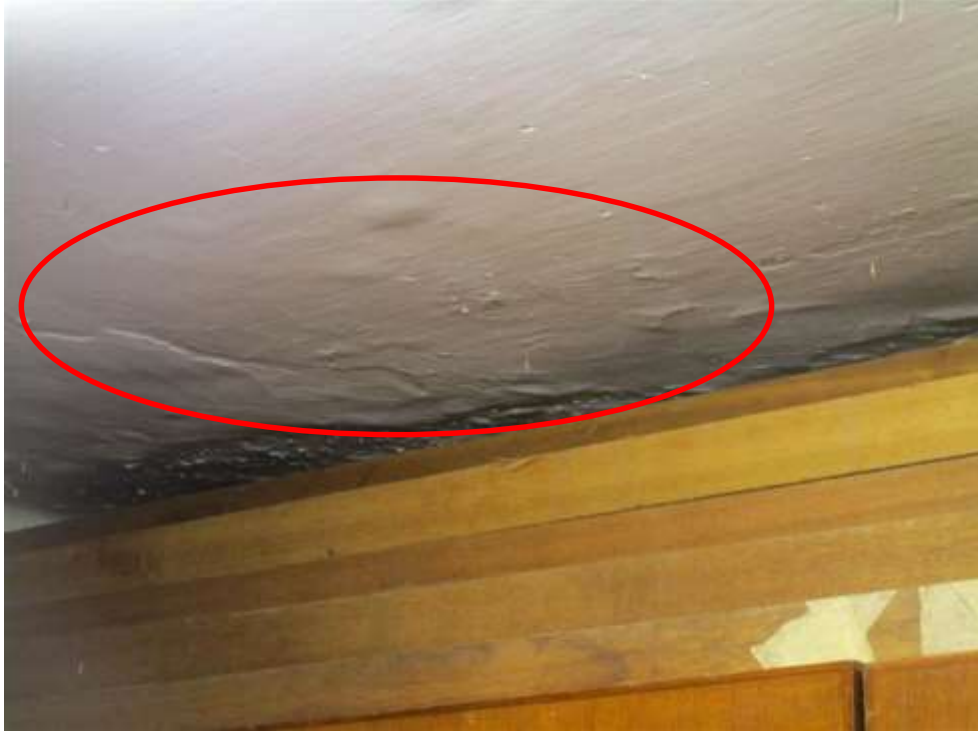
Photo No. 1541

Defect No.	270	Location	LG/F South wing, Scout room	Component	beam
-------------------	-----	-----------------	-----------------------------	------------------	------

Description	Minor chipped edge of beam finishing				
--------------------	--------------------------------------	--	--	--	--

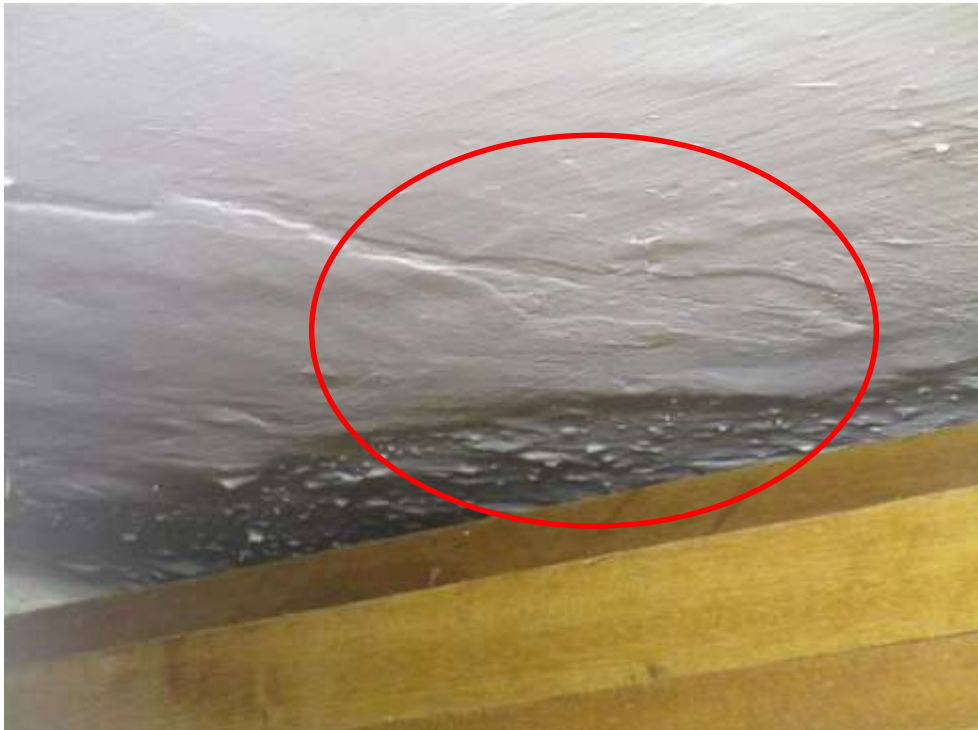
Photo No. 1542

Defect No. 271	Location LG/F South wing, Scout room	Component slab
-----------------------	---------------------------------------------	-----------------------

Description A paint peeling was observed on slab soffit

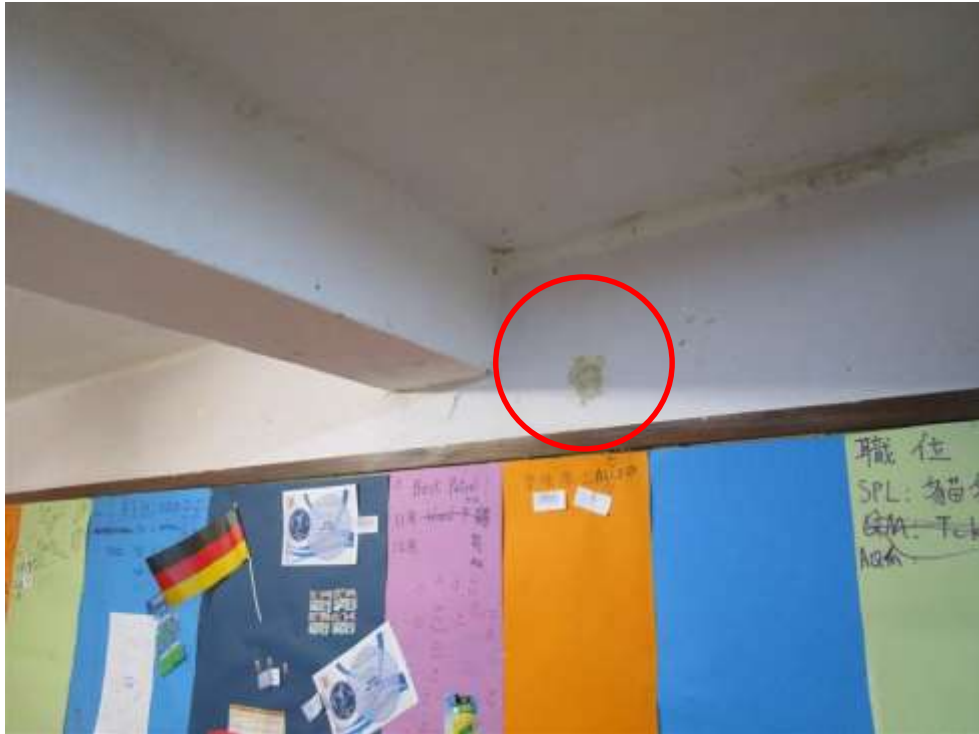
Photo No. 1543

Defect No. 271	Location LG/F South wing, Scout room	Component slab
-----------------------	---------------------------------------------	-----------------------

Description A paint peeling was observed on slab soffit

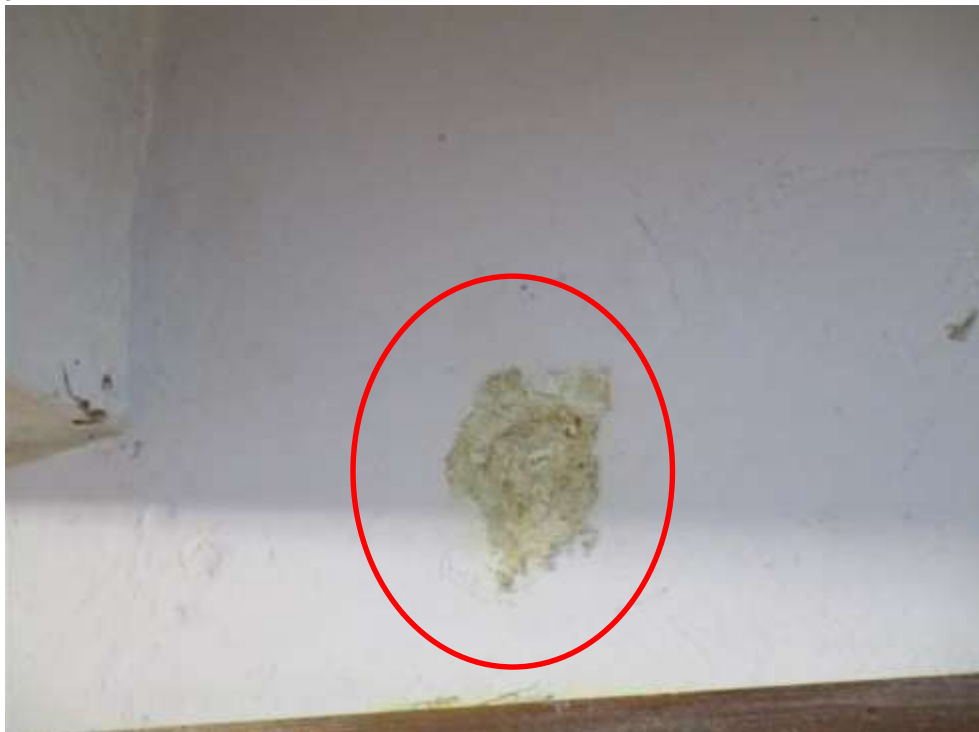
Photo No. 1544

Defect No. 272 **Location** LG/F South wing, Scout room **Component** wall

Description Stain mark was observed on beam finishing

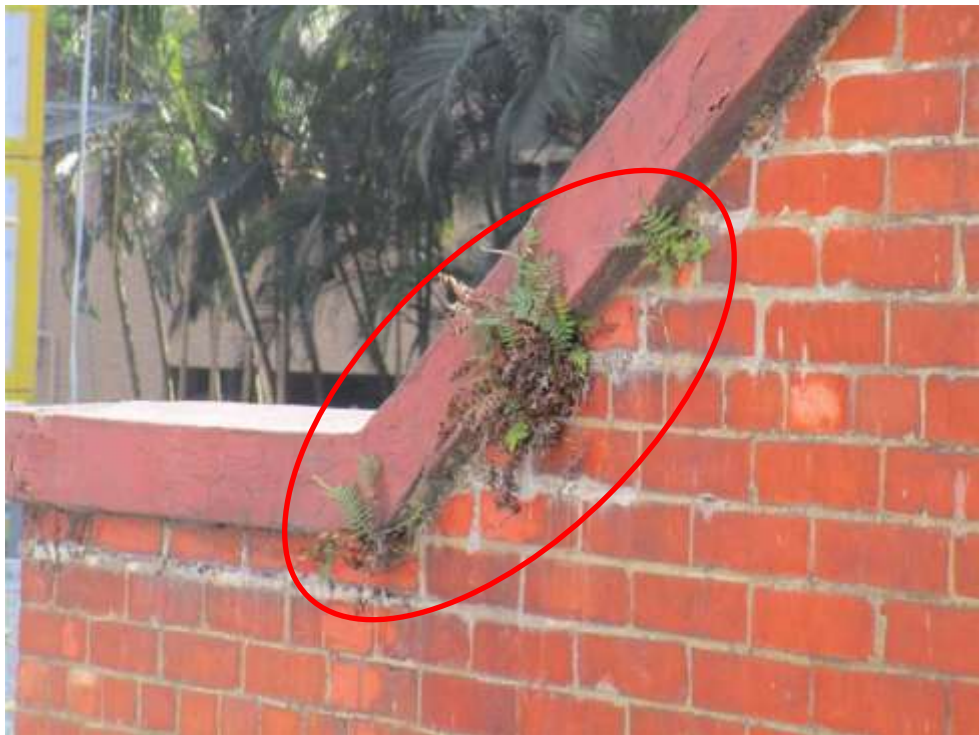
Photo No. 1546

Defect No. 273	Location R/F East wing, Assembly hall's roof	Component brick wall
-----------------------	-----------------------------------------------------	-----------------------------

Description A vegetation growth was observed on brick wall

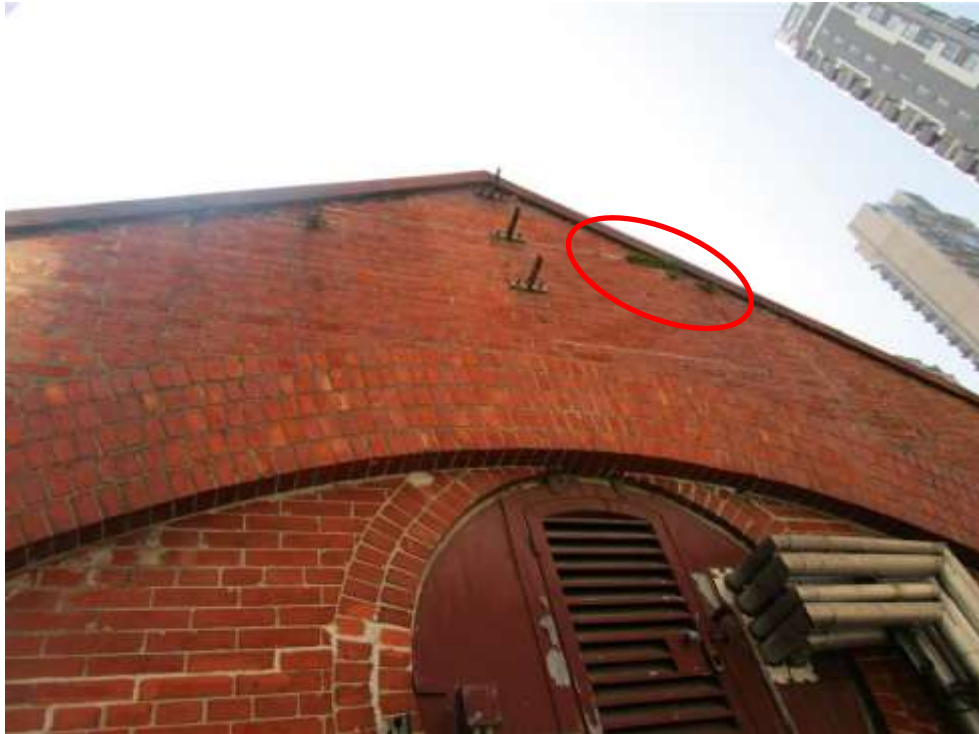
Photo No. 1547

Defect No. 273	Location R/F East wing, Assembly hall's roof	Component brick wall
-----------------------	-----------------------------------------------------	-----------------------------

Description A vegetation growth was observed on brick wall

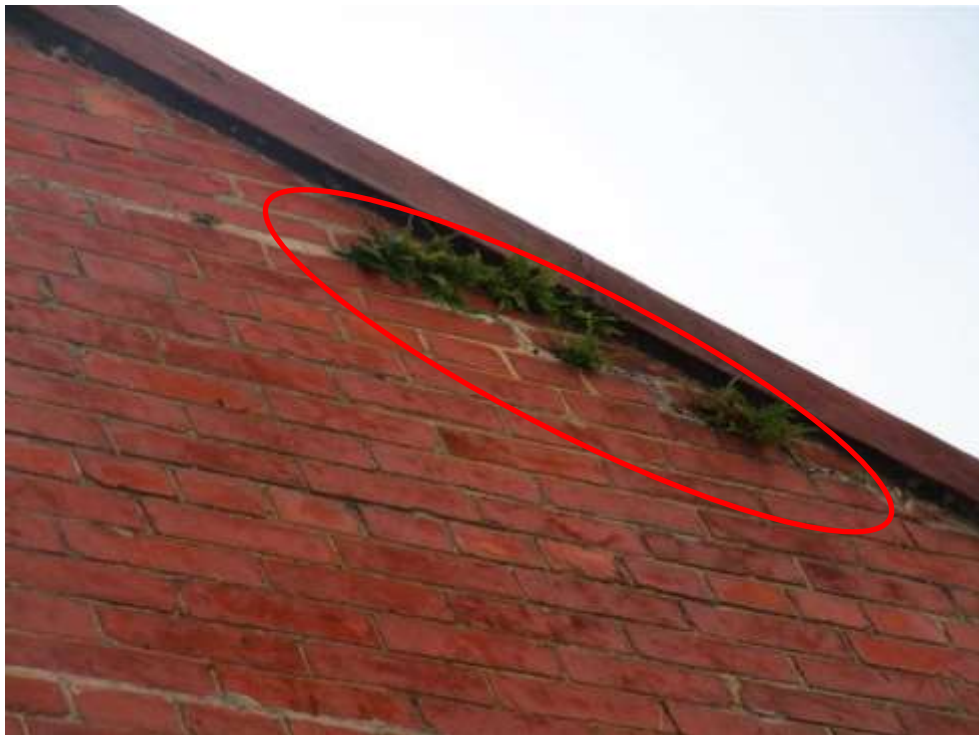
Photo No. 1548

Defect No. 274	Location R/F East wing, Assembly hall's roof	Component brick wall
-----------------------	-----------------------------------------------------	-----------------------------

Description A vegetation growth was observed on brick wall

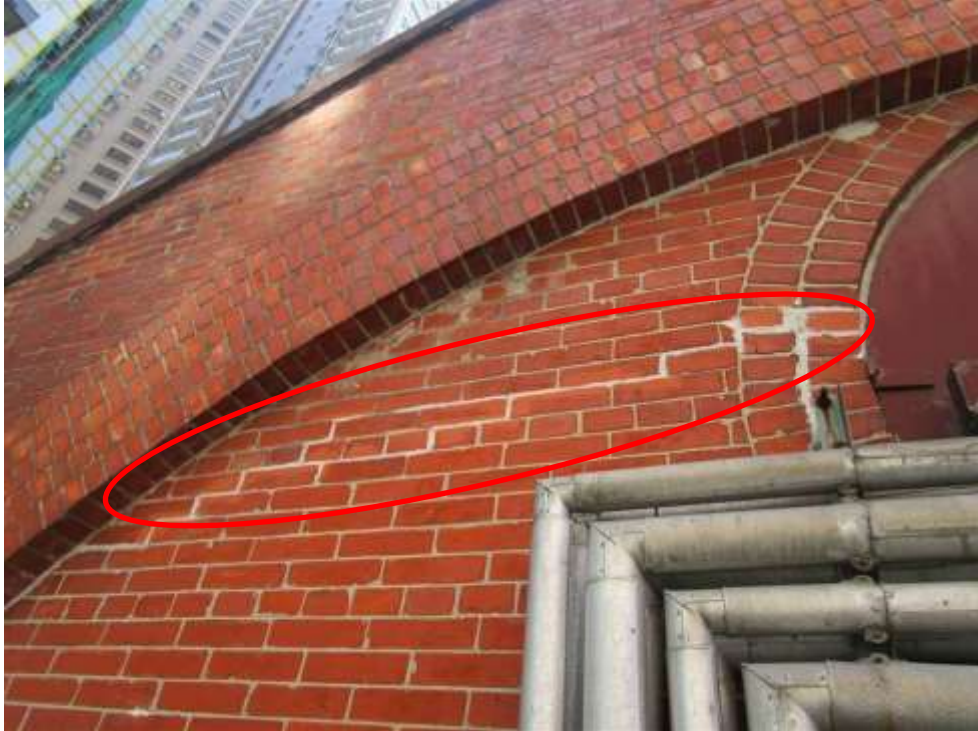
Photo No. 1549

Defect No. 274	Location R/F East wing, Assembly hall's roof	Component brick wall
-----------------------	-----------------------------------------------------	-----------------------------

Description A vegetation growth was observed on brick wall

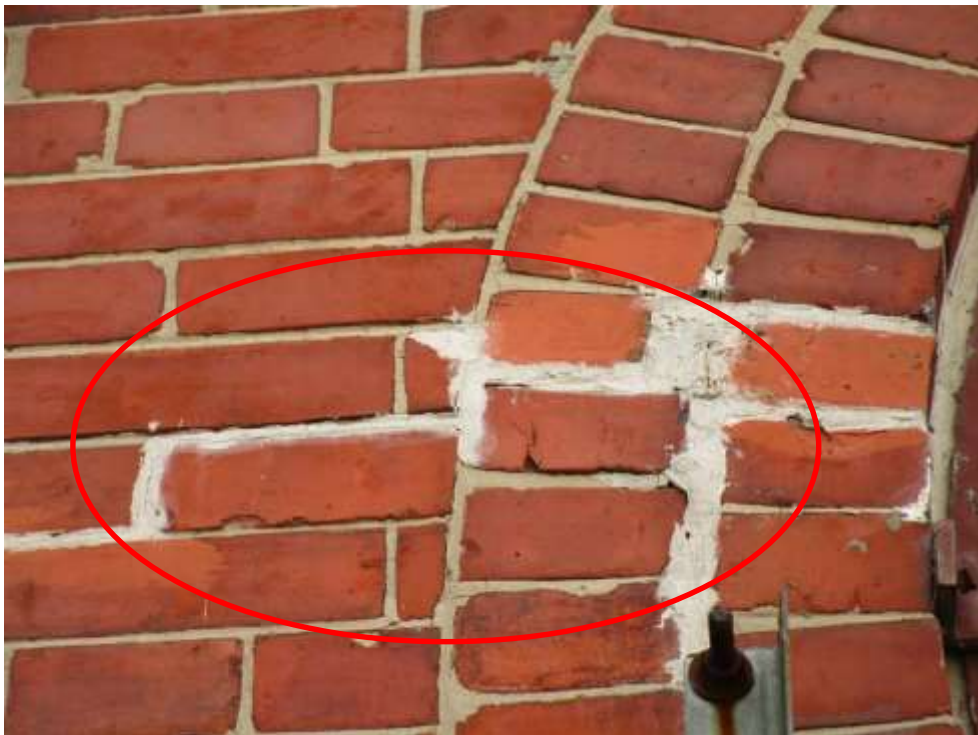
Photo No. 1550

Defect No. 275	Location R/F East wing, Assembly hall's roof	Component brick wall
-----------------------	-----------------------------------------------------	-----------------------------

Description Fine crack on mortar joint with sign of previous repair on brick wall

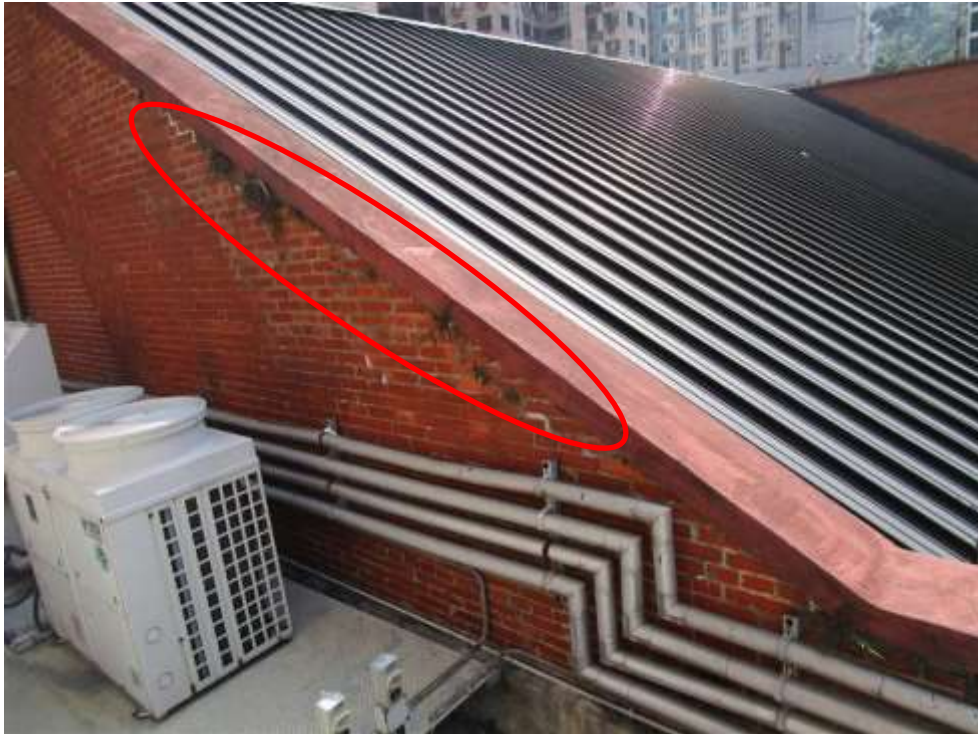
Photo No. 1551

Defect No. 275	Location R/F East wing, Assembly hall's roof	Component brick wall
-----------------------	-----------------------------------------------------	-----------------------------

Description Fine crack on mortar joint with sign of previous repair on brick wall

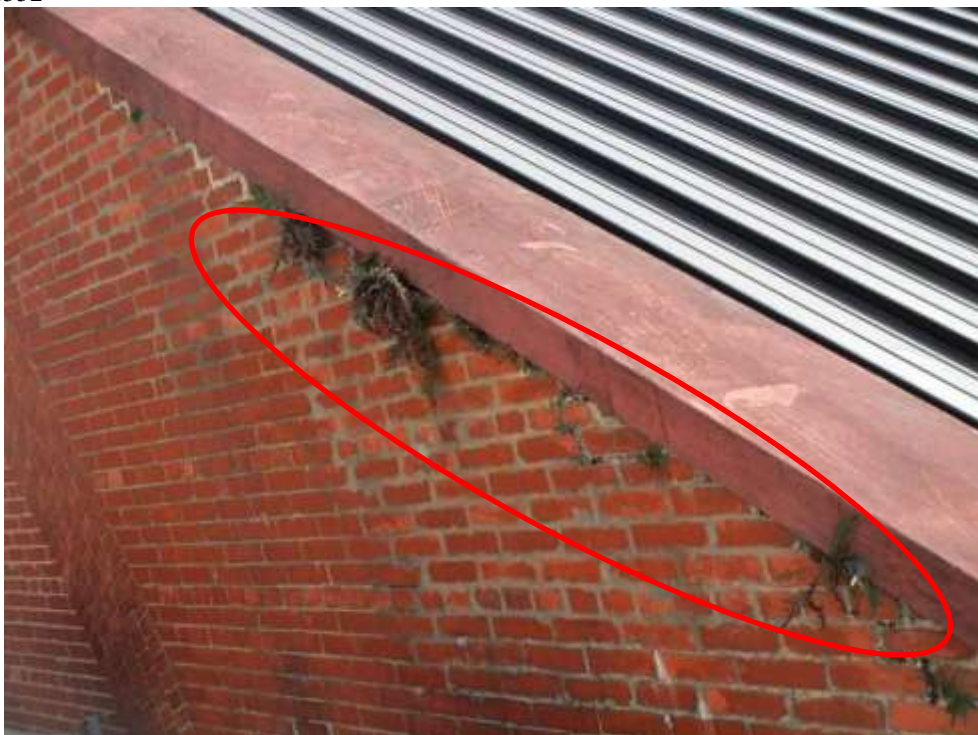
Photo No. 1552

Defect No. 276	Location R/F East wing, Assembly hall's roof	Component brick wall
-----------------------	-----------------------------------------------------	-----------------------------

Description A vegetation growth was observed on brick wall

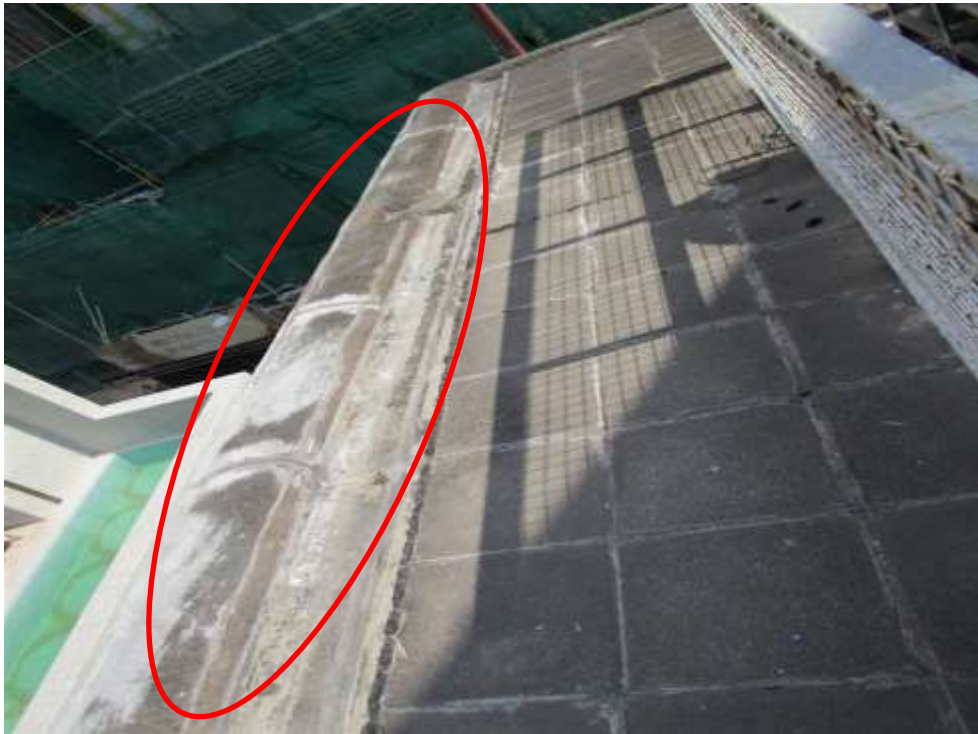
Photo No. 1554

Defect No. 277 **Location** R/F East wing, Roof **Component** capping

Description An area of wide crack was observed on capping

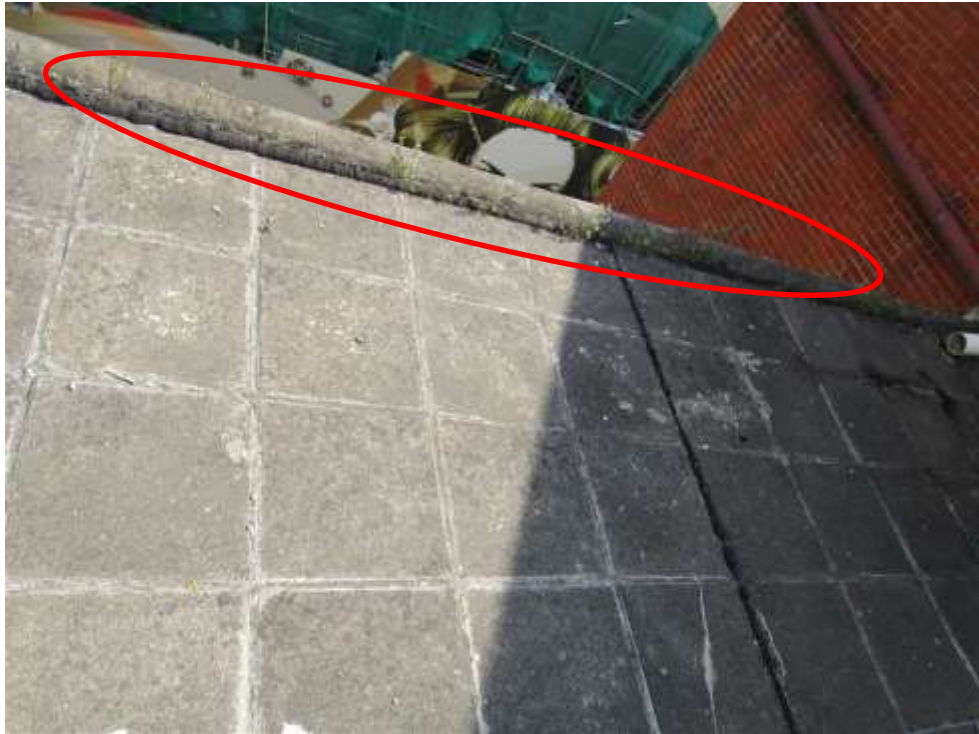
Photo No. 1555

Defect No. 277 **Location** R/F East wing, Roof **Component** capping

Description An area of wide crack was observed on capping

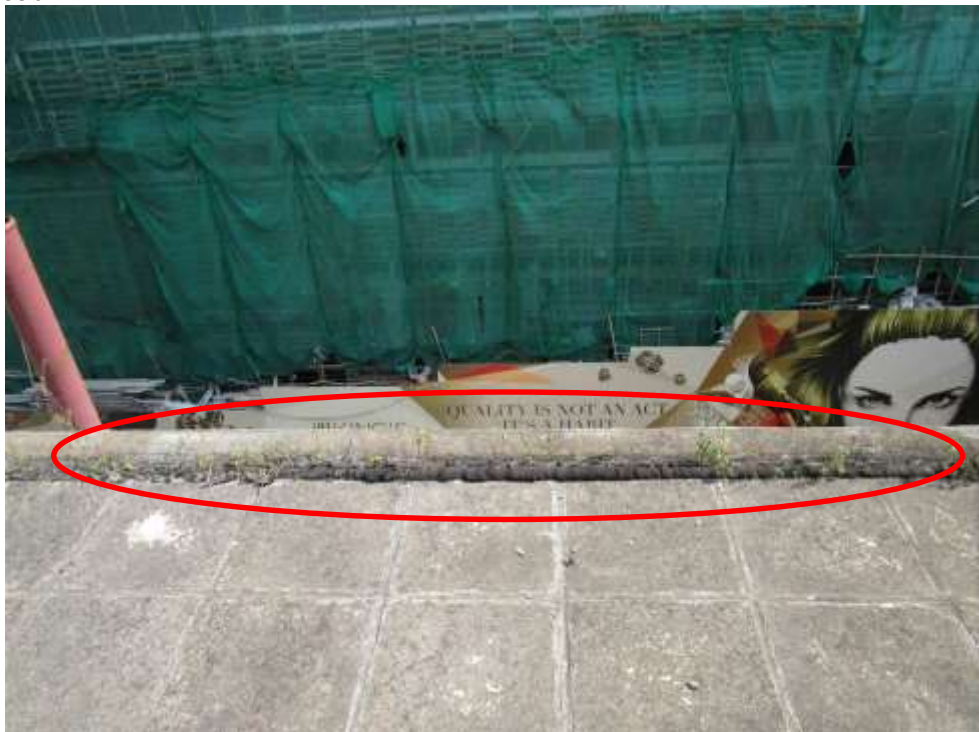
Photo No. 1556

Defect No.	278	Location	R/F East wing, Roof	Component	capping
-------------------	-----	-----------------	---------------------	------------------	---------

Description	An area of wide crack was observed on capping				
--------------------	-----------------------------------------------	--	--	--	--

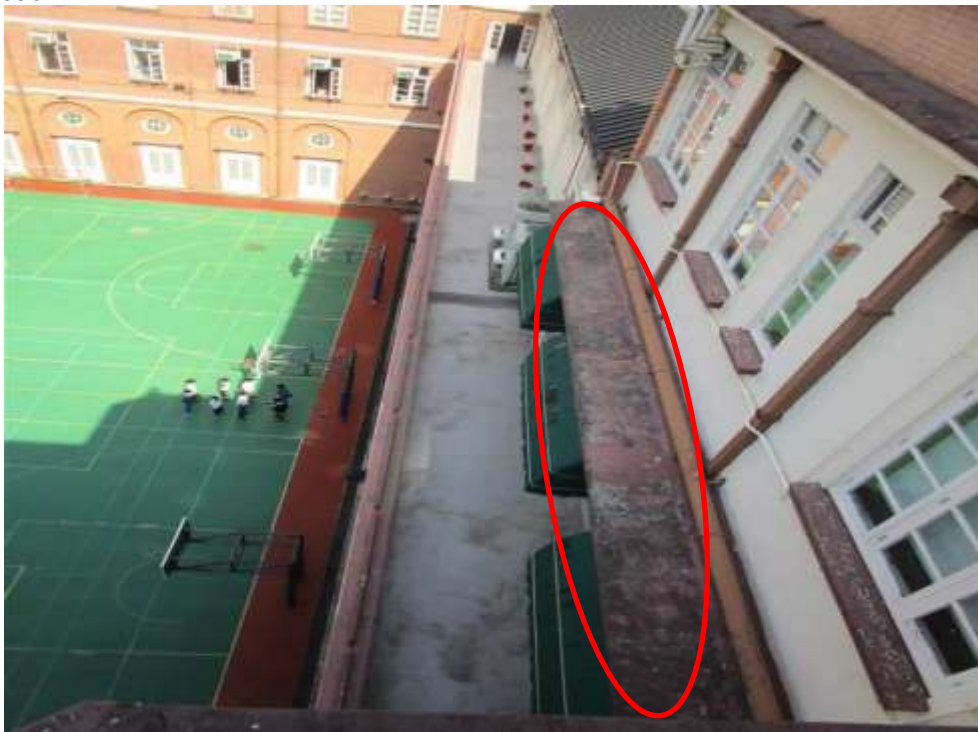
Photo No. 1558

Defect No. 279 **Location** R/F East wing, West elevation **Component** canopy

Description Deteriorated paint was observed on top face of canopies

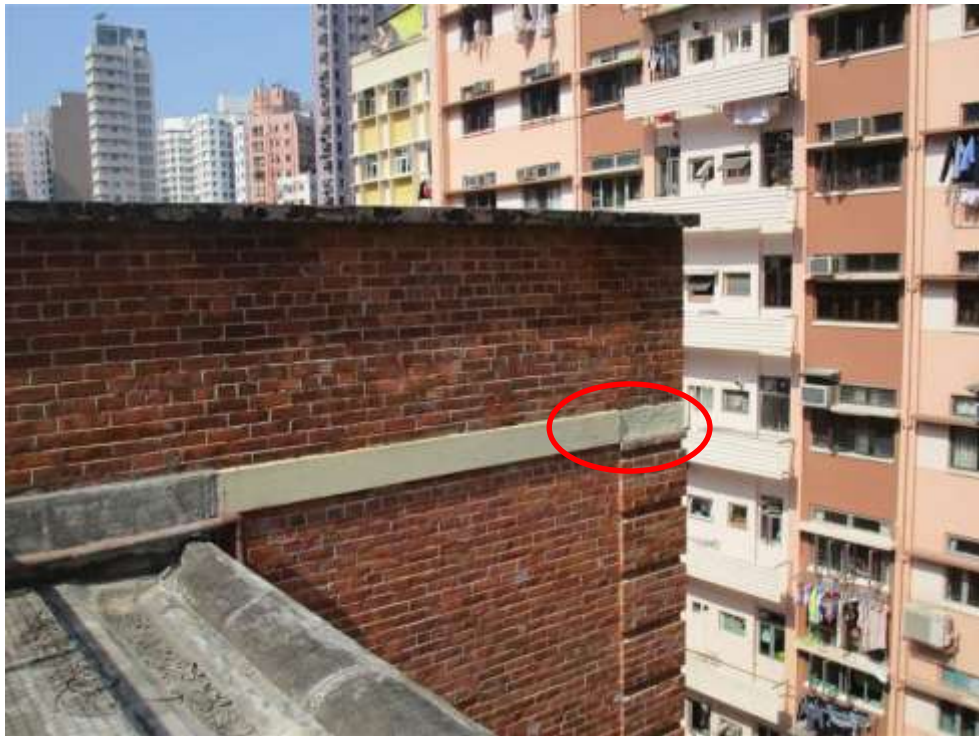
Photo No. 1559

Defect No. 279 **Location** R/F East wing, West elevation **Component** canopy

Description Deteriorated paint was observed on top face of canopies

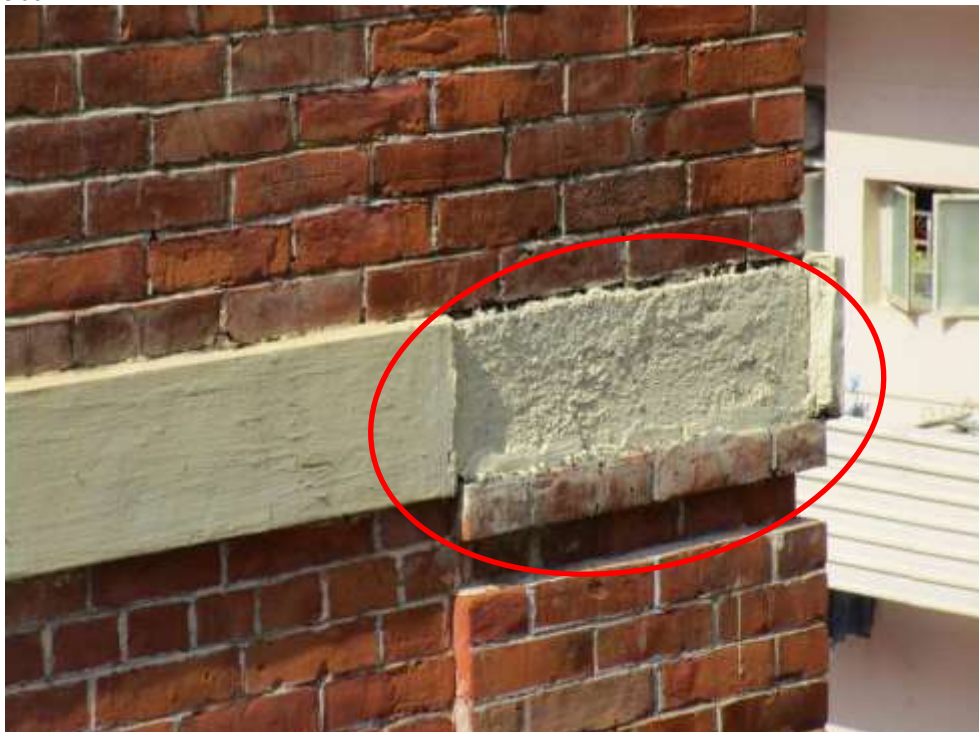
Photo No. 1560

Defect No.	280	Location	R/F North wing, Roof	Component	beam
-------------------	-----	-----------------	----------------------	------------------	------

Description	The edge of the beam was found missing				
--------------------	----------------------------------------	--	--	--	--

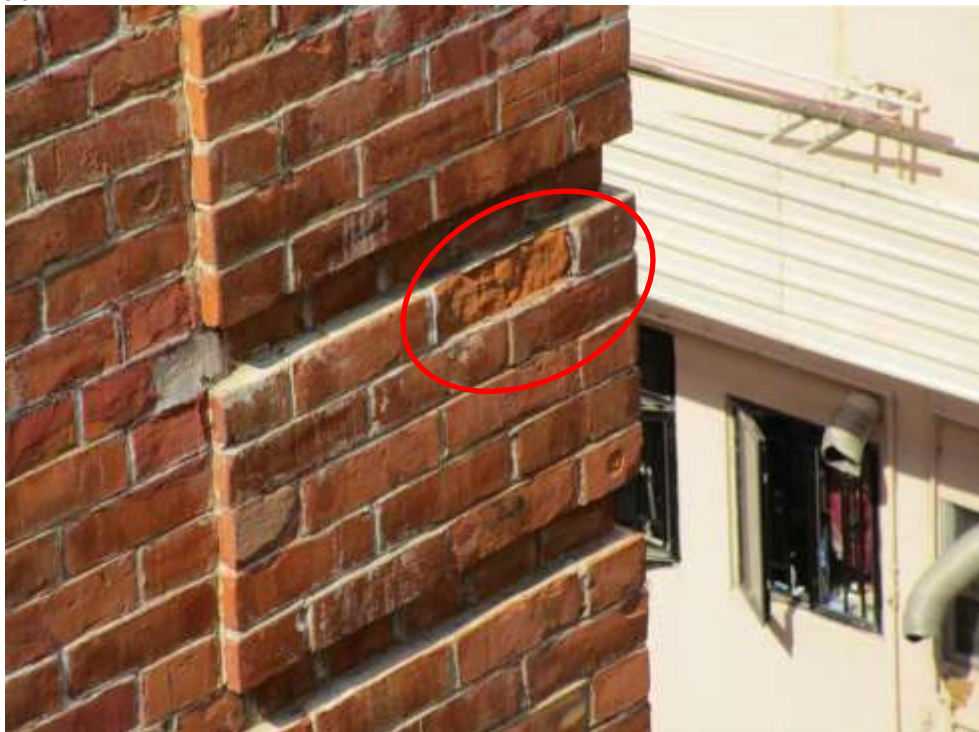
Photo No. 1562

Defect No.	281	Location	R/F North wing, Roof	Component	brick wall
-------------------	-----	-----------------	----------------------	------------------	------------

Description	A delaminated brick was observed on the wall				
--------------------	----------------------------------------------	--	--	--	--

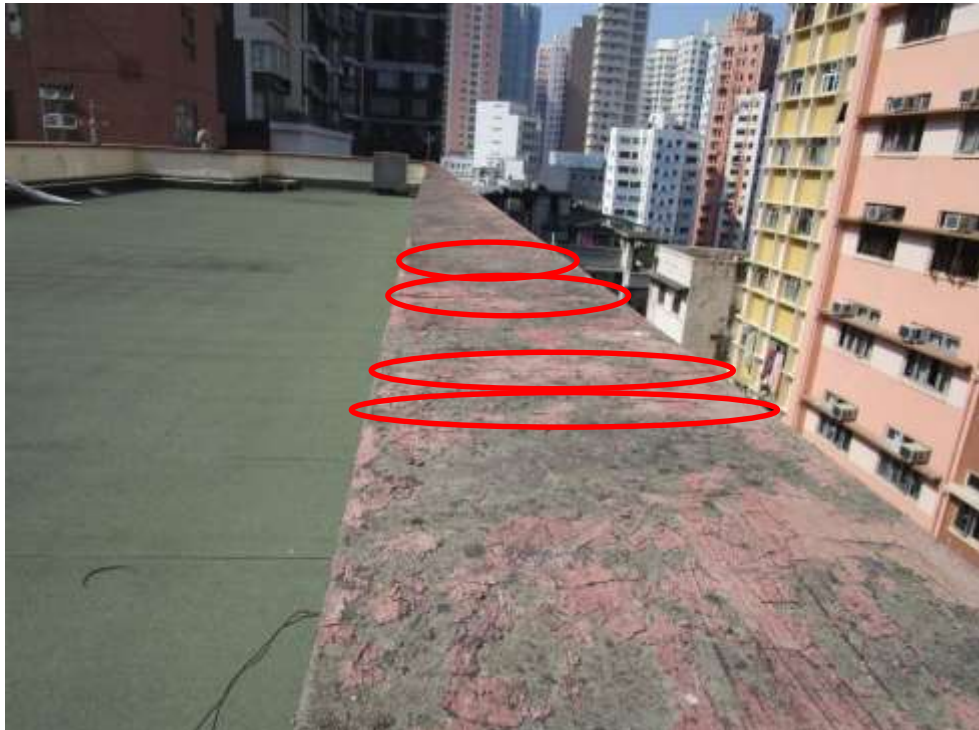
Photo No. 1564

Defect No.	282	Location	R/F North wing, Roof	Component	parapet
Description	Transverse cracks were observed on parapet top capping across the whole roof

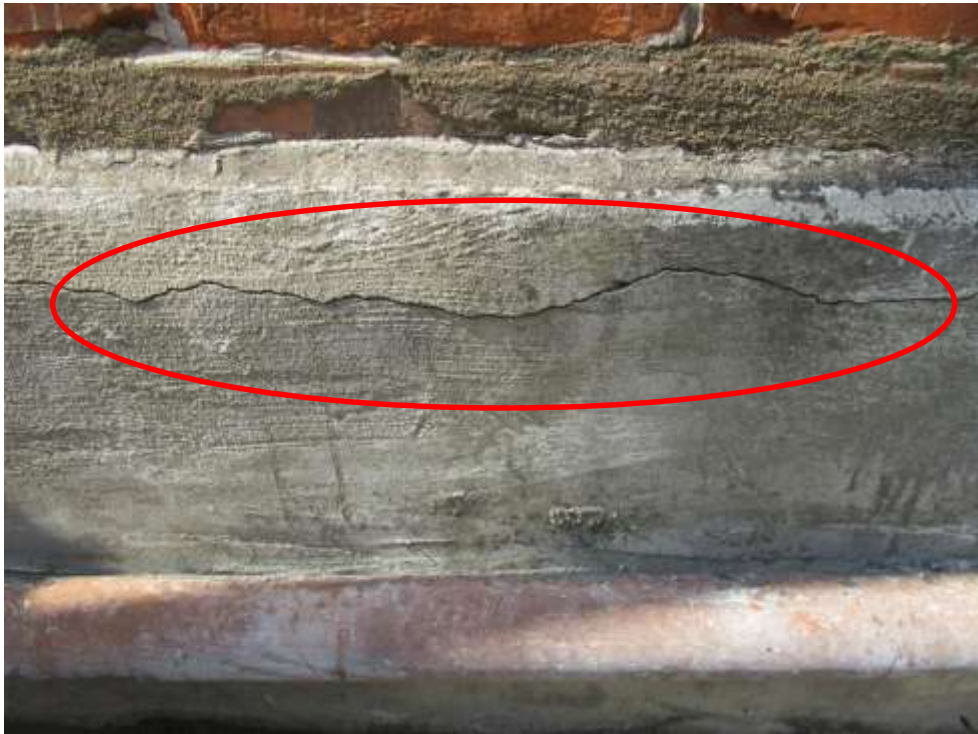
Photo No. 1566

Defect No. 283	Location R/F North wing, Roof	Component parapet
-----------------------	--------------------------------------	--------------------------

Description A wide crack was observed on the finishing of the skirting

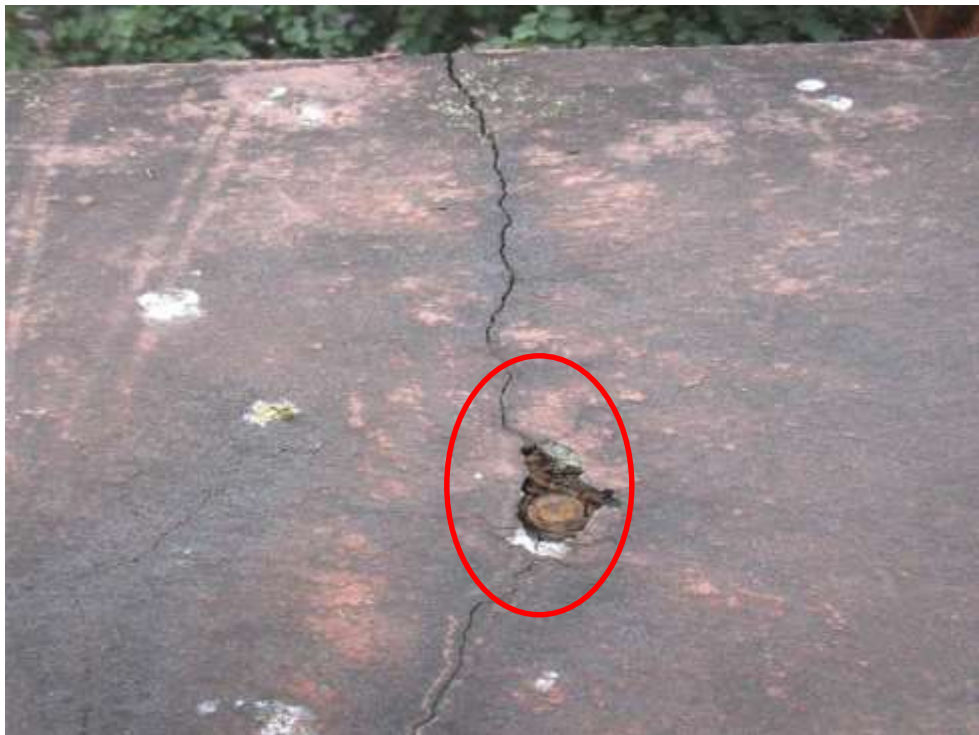
Photo No. 1568

Defect No. 284	Location R/F South wing and east wing's Roof	Component parapet
-----------------------	-----------------------------------------------------	--------------------------

Description A rusted anchor was observed on parapet

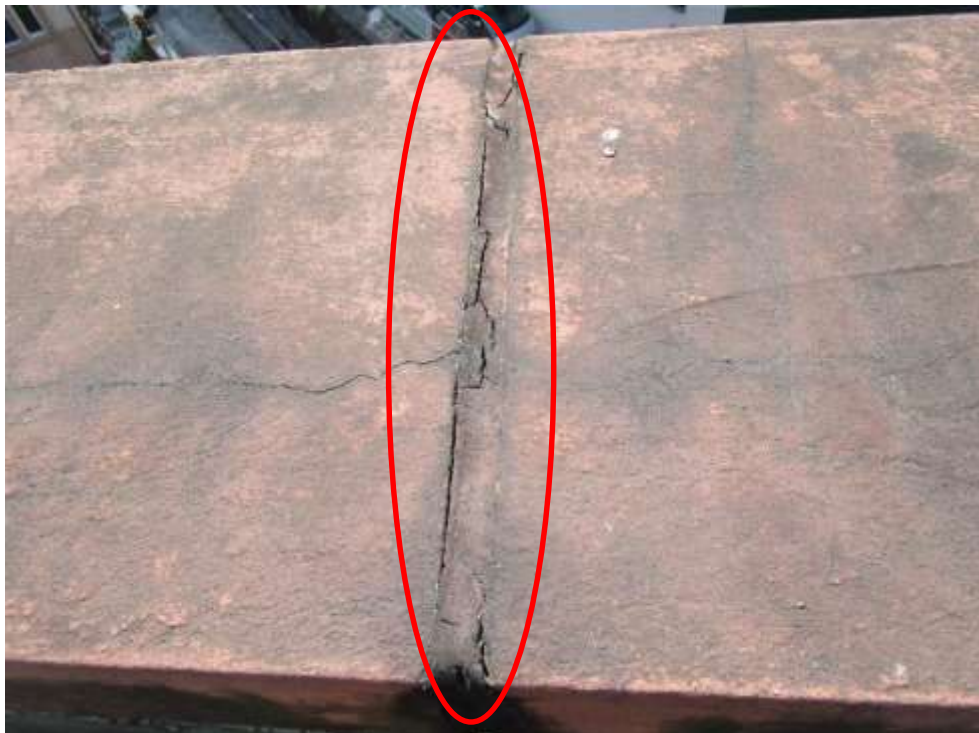
Photo No. 1570

Defect No.	285	Location	R/F South wing and east wing's Roof	Component	parapet
-------------------	-----	-----------------	-------------------------------------	------------------	---------

Description A crack was observed at the joint sealant

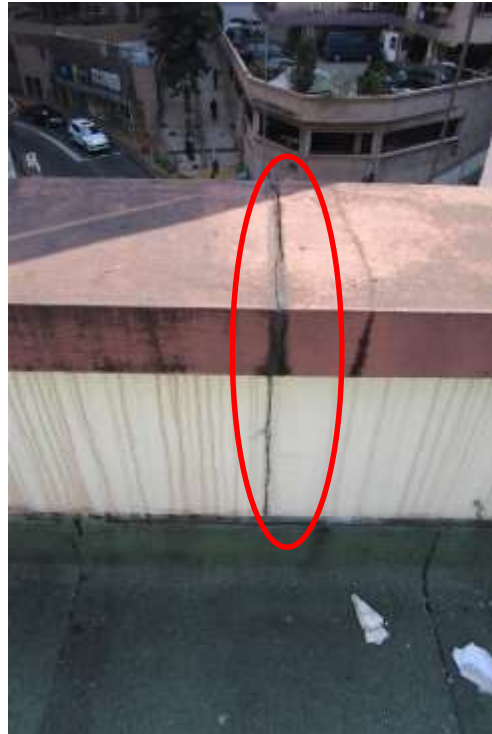
Photo No. 1571

Defect No.	285	Location	R/F South wing and east wing's Roof	Component	parapet
-------------------	-----	-----------------	-------------------------------------	------------------	---------

Description A crack was observed at the joint sealant

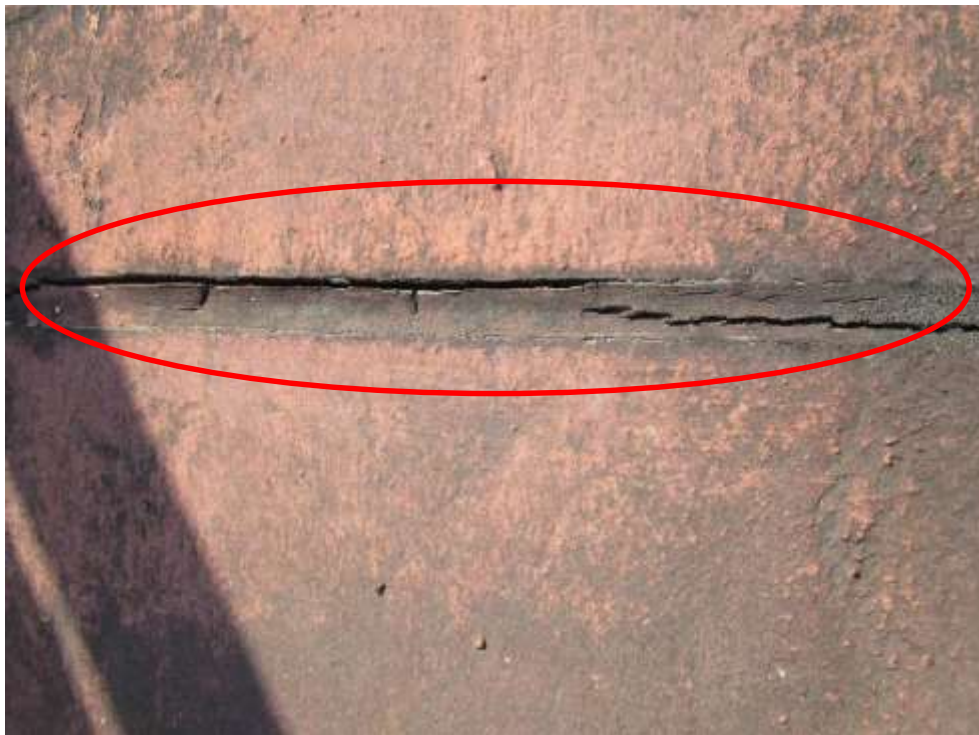
Photo No. 1572

Defect No. 286	Location R/F South wing and east wing's Roof	Component parapet
-----------------------	-----------------------------------------------------	--------------------------

Description A crack was observed at the joint sealant

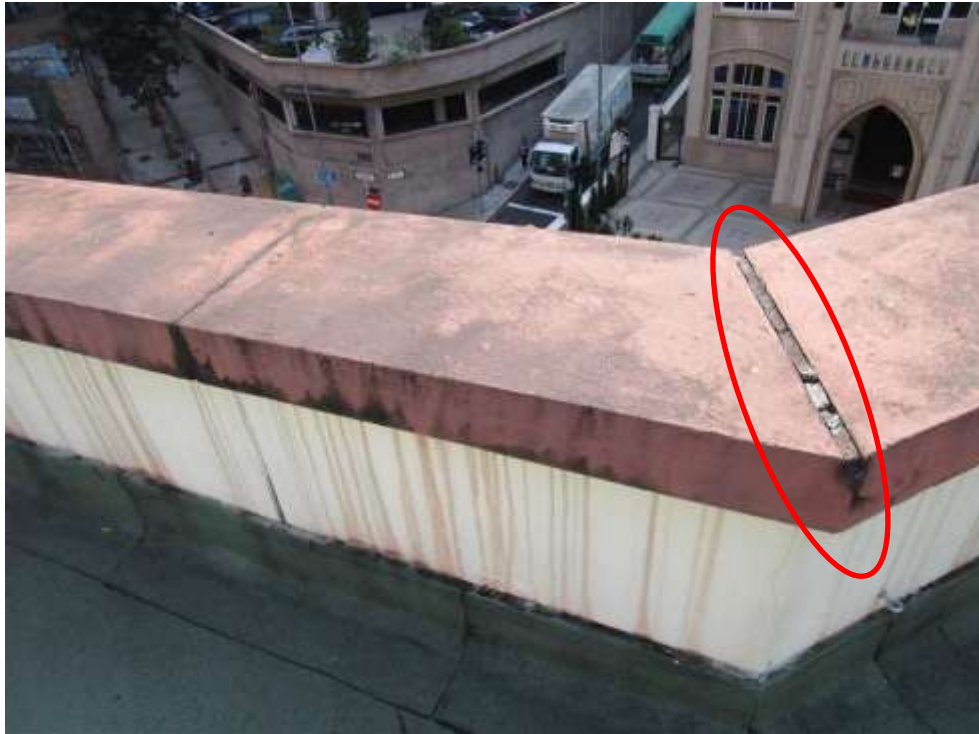
Photo No. 1573

Defect No. 286	Location R/F South wing and east wing's Roof	Component parapet
-----------------------	-----------------------------------------------------	--------------------------

Description A crack was observed at the joint sealant
