**Slope Upgrading Works at
Feature No. 11SW-A/R526,
King's College,
Bonham Road, Hong Kong**

Project Profile for Slope Upgrading Works at
Feature No. 11SW-A/R526, King's College

May 2018

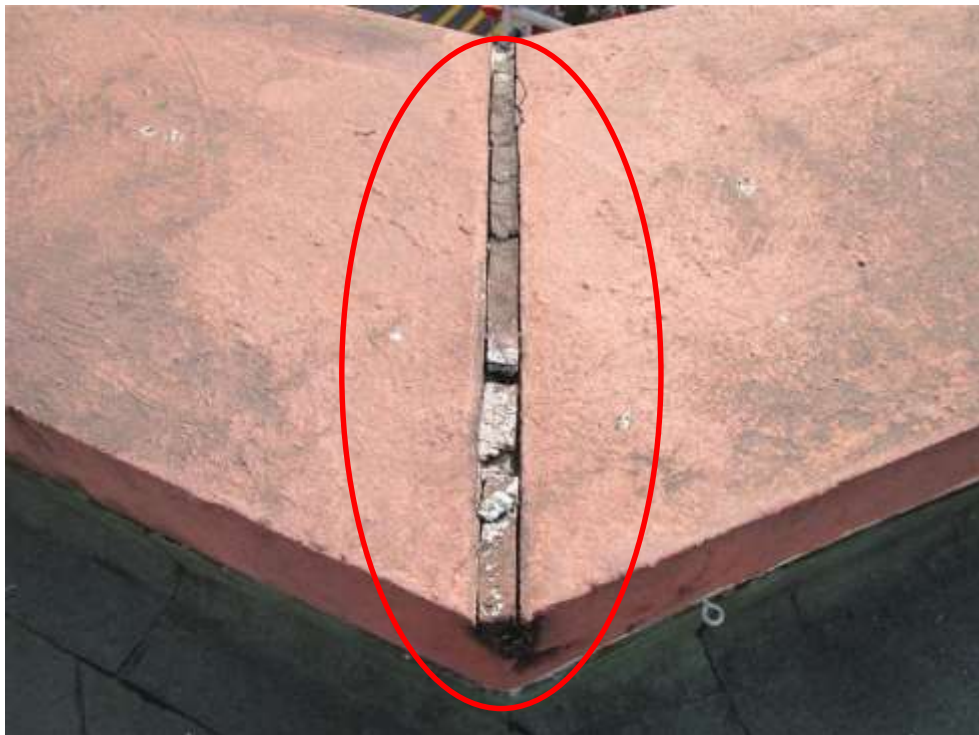
Photo No. 1574

Defect No. 287	Location R/F South wing and east wing's Roof	Component parapet
-----------------------	-----------------------------------------------------	--------------------------

Description Deteriorated joint sealants were observed on parapet

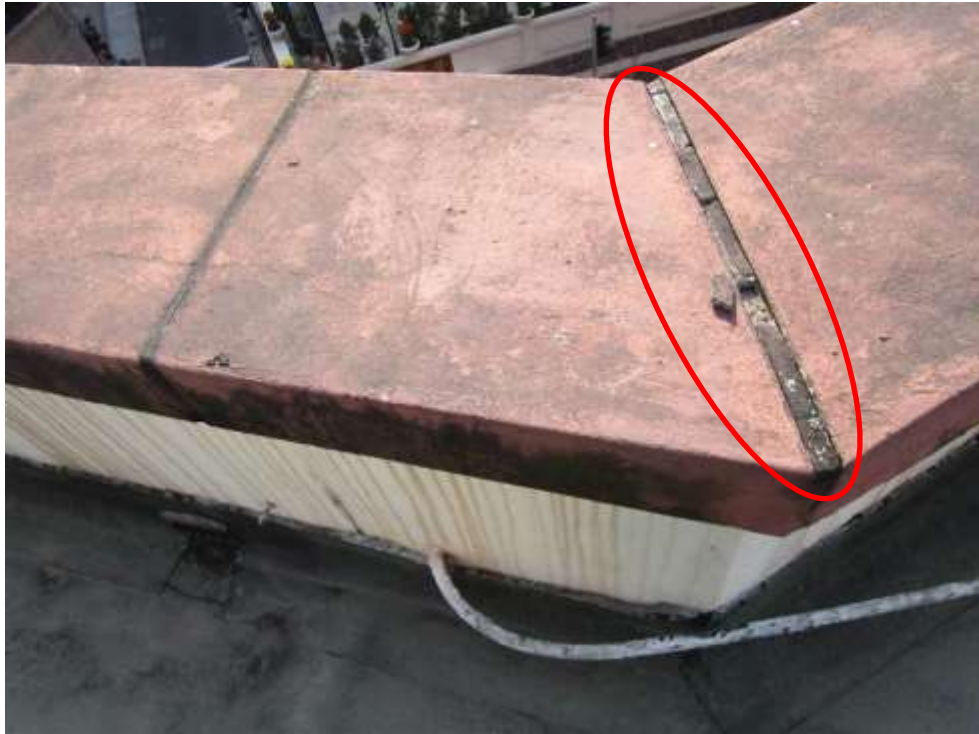
Photo No. 1575

Defect No. 287	Location R/F South wing and east wing's Roof	Component parapet
-----------------------	-----------------------------------------------------	--------------------------

Description Deteriorated joint sealants were observed on parapet

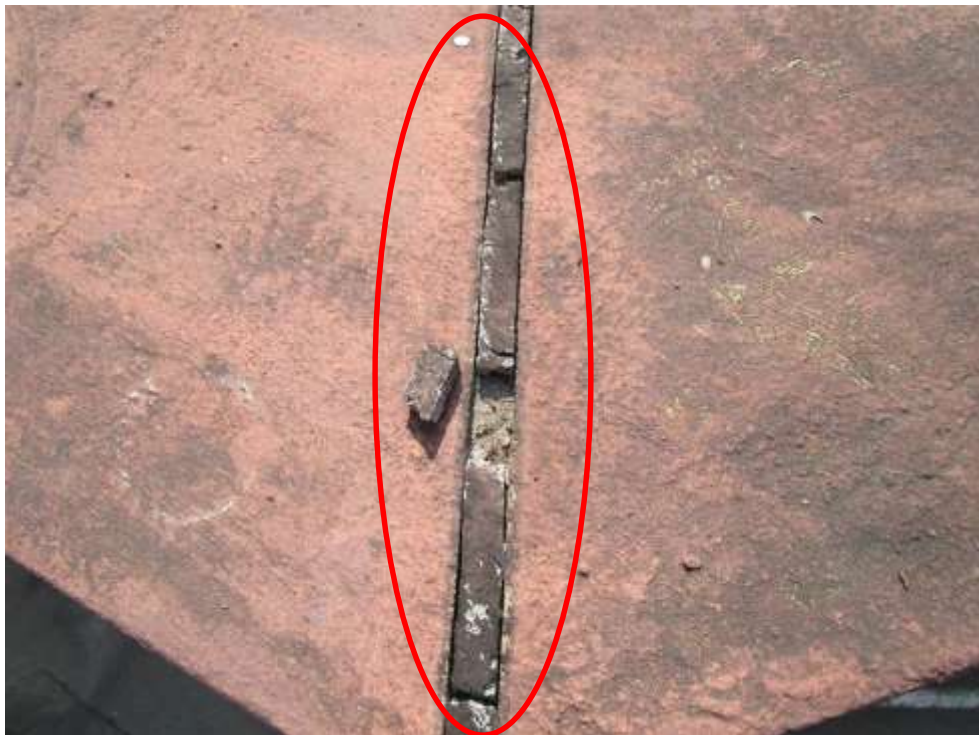
Photo No. 1576

Defect No.	288	Location	R/F South wing and east wing's Roof	Component	parapet
-------------------	-----	-----------------	-------------------------------------	------------------	---------

Description Deteriorated joint sealants were observed on parapet

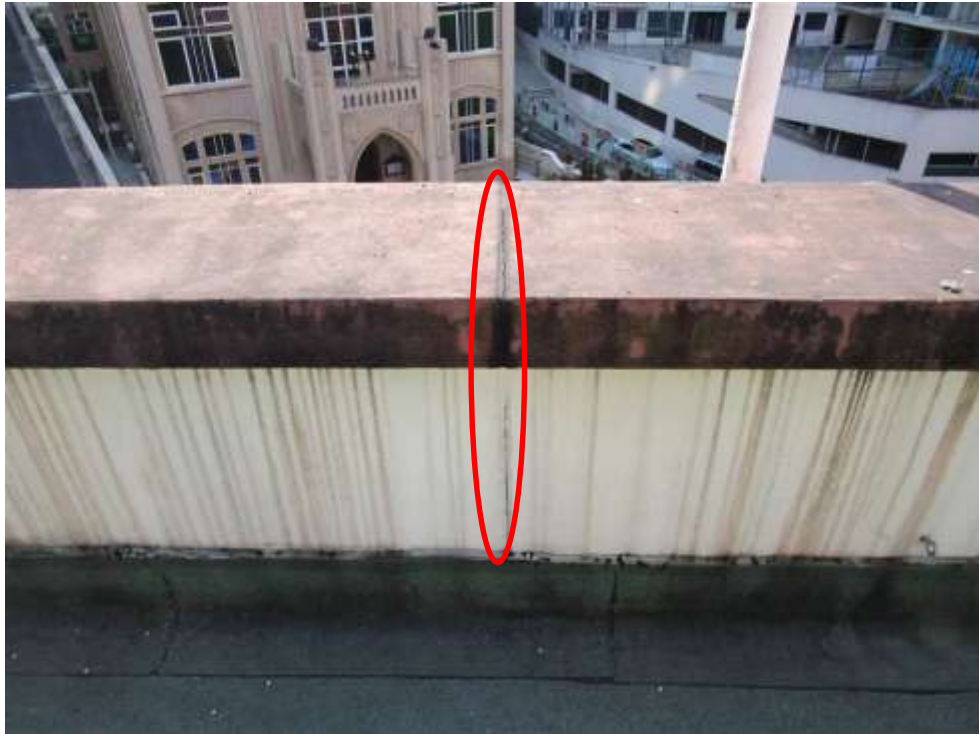
Photo No. 1577

Defect No.	288	Location	R/F South wing and east wing's Roof	Component	parapet
-------------------	-----	-----------------	-------------------------------------	------------------	---------

Description Deteriorated joint sealants were observed on parapet

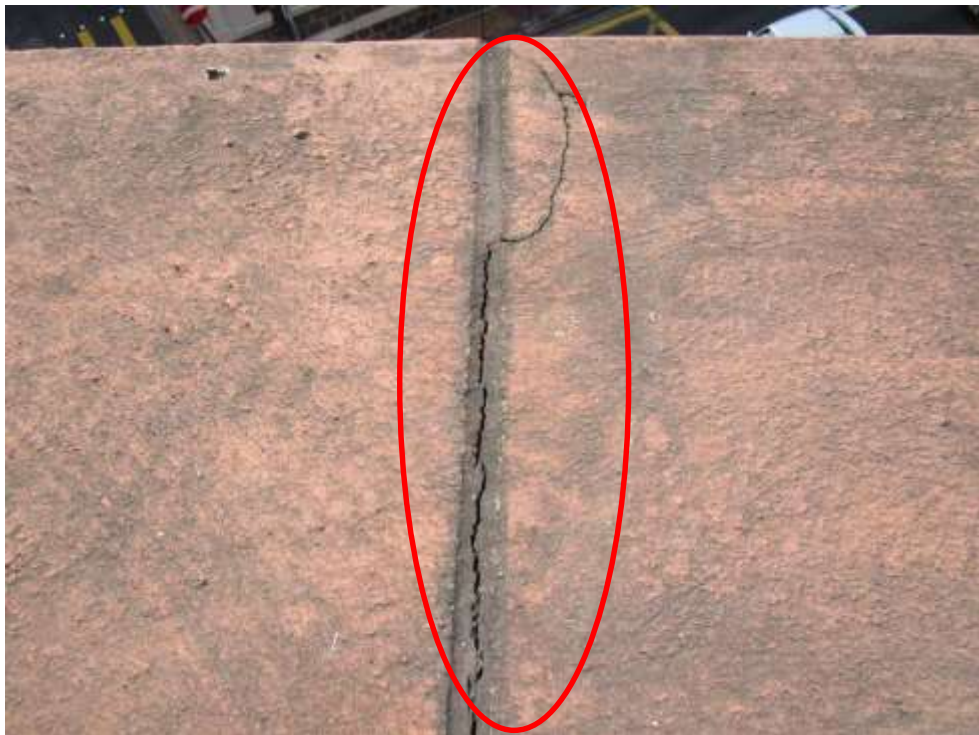
Photo No. 1578

Defect No. 289	Location R/F South wing and east wing's Roof	Component parapet
-----------------------	-----------------------------------------------------	--------------------------

Description A crack was observed at the joint sealant

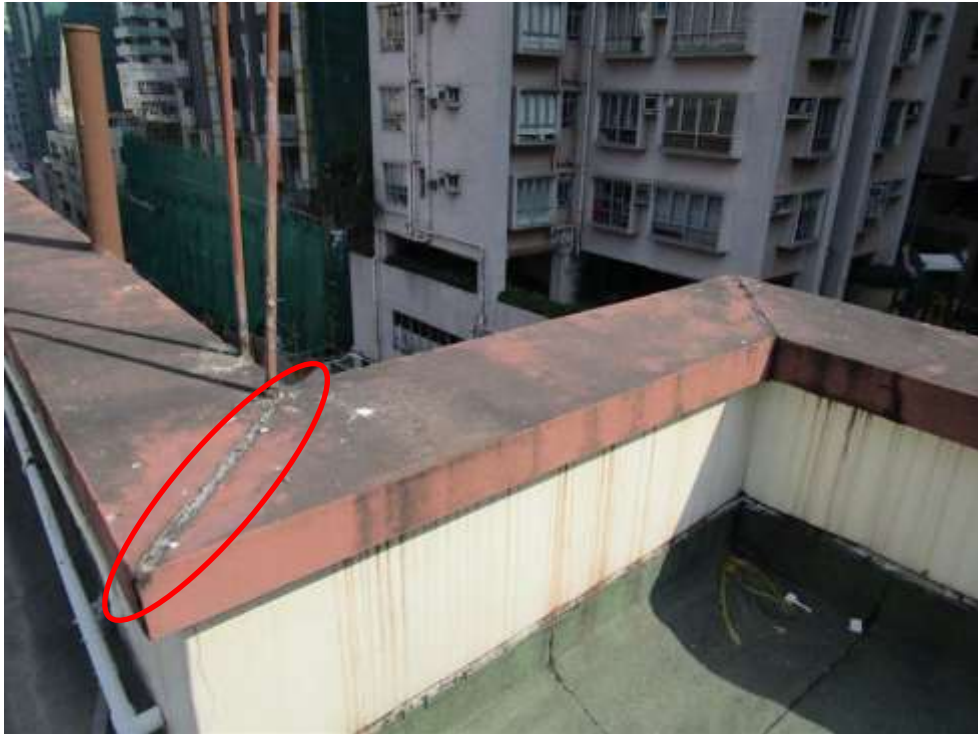
Photo No. 1579

Defect No. 289	Location R/F South wing and east wing's Roof	Component parapet
-----------------------	-----------------------------------------------------	--------------------------

Description A crack was observed at the joint sealant

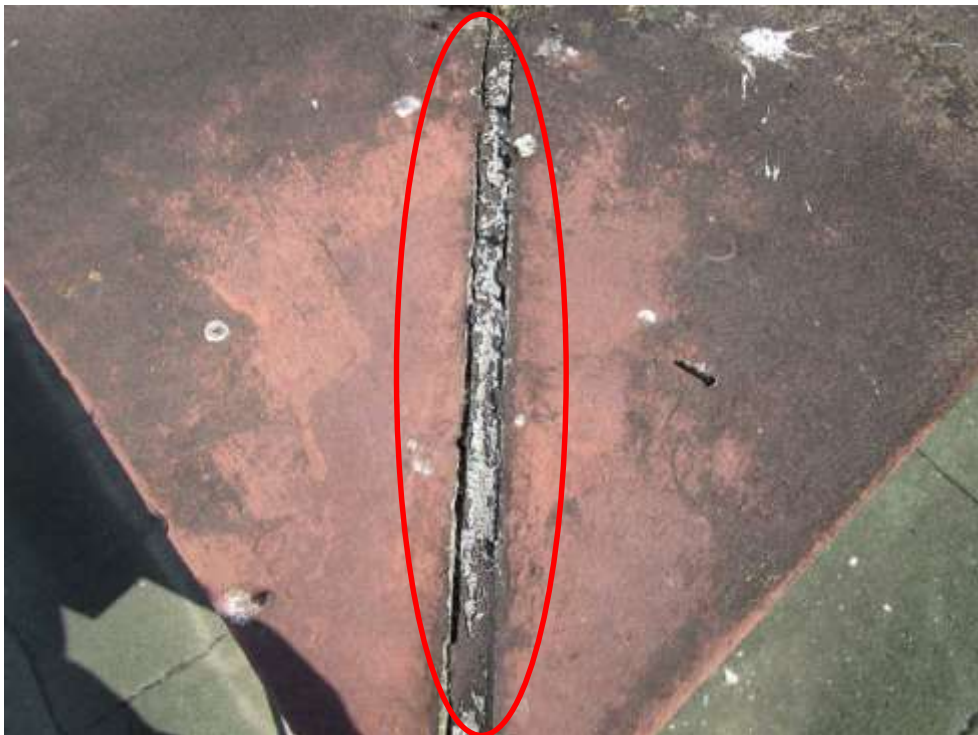
Photo No. 1580

Defect No. 290	Location R/F South wing and east wing's Roof	Component parapet
-----------------------	-----------------------------------------------------	--------------------------

Description Deteriorated joint sealants were observed on parapet

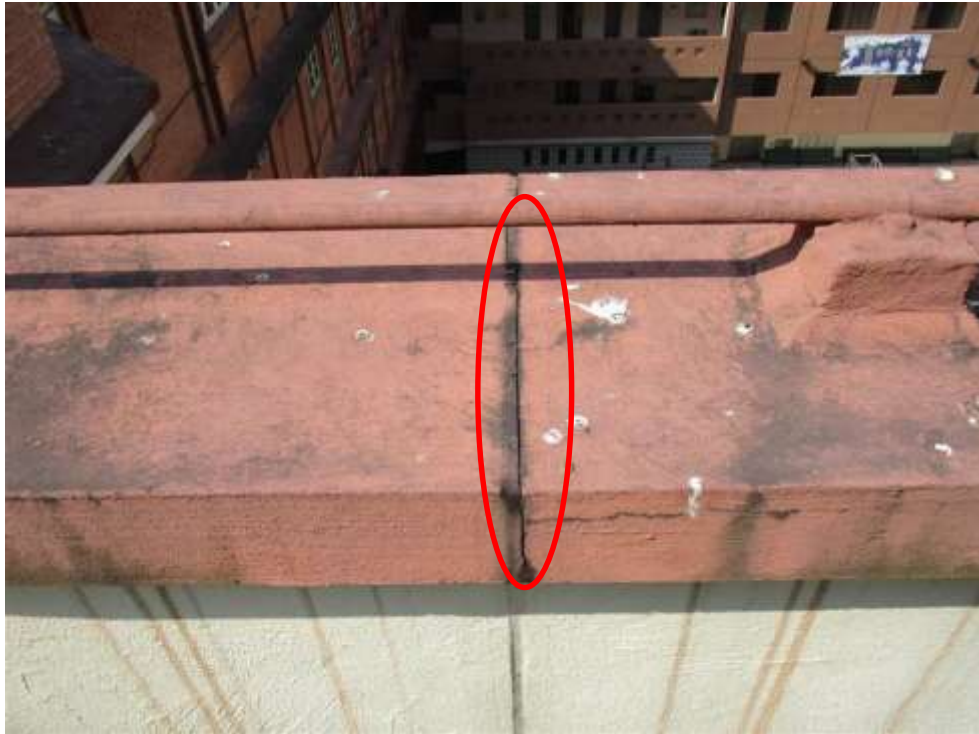
Photo No. 1581

Defect No. 290	Location R/F South wing and east wing's Roof	Component parapet
-----------------------	-----------------------------------------------------	--------------------------

Description Deteriorated joint sealants were observed on parapet

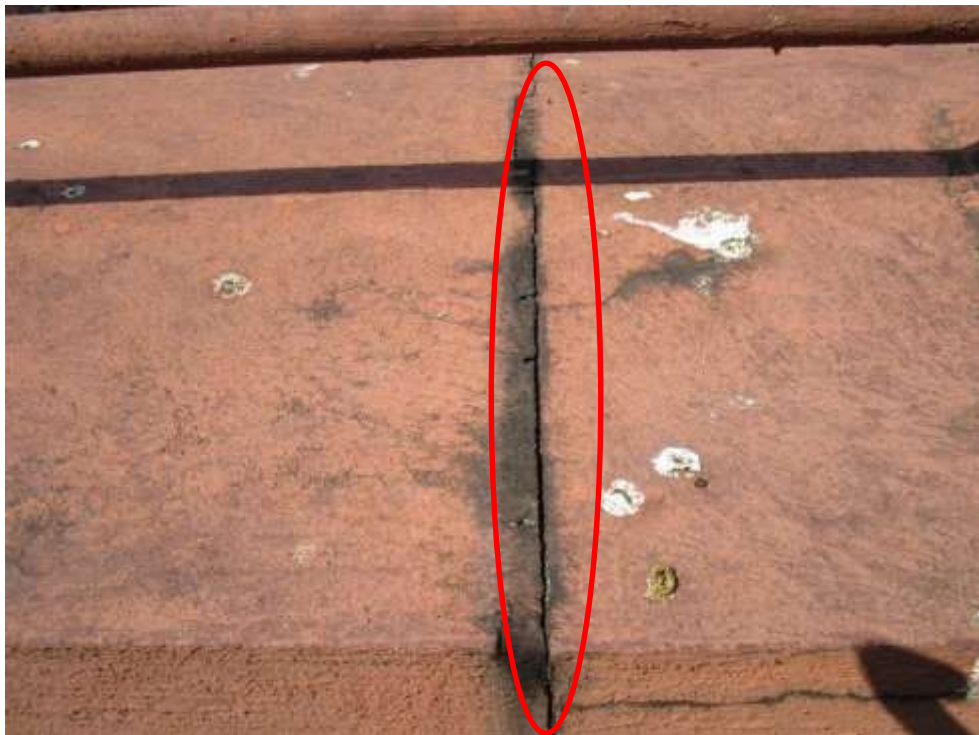
Photo No. 1582

Defect No. 291	Location R/F South wing and east wing's Roof	Component parapet
-----------------------	-----------------------------------------------------	--------------------------

Description A crack was observed at the joint sealant

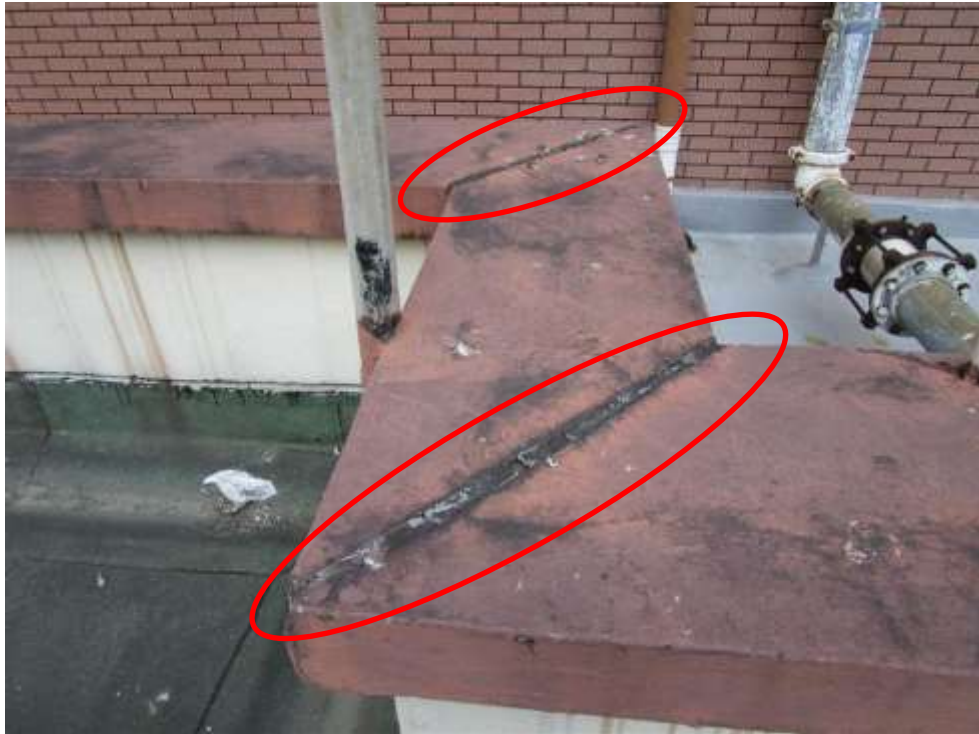
Photo No. 1583

Defect No. 291	Location R/F South wing and east wing's Roof	Component parapet
-----------------------	-----------------------------------------------------	--------------------------

Description A crack was observed at the joint sealant

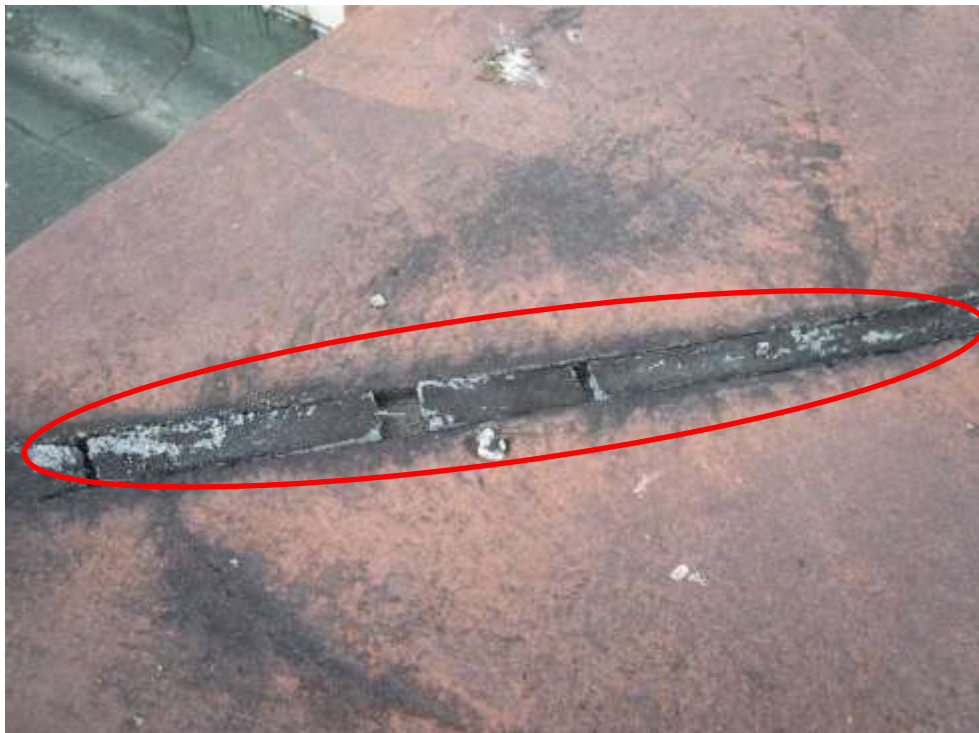
Photo No. 1584

Defect No. 292	Location R/F South wing and east wing's Roof	Component parapet
-----------------------	-----------------------------------------------------	--------------------------

Description Deteriorated joint sealants were observed on parapet

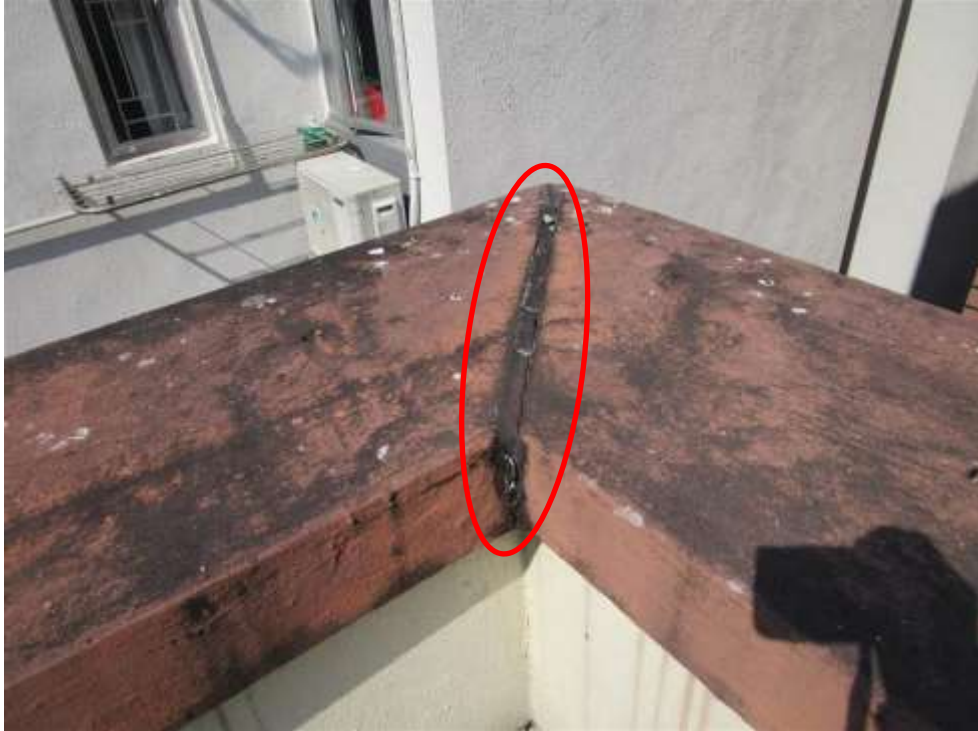
Photo No. 1585

Defect No. 292	Location R/F South wing and east wing's Roof	Component parapet
-----------------------	-----------------------------------------------------	--------------------------

Description Deteriorated joint sealants were observed on parapet

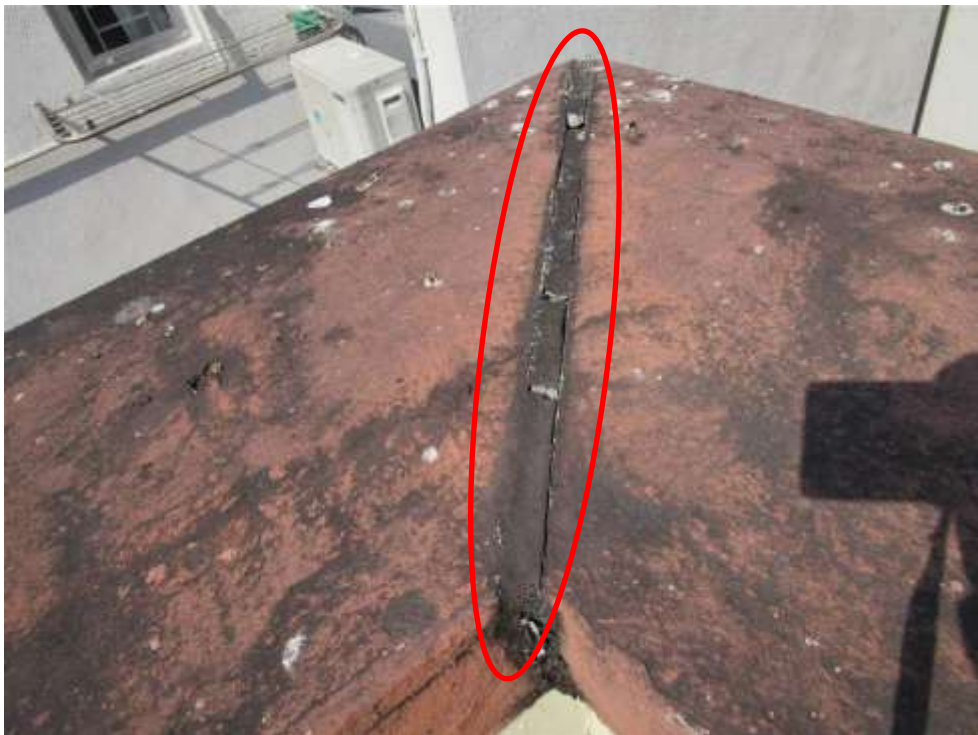
Photo No. 1586

Defect No. 293	Location R/F South wing and east wing's Roof	Component parapet
-----------------------	-----------------------------------------------------	--------------------------

Description Deteriorated joint sealants were observed on parapet

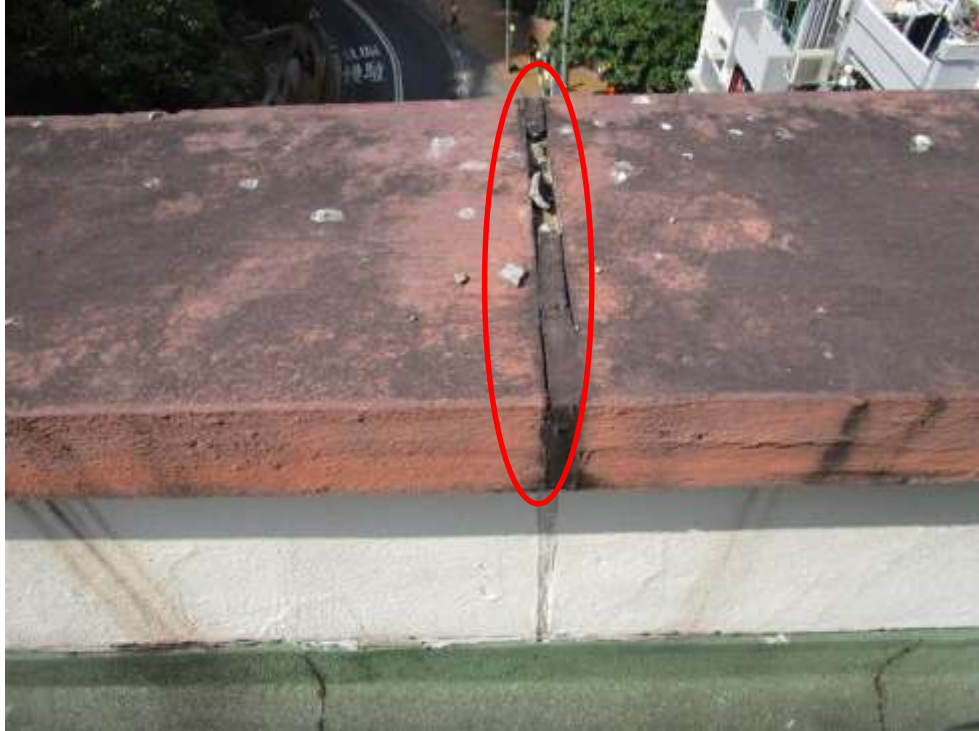
Photo No. 1587

Description Deteriorated joint sealants were observed on parapet

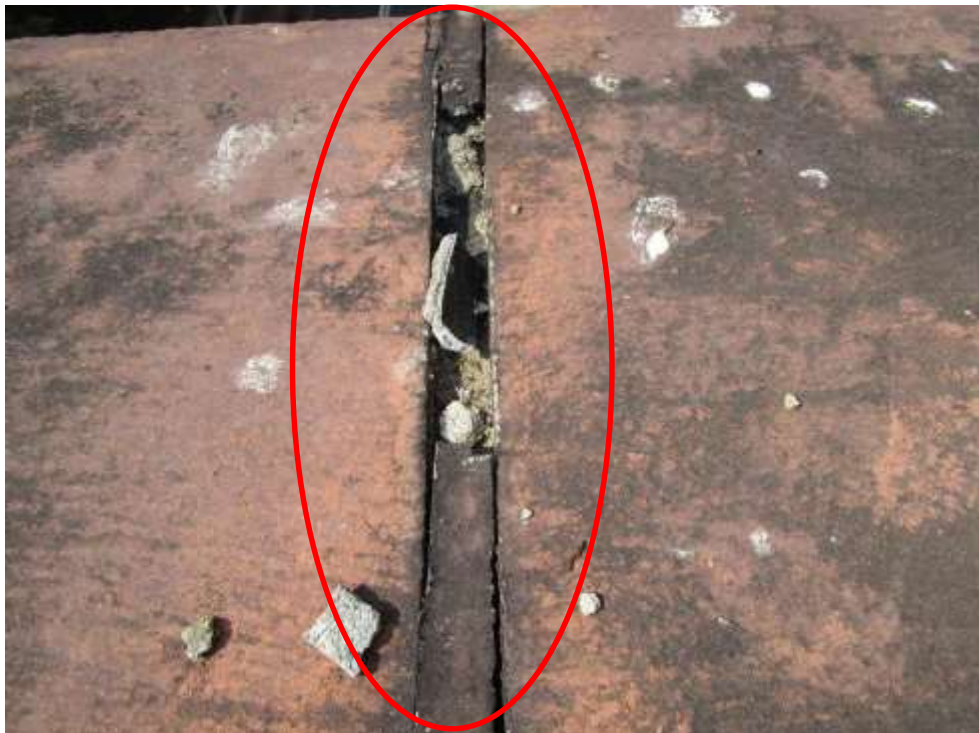
Photo No. 1588

Description Deteriorated joint sealants were observed on parapet

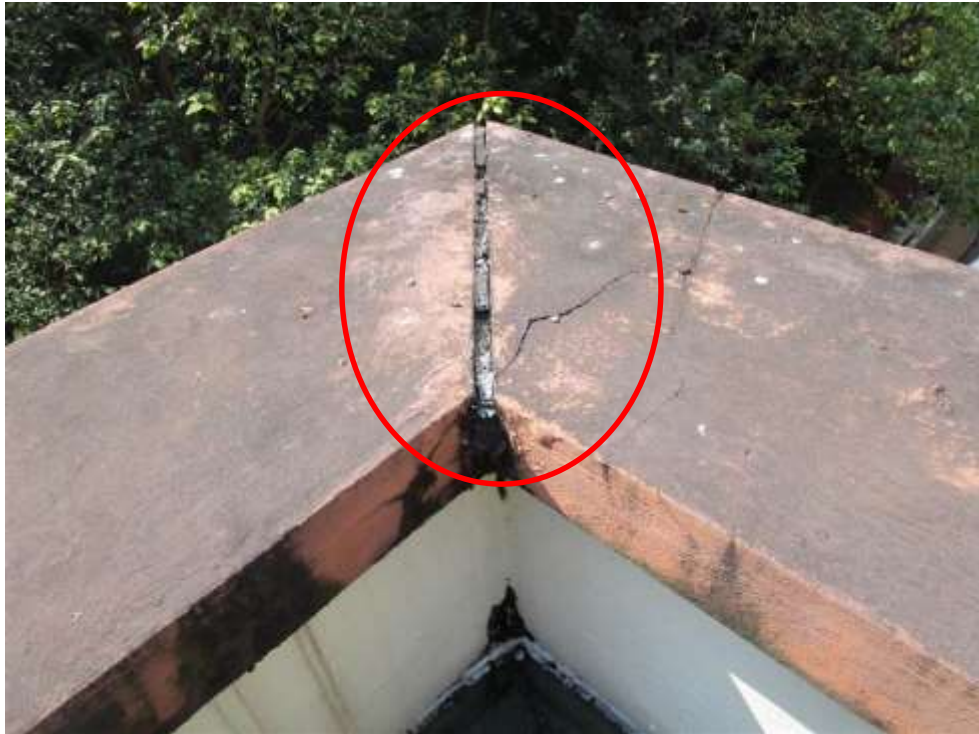
Photo No. 1589

Description Deteriorated joint sealants were observed on parapet

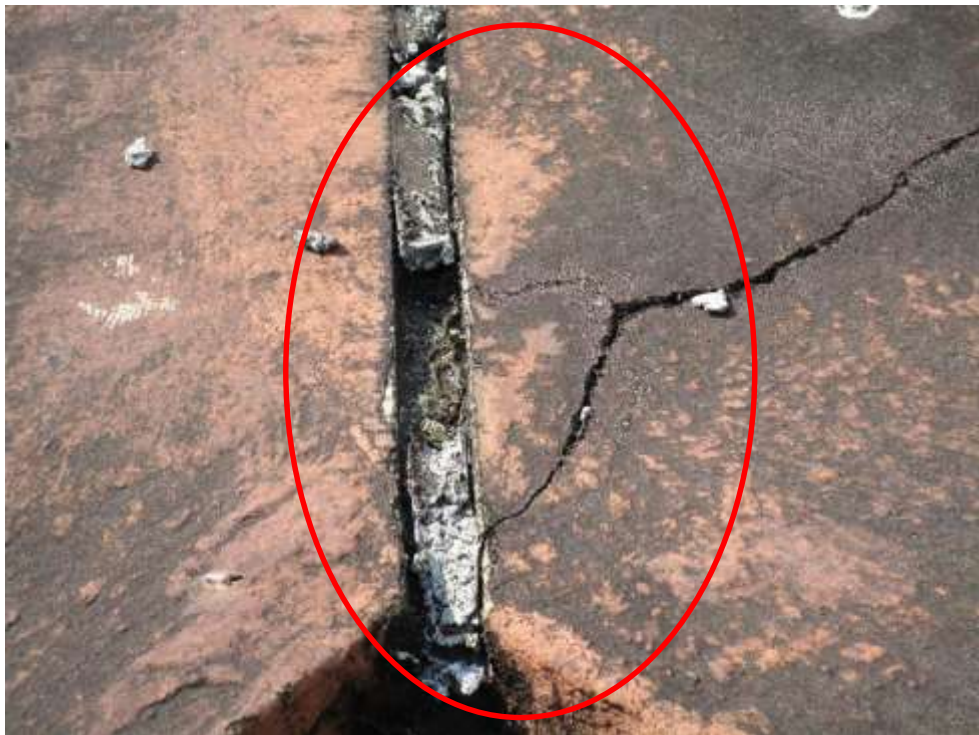
Photo No. 1590

Description Deteriorated joint sealants were observed on parapet

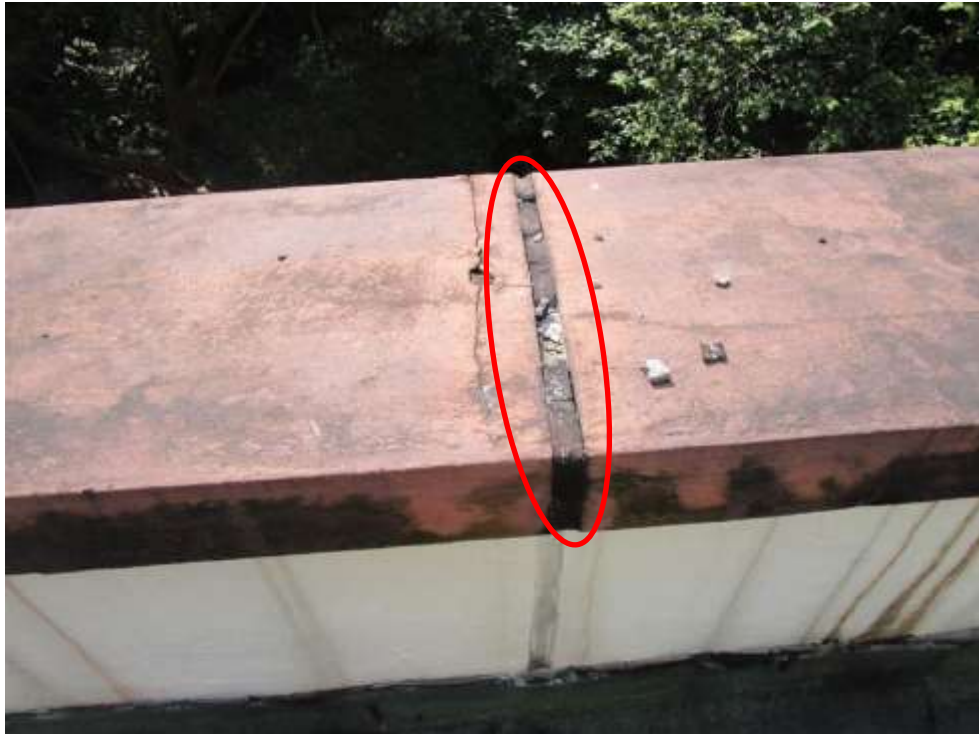
Photo No. 1591

Description Deteriorated joint sealants were observed on parapet

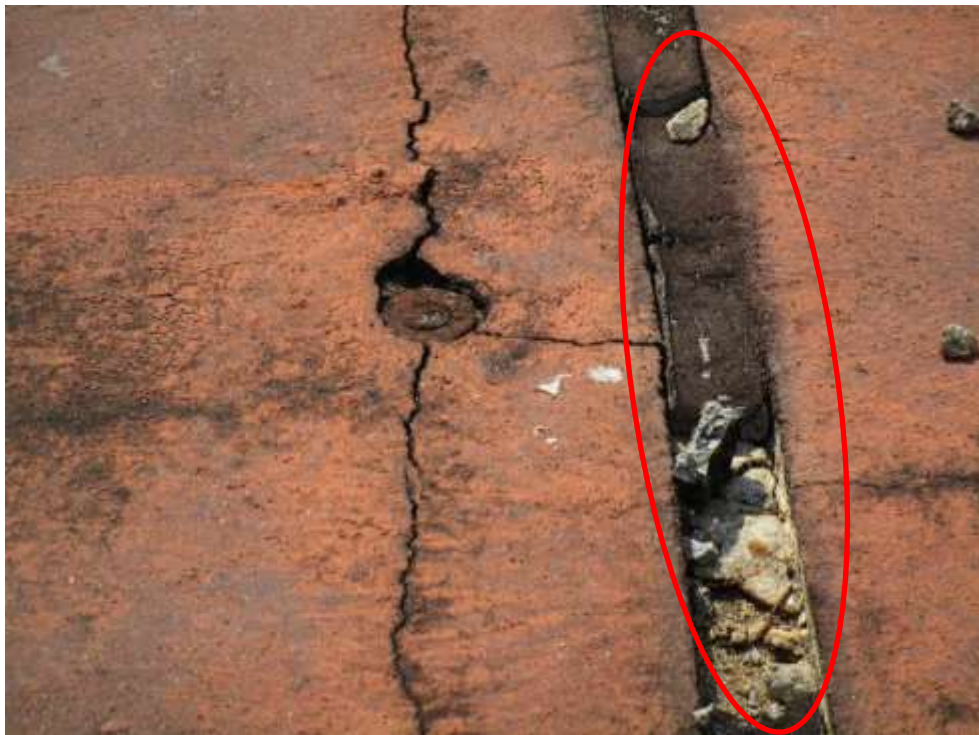
Photo No. 1592

Description Deteriorated joint sealants were observed on parapet

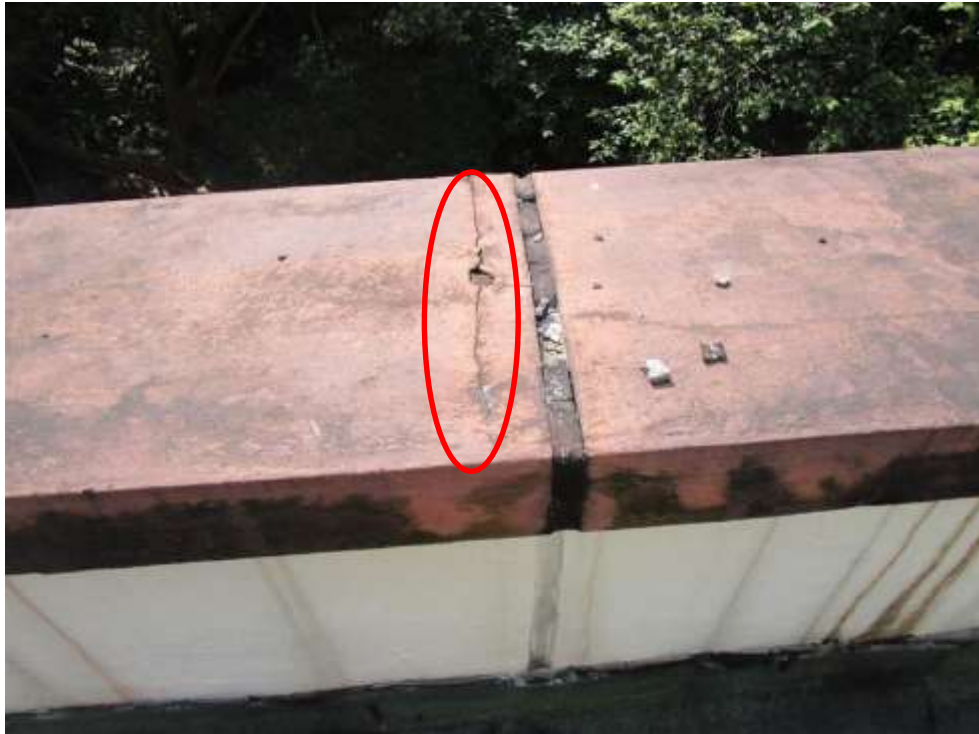
Photo No. 1593

Description Deteriorated joint sealants were observed on parapet

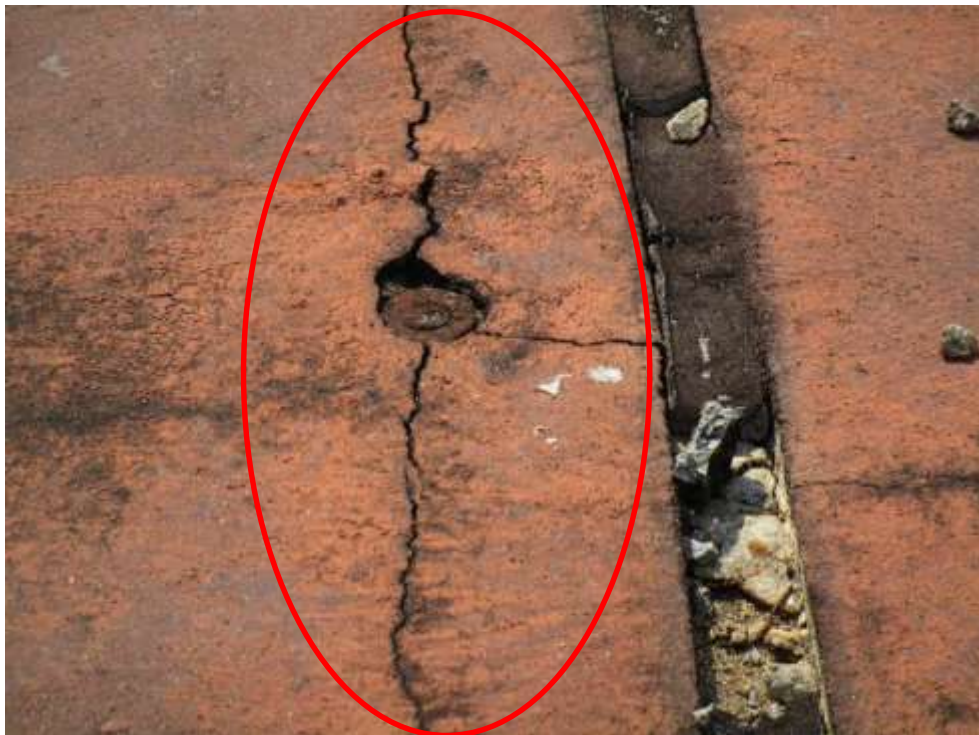
Photo No. 1594

Description Rusted anchor was observed on parapet

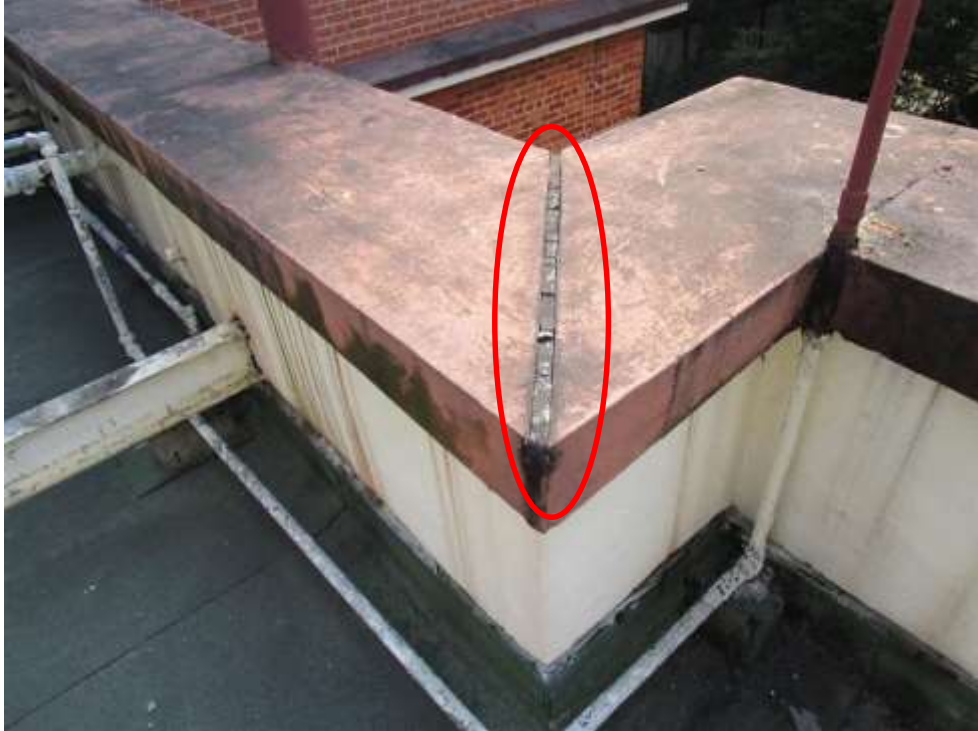
Photo No. 1595

Description Rusted anchor was observed on parapet

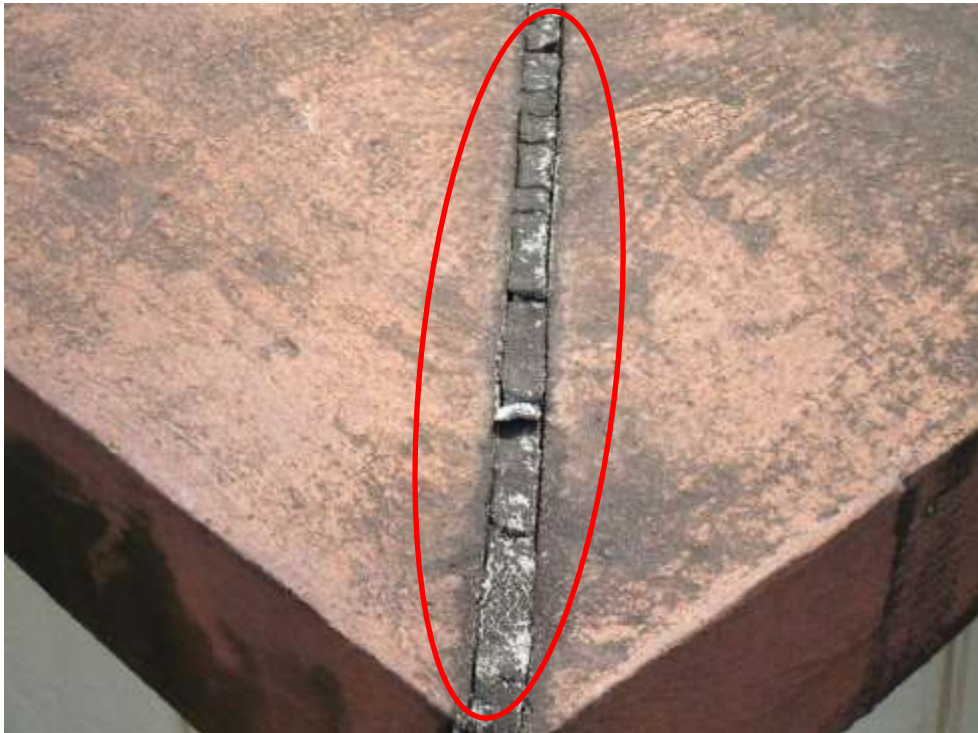
Photo No. 1596

Description Deteriorated joint sealants were observed on parapet

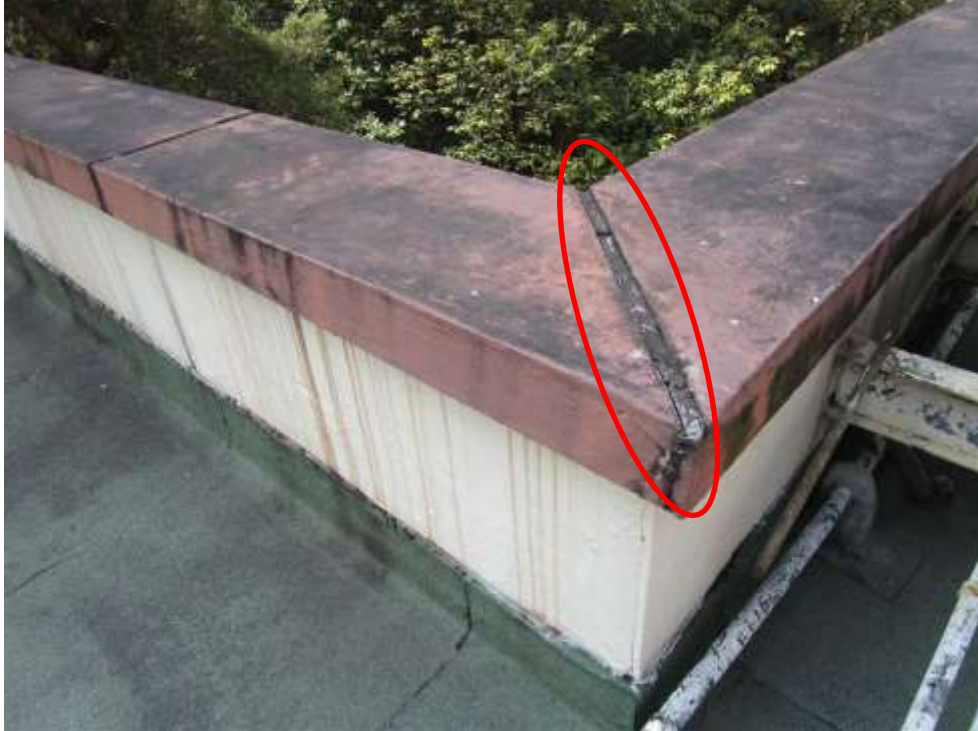
Photo No. 1597

Description Deteriorated joint sealants were observed on parapet

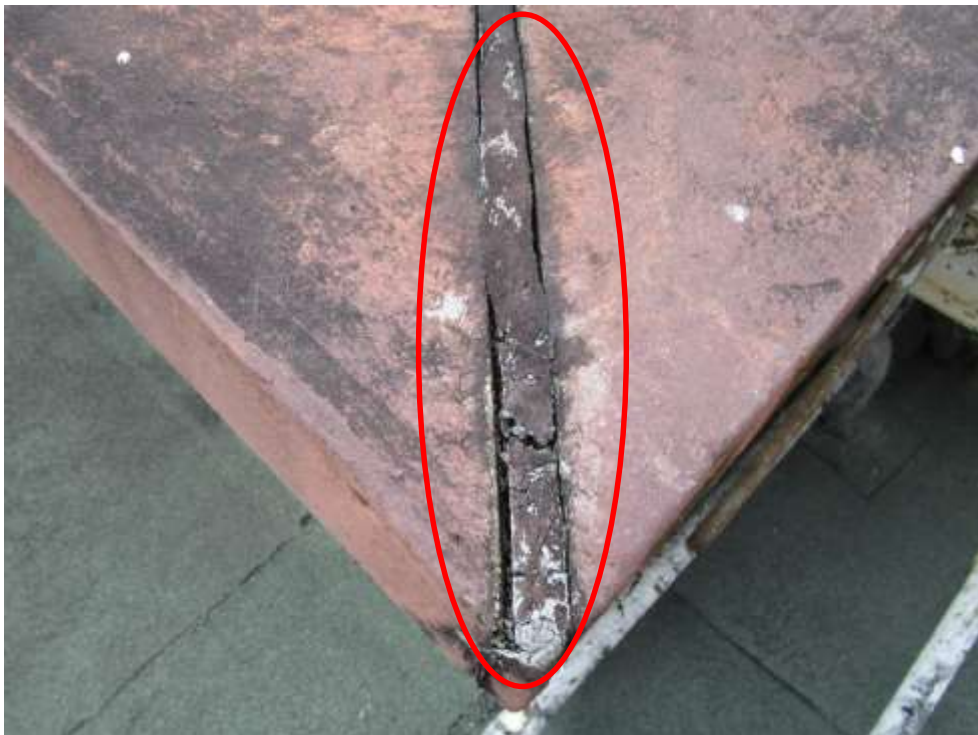
Photo No. 1598

Description Deteriorated joint sealants were observed on parapet

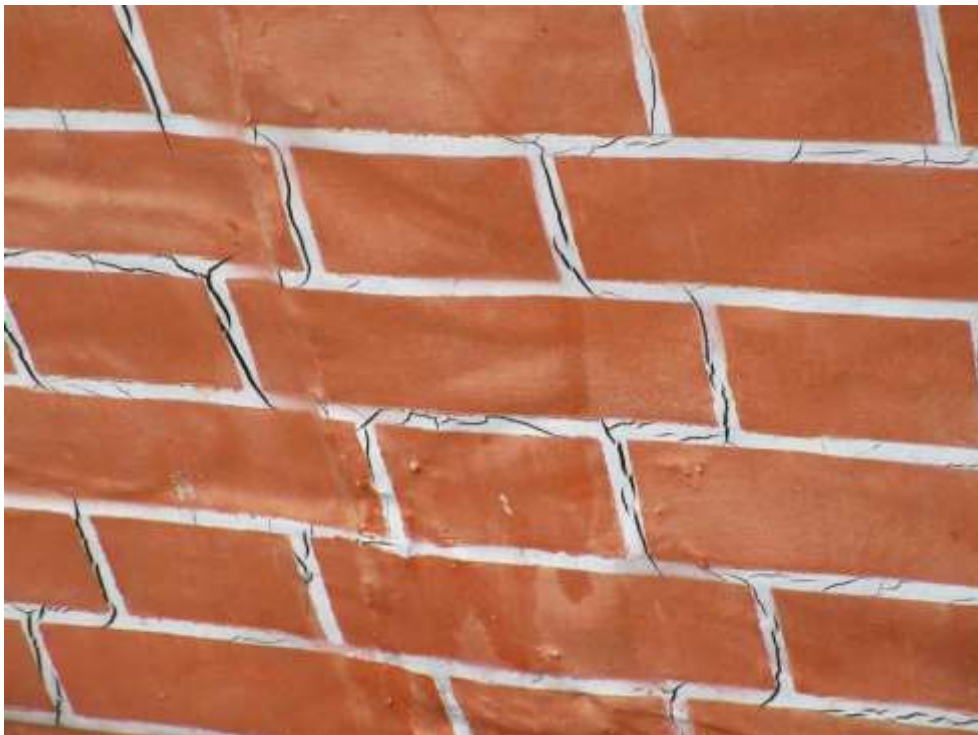
Photo No. 1600

Description Paint peeling was generally observed on external side of south and east wings' parapet

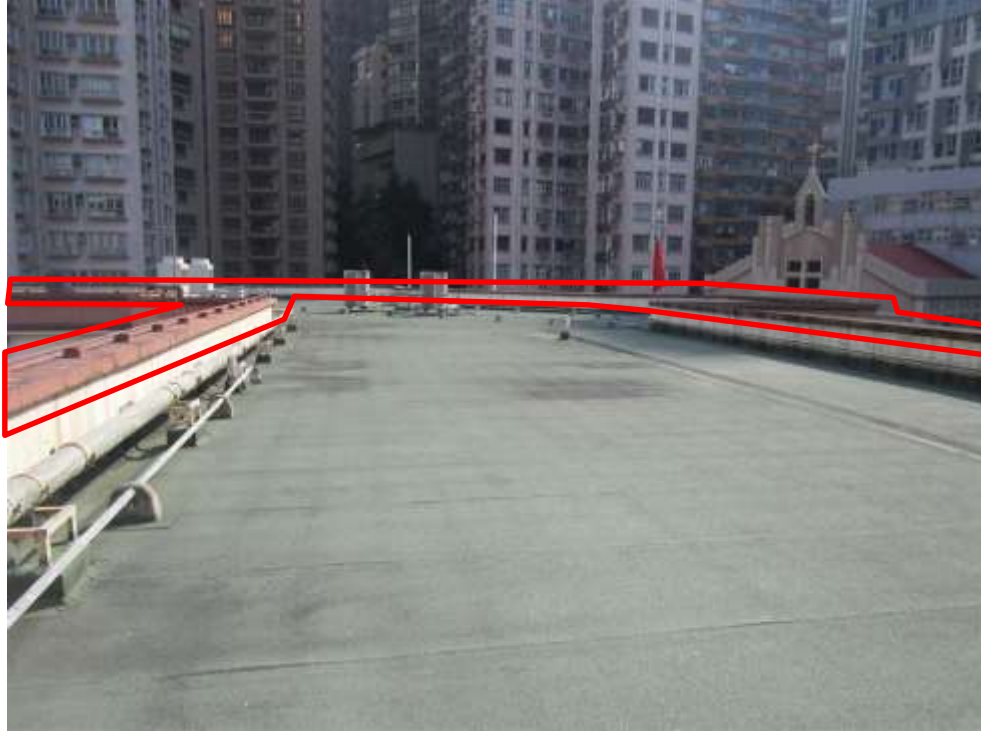
Photo No. 1601

Description Paint peeling was generally observed on external side of south and east wings' parapet

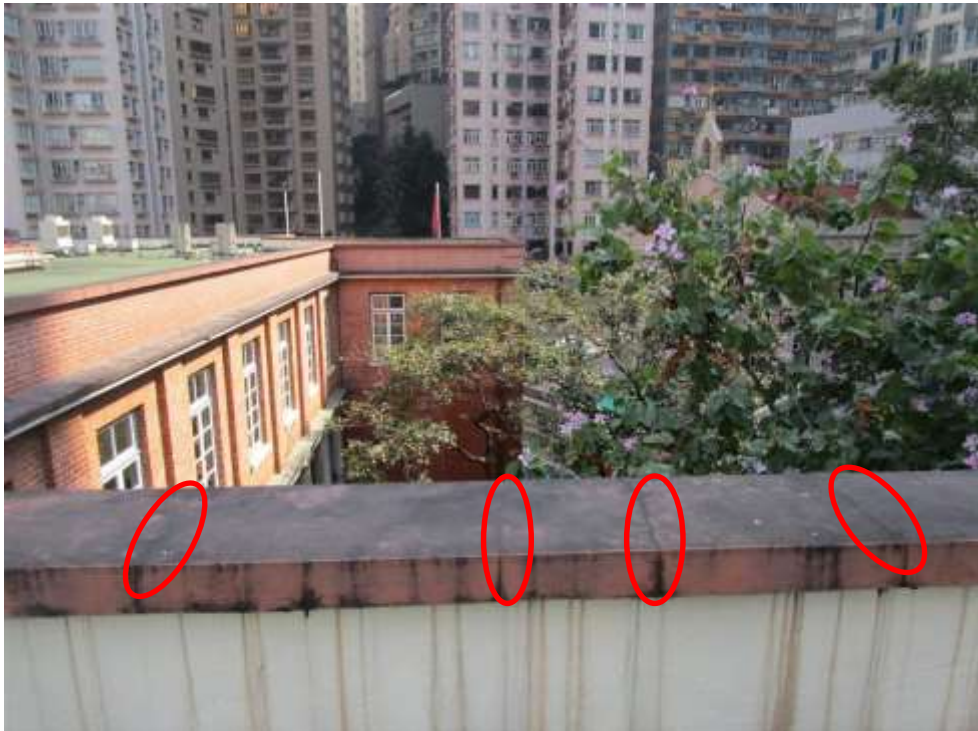
Photo No. 1602

Defect No.	301	Location	R/F South wing, South wing and east wing's Roof	Component	parapet
Description	Transverse cracks were observed on parapet top capping across the whole roof at 0.5-1m interval
