FORM 5  
ENVIRONMENTAL IMPACT ASSESSMENT ORDINANCE  
(CHAPTER 499)  
SECTION 13(1)

Application for Variation of an Environmental Permit

C1. Name of the Current Environmental Permit Holder :  
Drainage Services Department  
C2. Application No. of the Current Environmental Permit : AEP-517/2016  
C3. The Current Environmental Permit was Issued in : month / year  
02 | 2017

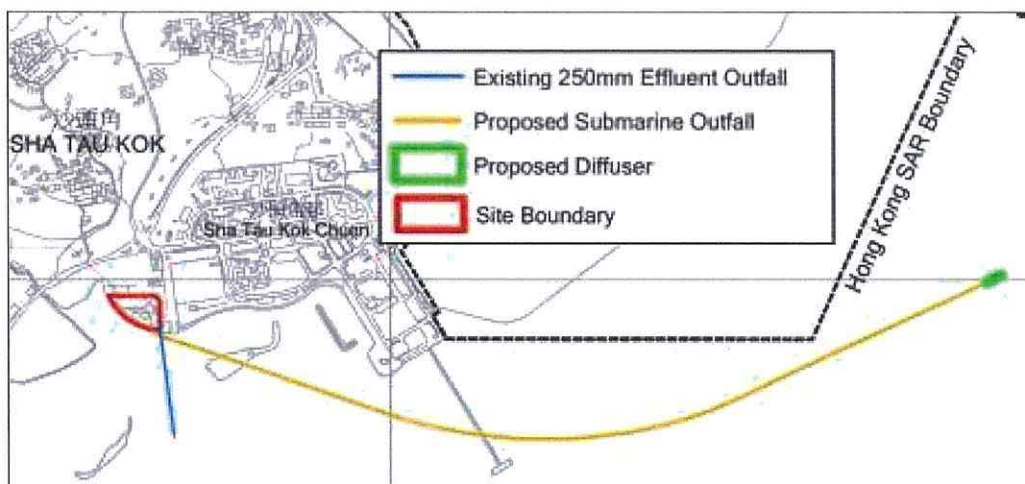
Figure 2.1 Proposed Submarine Outfall and Diffuser (Extracted from the EIA Report)

Reaming of drilled hole and submarine pipeline installation would then proceed. Subsequently, sediment removal, installation of precast diffuser structure and backfilling would be carried out within the cofferdam. The cofferdam would be removed after completion of all the outfall construction works. The EIA Report assumed that the cofferdam would be erected at the diffuser site for over 2 years.

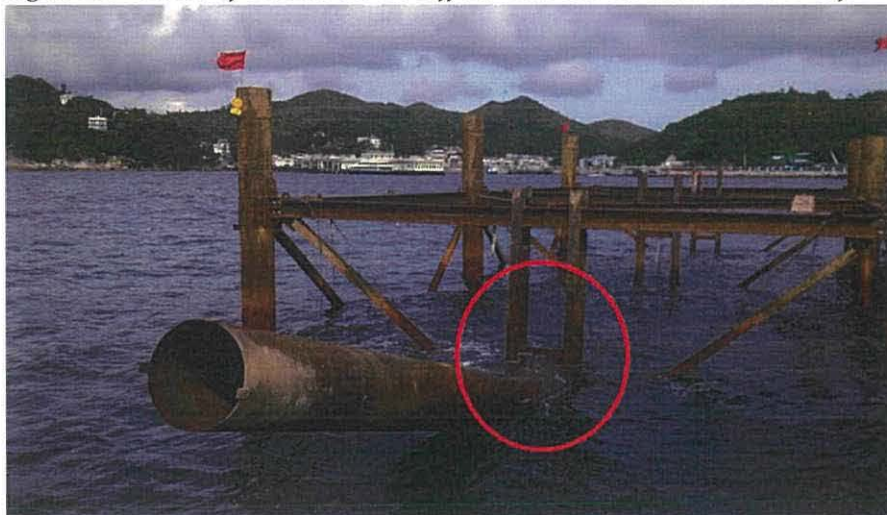
*Figure 2.2 Photo of Similar Steel Scaffold Constructed under a Past Project*

The water depth at the diffuser site would be about 5.95 to 8.25m m. The level of seabed, alluvium, and bedrock would be about -5.9mPD, -10.4mPD and -49.5mPD respectively. The temporary steel scaffold would be supported by 8 nos. of pipe piles and each pile would have a diameter of 0.61 m. The length of each pipe pile would be about 21 m and would be inserted perpendicular to the seabed level. Silt curtain will be deployed to surround the pipe pile insertion and removal works to minimize the environmental impact. The steel casing would have a maximum diameter of 1 m and a total length of about 70m. The steel casing would be inserted into the seabed at an inclination angle of 22.5° from the seabed. The temporary steel scaffold would consist of at least two nos. of steel bracket in the form of "U-shape" to support the steel casing and to secure the casing of any laterally movement during installation as illustrated in **Figure 2.2**. The cross-sectional view and plan view of the steel casing and scaffold is shown in **Figure 2.3**.

<sup>(4)</sup> With consideration of a buffer zone of about 20 m surrounding the piled working platform and the flat-top barge as shown in Figure 2.2, the temporary loss of fishing ground would be about 0.8 ha.

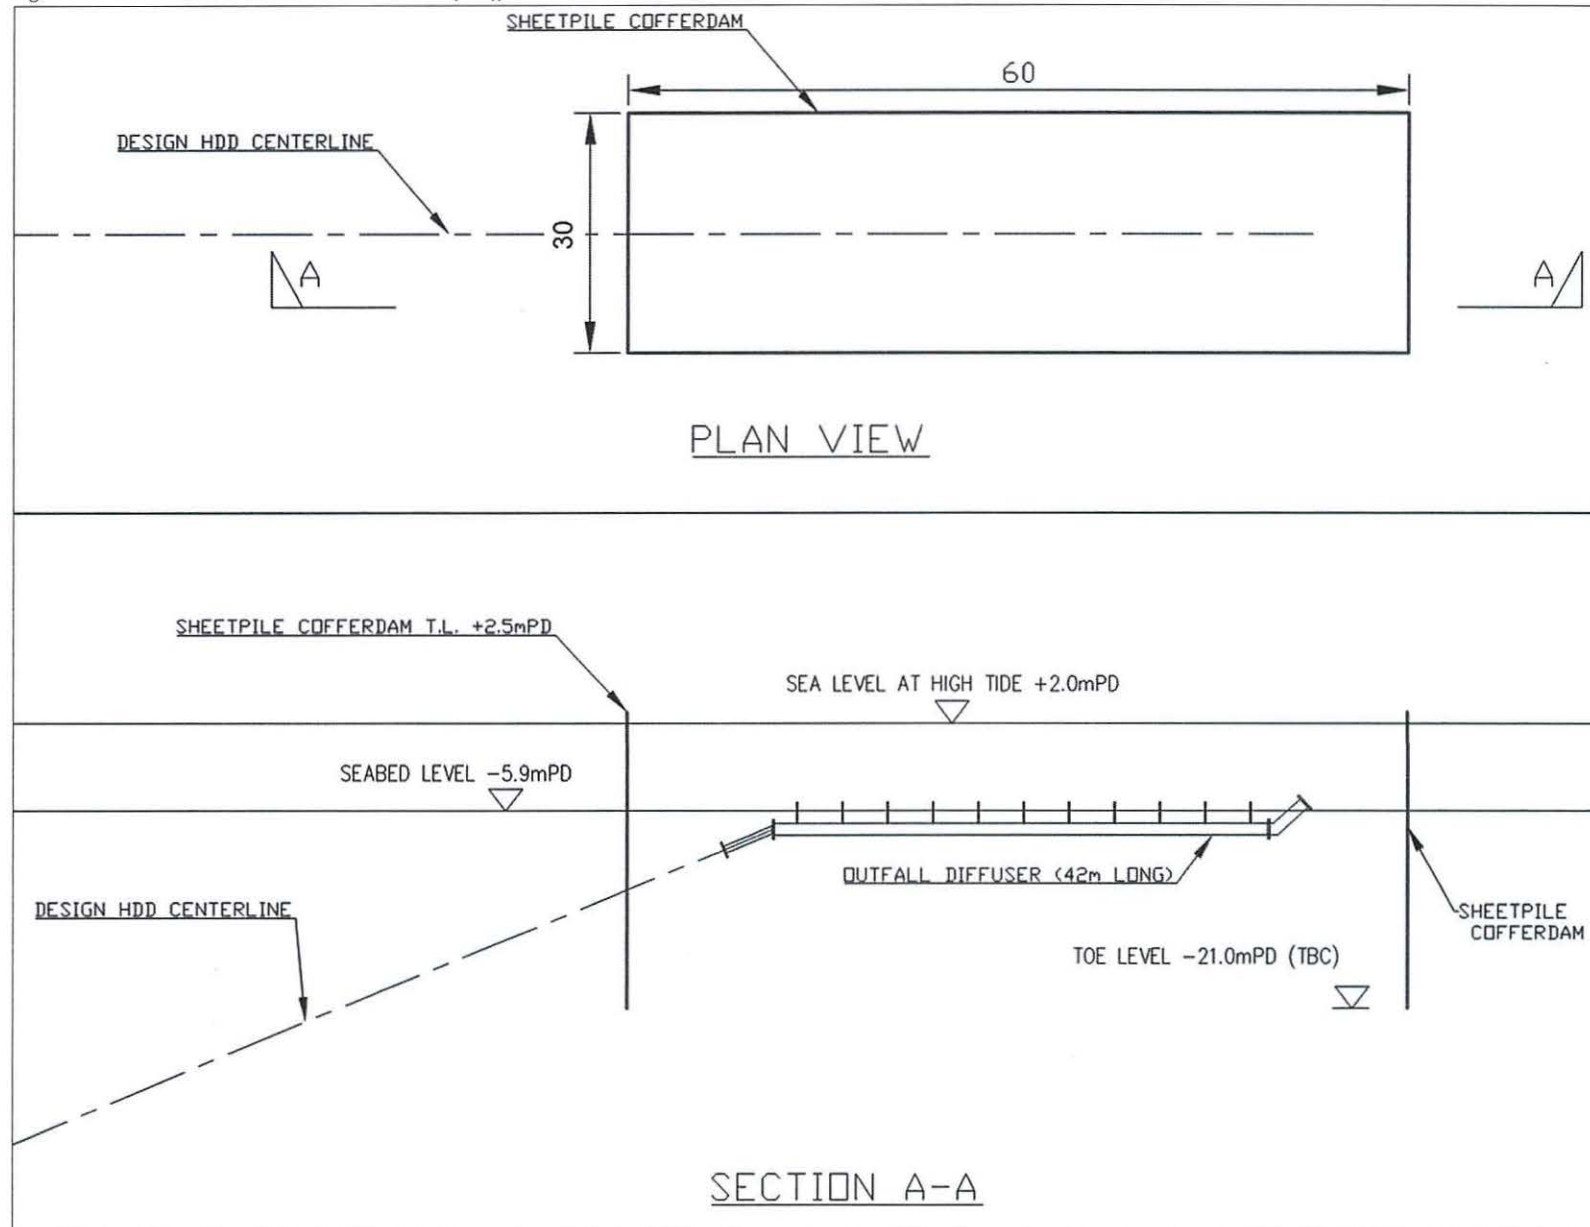
Figure 2.4 Cross-sectional View and Plan View of Cofferdam

HDD method. After completion of the HDD works, a marine cofferdam as assumed in the EIA would be installed. Sediment removal and diffuser installation works would then proceed within the cofferdam. The construction methods and locations for the cofferdam installation, sediment removal and diffuser installation works would remain unchanged. Sediment removal and backfilling would be confined within the cofferdam as assumed in the EIA Report. The cross-sectional view and plan view of the cofferdam structure is shown in **Figure 2.4**.

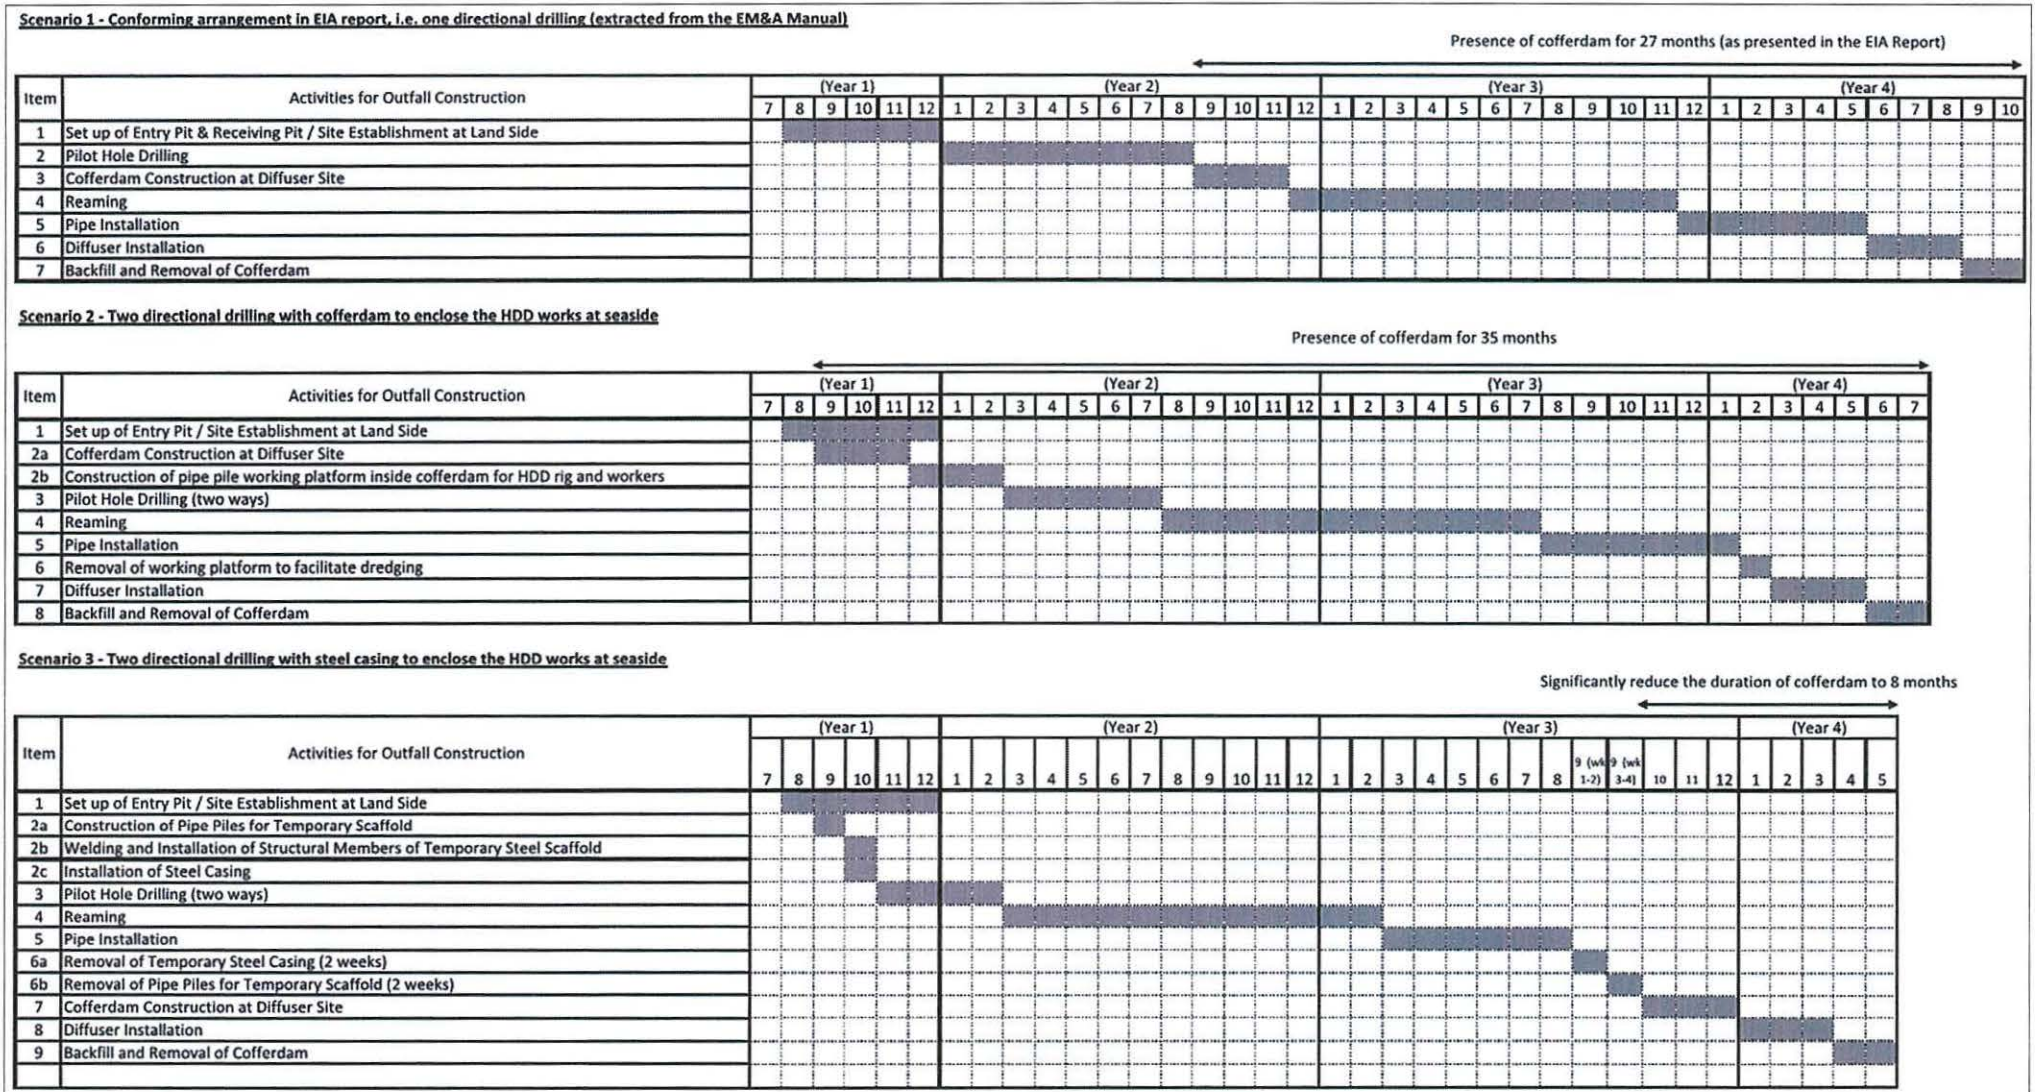
Figure 3.2 Comparison of Construction Sequence for Alternative HDD Methods

Risk to Project due to Damage of Cofferdam	High (exposure to risks for 27 months covering two typhoon seasons)	High (exposure to risks for 35 months covering three typhoon seasons)	Low (exposure to risks for 8 months, which should avoid typhoon season as far as practicable)

The duration of temporary loss of fisheries habitat and fishing ground of 1 ha. <sup>(3)</sup> would be increased from approximately 27 months to approximately 35 months as illustrated in Figure 3.2 below.

The duration of temporary loss of subtidal soft bottom habitats of 0.18 ha. would be increased from approximately 27 months to approximately 35 months as illustrated in Figure 3.2 below.

The duration of temporary loss of fisheries habitat and fishing ground would be changed from approximately 35 months under Scenario 2 to approximately 33 months under Scenario 3 as illustrated in Figure 3.2. Under Scenario 2, cofferdam in the form of interlocking sheetpiles would be used to enclose the HDD works and extra time would be required for maintenance of the cofferdam to secure its watertightness as the pilot drilling works would be suspended intermittently to maintain the cofferdam under a drained condition. The maintenance would disrupt and prolong the pilot hole drilling operation. In this respect, the duration of pilot drilling under Scenario 2 would be longer than the scenario of using a steel casing to enclose the HDD works. Hence, the overall duration of marine works under Scenario 3 would be less than that under Scenario 2.

The revised construction sequence of the outfall construction work is illustrated in Figure 3.2 (Scenario 3) in Section 3. The proposed working rate, working hours per day, the size of steel casing and size of pipe piles etc. as listed above will be specified in the design and construction. Any change in the work proposals and assumptions may alter the water quality impact review results. In case of change in construction works in the future, a review on the environmental implications may be necessary.

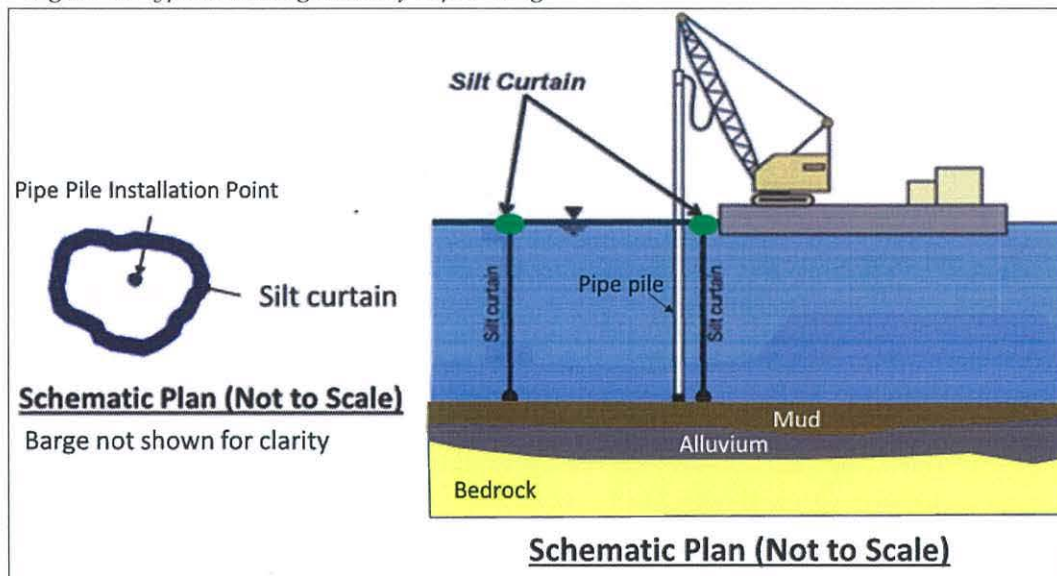
Figure 4.3 Typical Arrangement of Pipe Piling

quality impacts associated with the sheetpiling work were predicted in the EIA Report to be minimal and acceptable (as discussed in Section 4.6). Full compliance with the water quality objectives was predicted in the EIA Report. The proposed insertion and removal of pipe pile would not be undertaken concurrently with other marine works of this Project such as the cofferdam installation / removal works. Hence, the water quality impact of the sheetpiling works as assessed in the EIA Report would remain a worst-case condition. No unacceptable water quality impact would arise from the construction of the temporary scaffold. Full compliance with the water quality objectives would be achieved during the pipe pile insertion and removal. The typical arrangement of the piling work is illustrated in Figure 4.3.

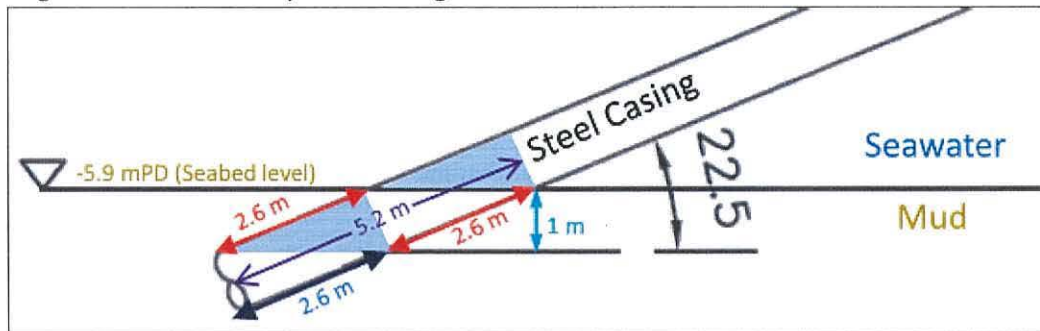
Figure 4.4 Inclination of Steel Casing

Following the EIA assumption, only the first 1 meter of sediment at the surface of the seabed would be potentially released into the water during the insertion or removal of the steel casing. After the initial insertion or removal action, these surface sediments would have been displaced or released by the vibratory action and no more sediment loss would occur from the remaining insertion or removal process. The EIA assumed that sediment below 1 m of the seabed level would not be brought up to the surface by the vibratory action. The steel casing would be inserted or removed at an inclination angle of 22.5° as shown in Figure 4.4.

Due to the inclination, the steel casing would need to be inserted or removed for a total length of about 5.2 m before it can completely displace the top 1 meter of sediment as shown in Figure 4.4. It would take about 5.2 hours to complete this initial process (or on average 1 hour per 1 meter of steel casing insertion or removal). Based on the same principles adopted in the EIA Report, the volume of sediment to be disturbed would be the same as the volume of the sediment to be displaced by the steel casing structure within the surface sediment layer. The sediment loss rate for steel casing insertion or removal would be about 0.0035 kg /sec (see calculations below):

$$\begin{aligned}
 &= \text{Circumference of Steel Casing (m)} \times \text{Thickness of Steel Casing (m)} \times \text{Length of Steel Casing within the First 1 meter of Surface Sediment (m)} \\
 &= 3.14 \text{ m (Circumference)} \times 0.025 \text{ m (Thickness)} \times 2.6 \text{ m (Length as shown in Figure 4.4)} \\
 &= 0.2041 \text{ m}^3
 \end{aligned}$$

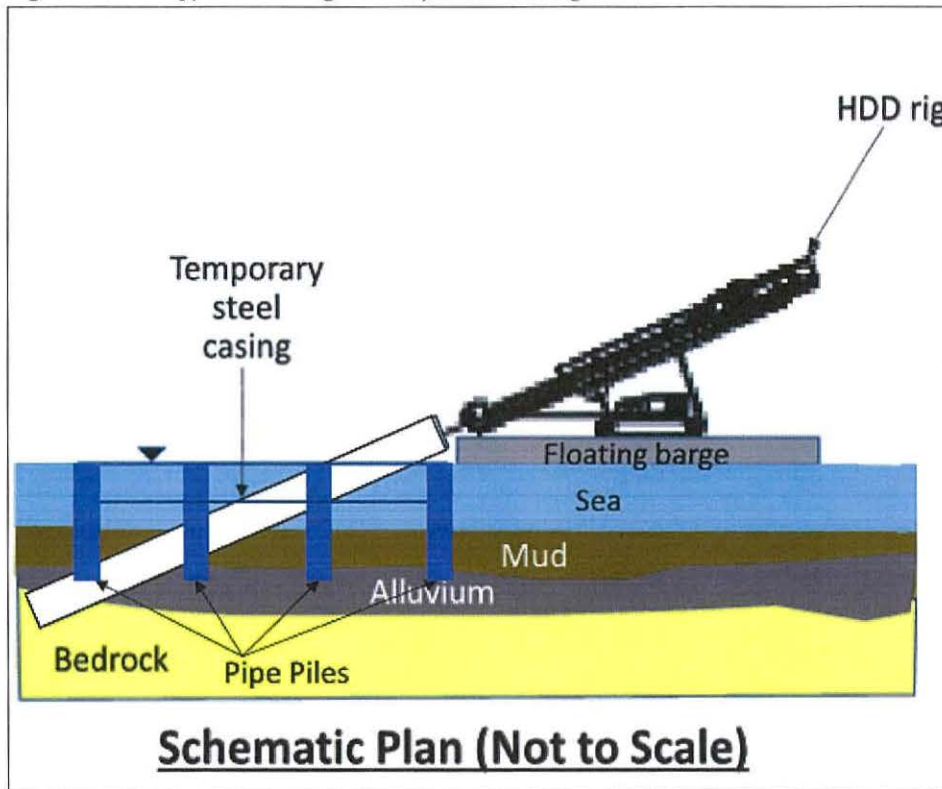
Figure 4.5 Typical Arrangement of Steel Casing

The typical set up of the drill rig and steel casing is illustrated in Figure 4.5 below.

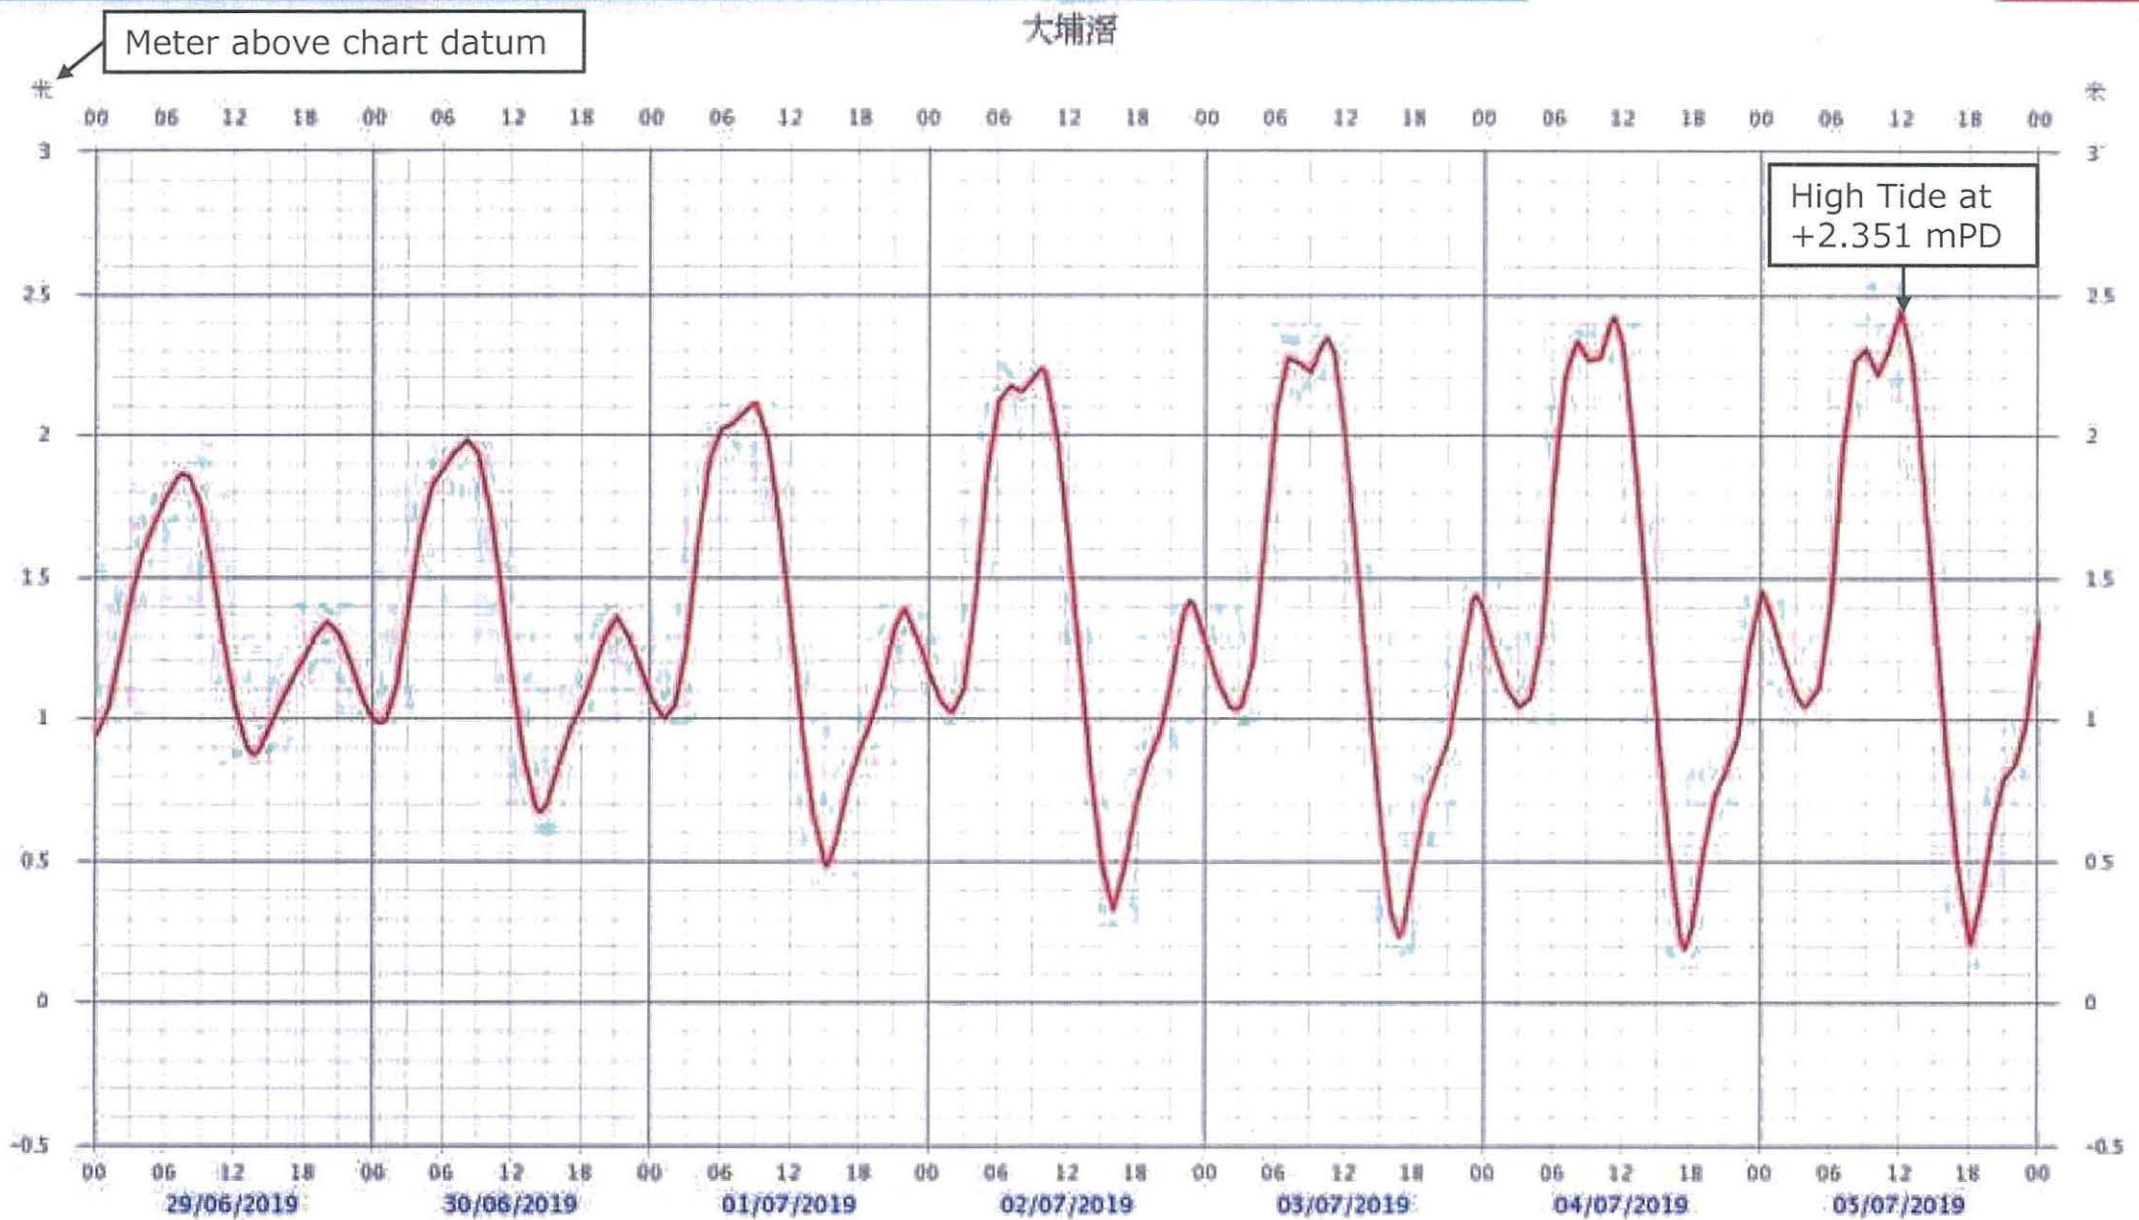
# Normal High Tide and Low Tide

Remarks : Chart Datum is 0.146 metre below the Principal Datum of Hong Kong.

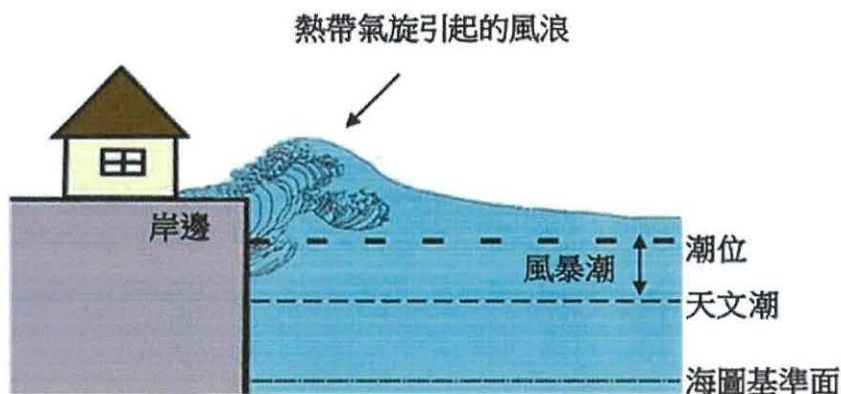
圖八 潮位、天文潮和風暴潮的關係

當日鯪魚涌的潮位(即天文潮位加風暴潮，圖八)最高升至3.88米(海圖基準面以上，下同)，超越了天鴿襲港時錄得的3.57米，並僅次於1962年溫黛襲港期間錄得的3.96米。大埔滘則錄得最高潮位4.71米，同樣僅次於溫黛襲港期間錄得的5.03米。
