9. LANDSCAPE AND VISUAL IMPACT ASSESSMENT

9.1.1 DRU Landscape Ltd conducted a landscape and visual impact assessment (LVIA) of the alternative Route 16 alternative alignment in February and March 1999. This LVIA updates the findings of the Previous LVIA (January 1998), which was based on the conforming alignment. Relevant findings of the Previous LVIA are presented in *Annex 9A* and have been incorporated into this section. This section summarizes the assessment findings.

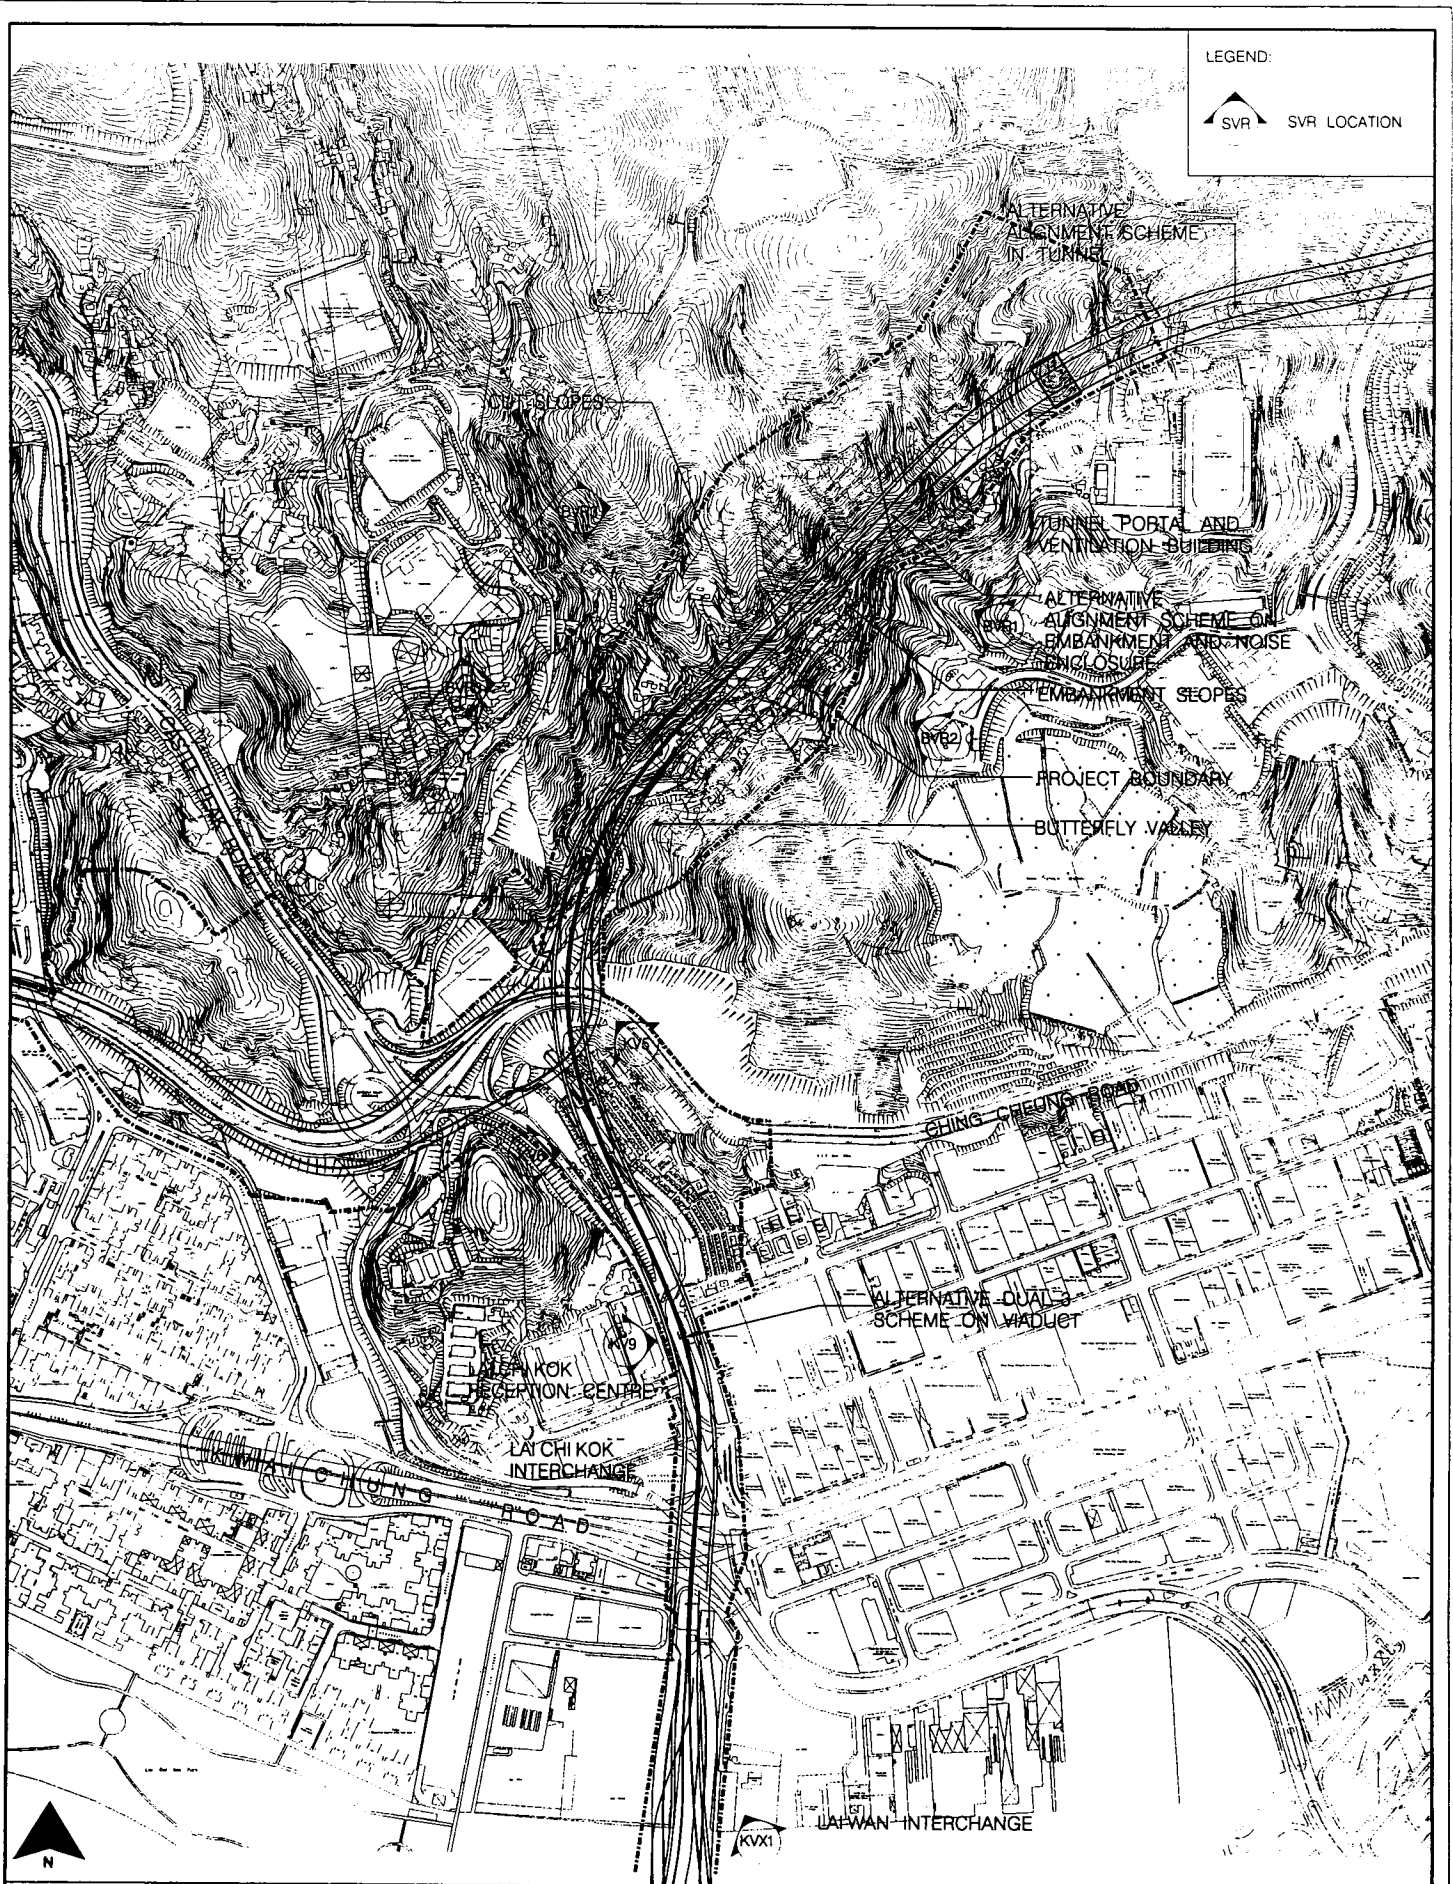
FIGURE 9.1

GENERAL ALIGNMENT OF ALTERNATIVE
ALIGNMENT AND LANDSCAPE IMPACT
ASSESSMENT STUDY AREA

9.2.1 The Study Area boundary for the LVIA was 500 m either side and along the full length of the proposed alignment (see *Figure 9.1a*) for the assessment of landscape impacts. No boundary was set for the assessment of visual impacts.

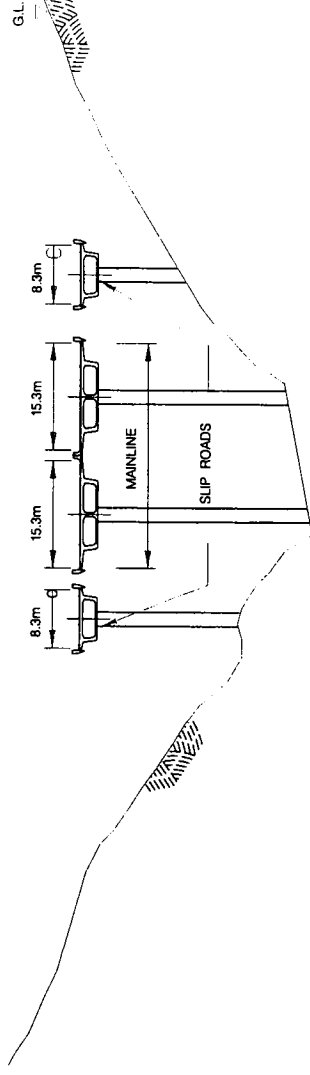
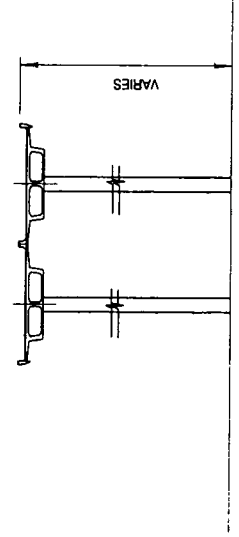
FIGURE 9.2(a)

TYPICAL CROSS SECTION OF VIADUCT BETWEEN CHING CHEUNG ROAD AND NORTH OF CHING CHEUNG ROAD

TYPICAL CROSS SECTION OF VIADUCT BETWEEN LAI CHI KOK INTERCHANGE AND CHING CHEUNG ROAD

ROUTE 16
TYPICAL CROSS SECTIONS THROUGH
ALTERNATIVE ALIGNMENT ON VIADUCT

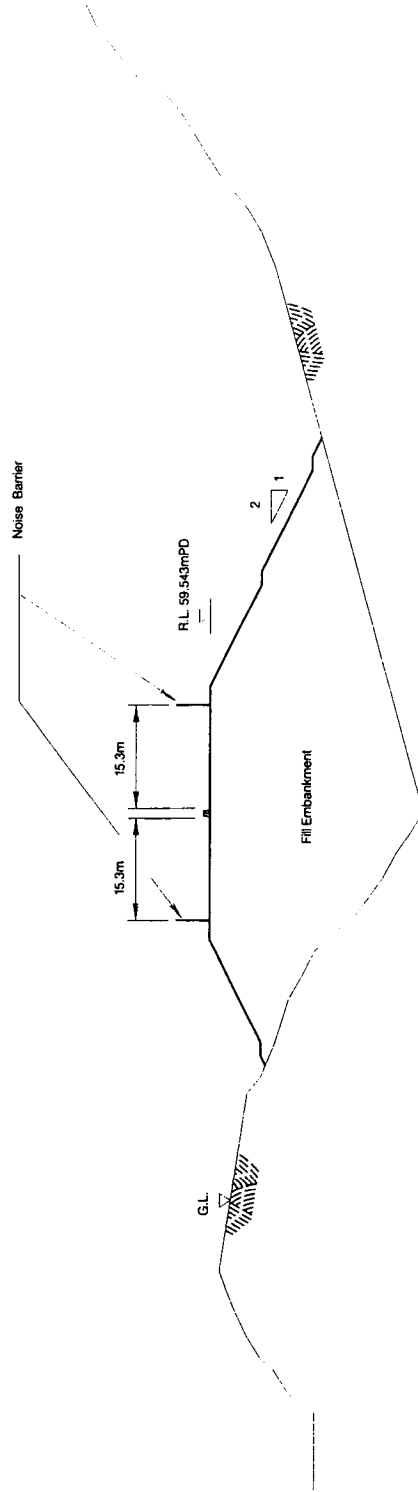
FIGURE 9.2(b)

ROUTE 16
 TYPICAL CROSS SECTION ALTERNATIVE
 ALIGNMENT ON EMBANKMENT
 SHEET 2 OF 3

- 9.8.3 Generally, the presence of a Dual-3 road on viaduct and embankment (refer to typical cross-sections shown on Figure 9.2b-c) extensive slope and drainage works within Butterfly Valley and the new tunnel portal will result in a severe level of landscape impact during the construction period (refer to Figure 9.7d to 9.7e) owing to the permanent loss of extensive areas of secondary woodland and shrubland. When combined with the landscape impact of the existing WSD construction works, the cumulative effect would be an extensive change from the original baseline condition. From Day 1 to Year 10 and beyond, the scale and mass of the new road formation and associated earthworks, combined with the WSD reservoir will contrast considerably with existing landform, substantially decreasing its desirability and importance in landscape terms from high to negligible local value.

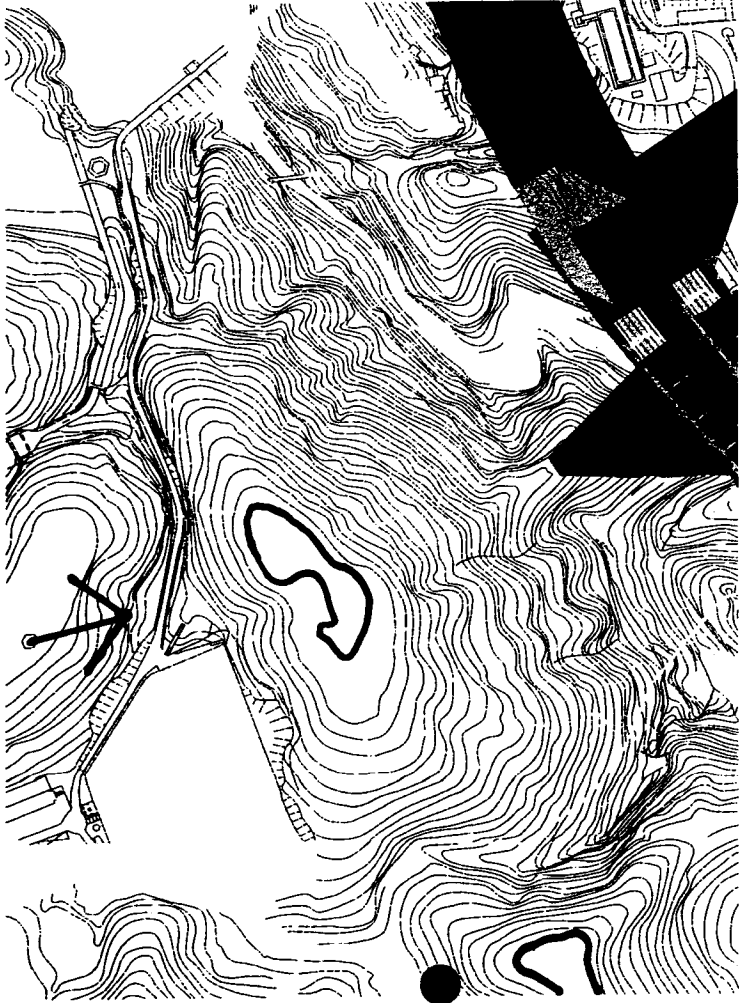
Figure 9.4 VISUAL ANALYSIS OF VIEWS FROM LION ROCK COUNTRY PARK

Viewpoint is a BBQ area in Lion Rock Country Park as close as possible to the alternative alignment. Red contour represents intermediate landform blocking views of the proposed road.

Alternative alignment on embankment

Alternative alignment in tunnel.

● Wireframe computer perspective demonstrating that the road alignment (illustrated in grey) is below the level of intermediate landform (shown as a red contour, see map above for location).

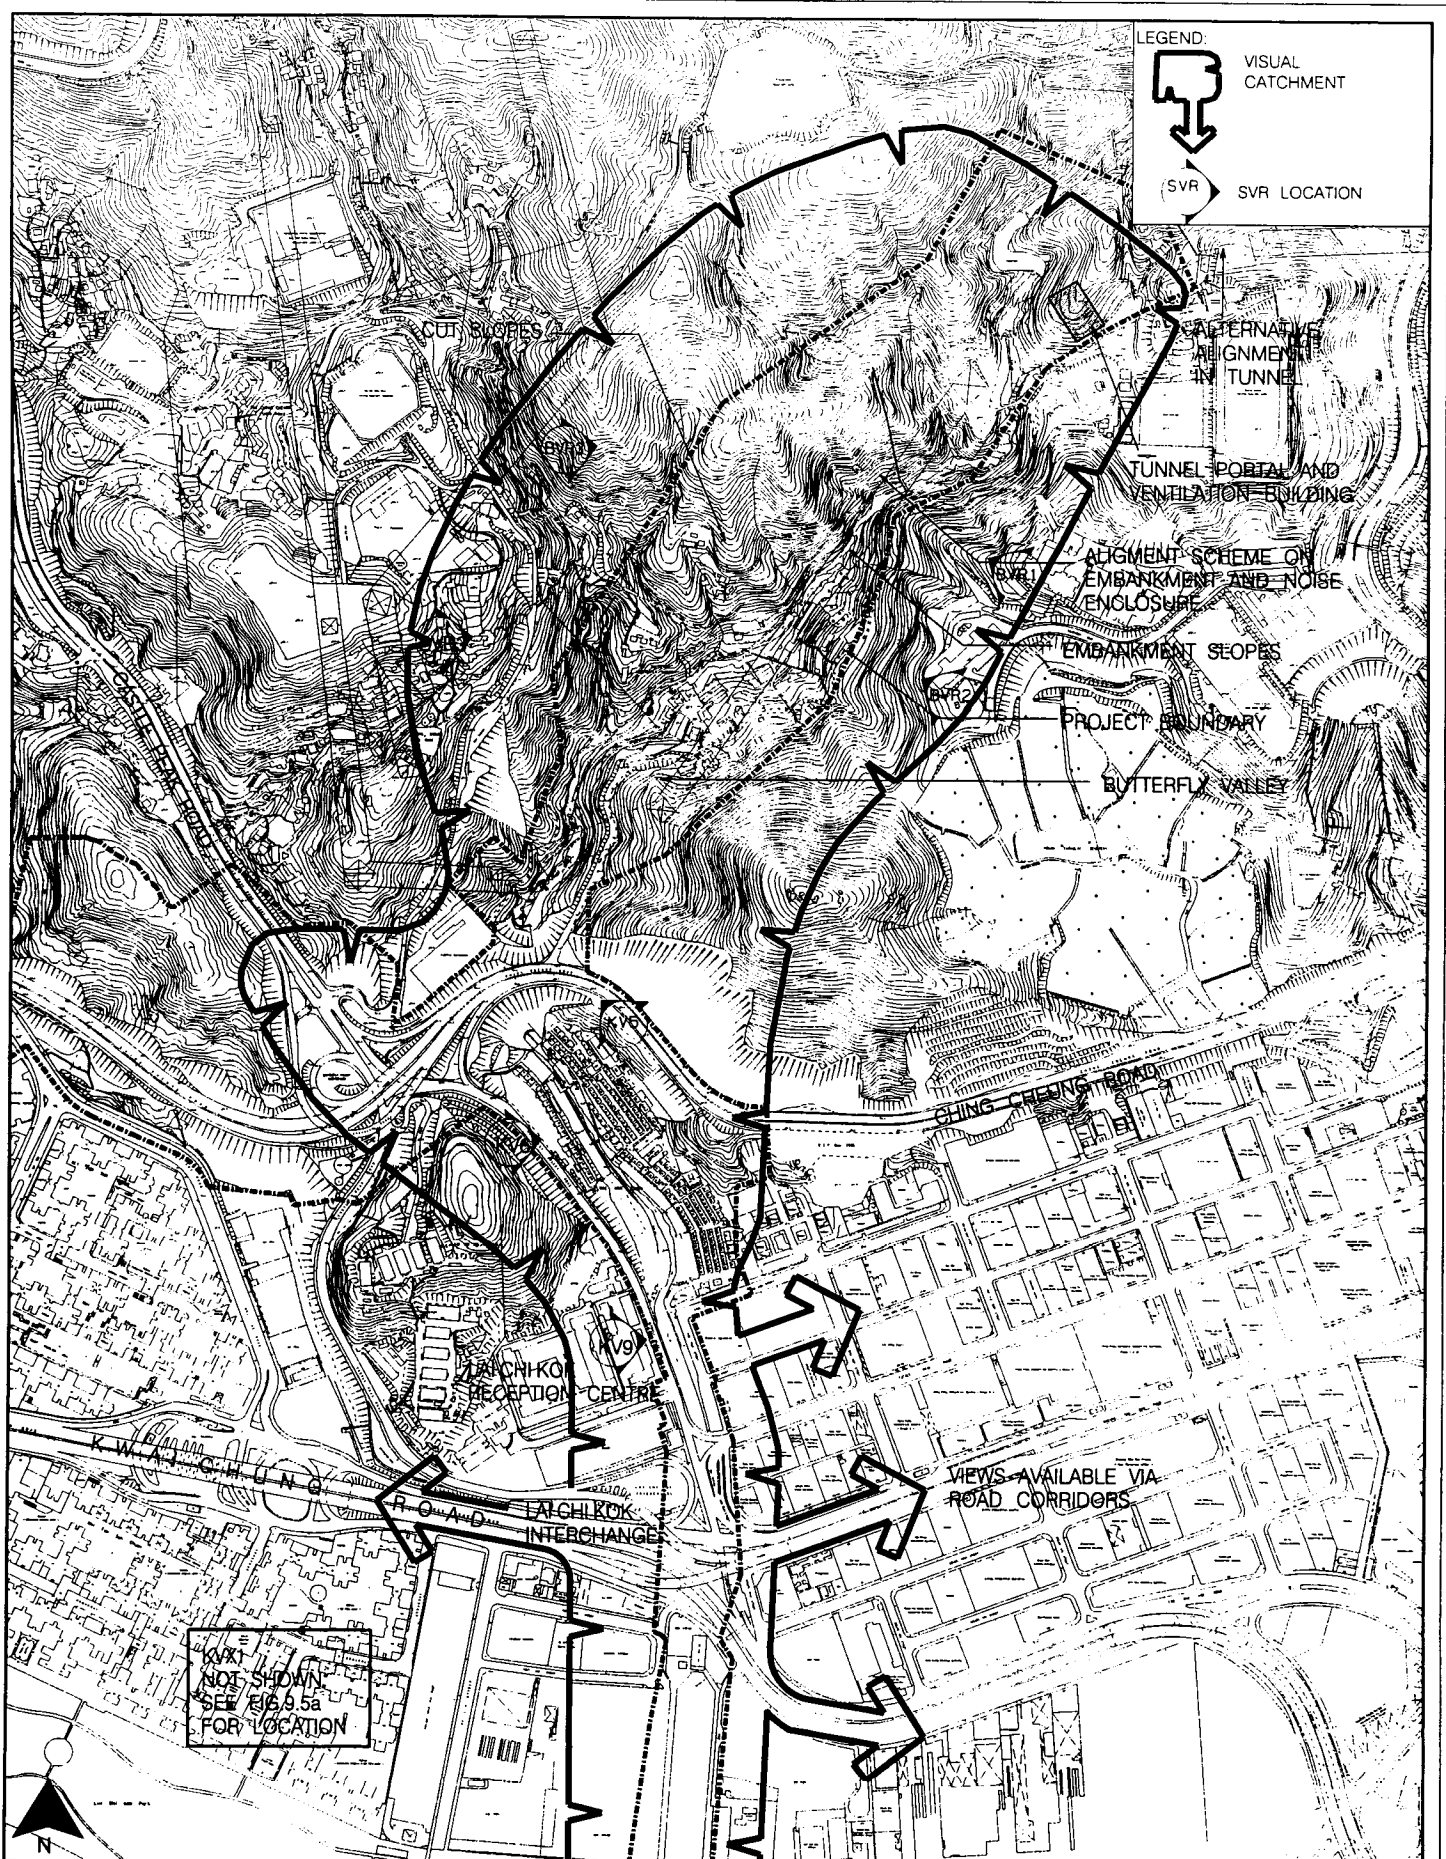
FIGURE 9.4(a)

LOCATIONS OF SENSITIVE VISUAL RECEIVERS AND VISUAL CATCHMENT

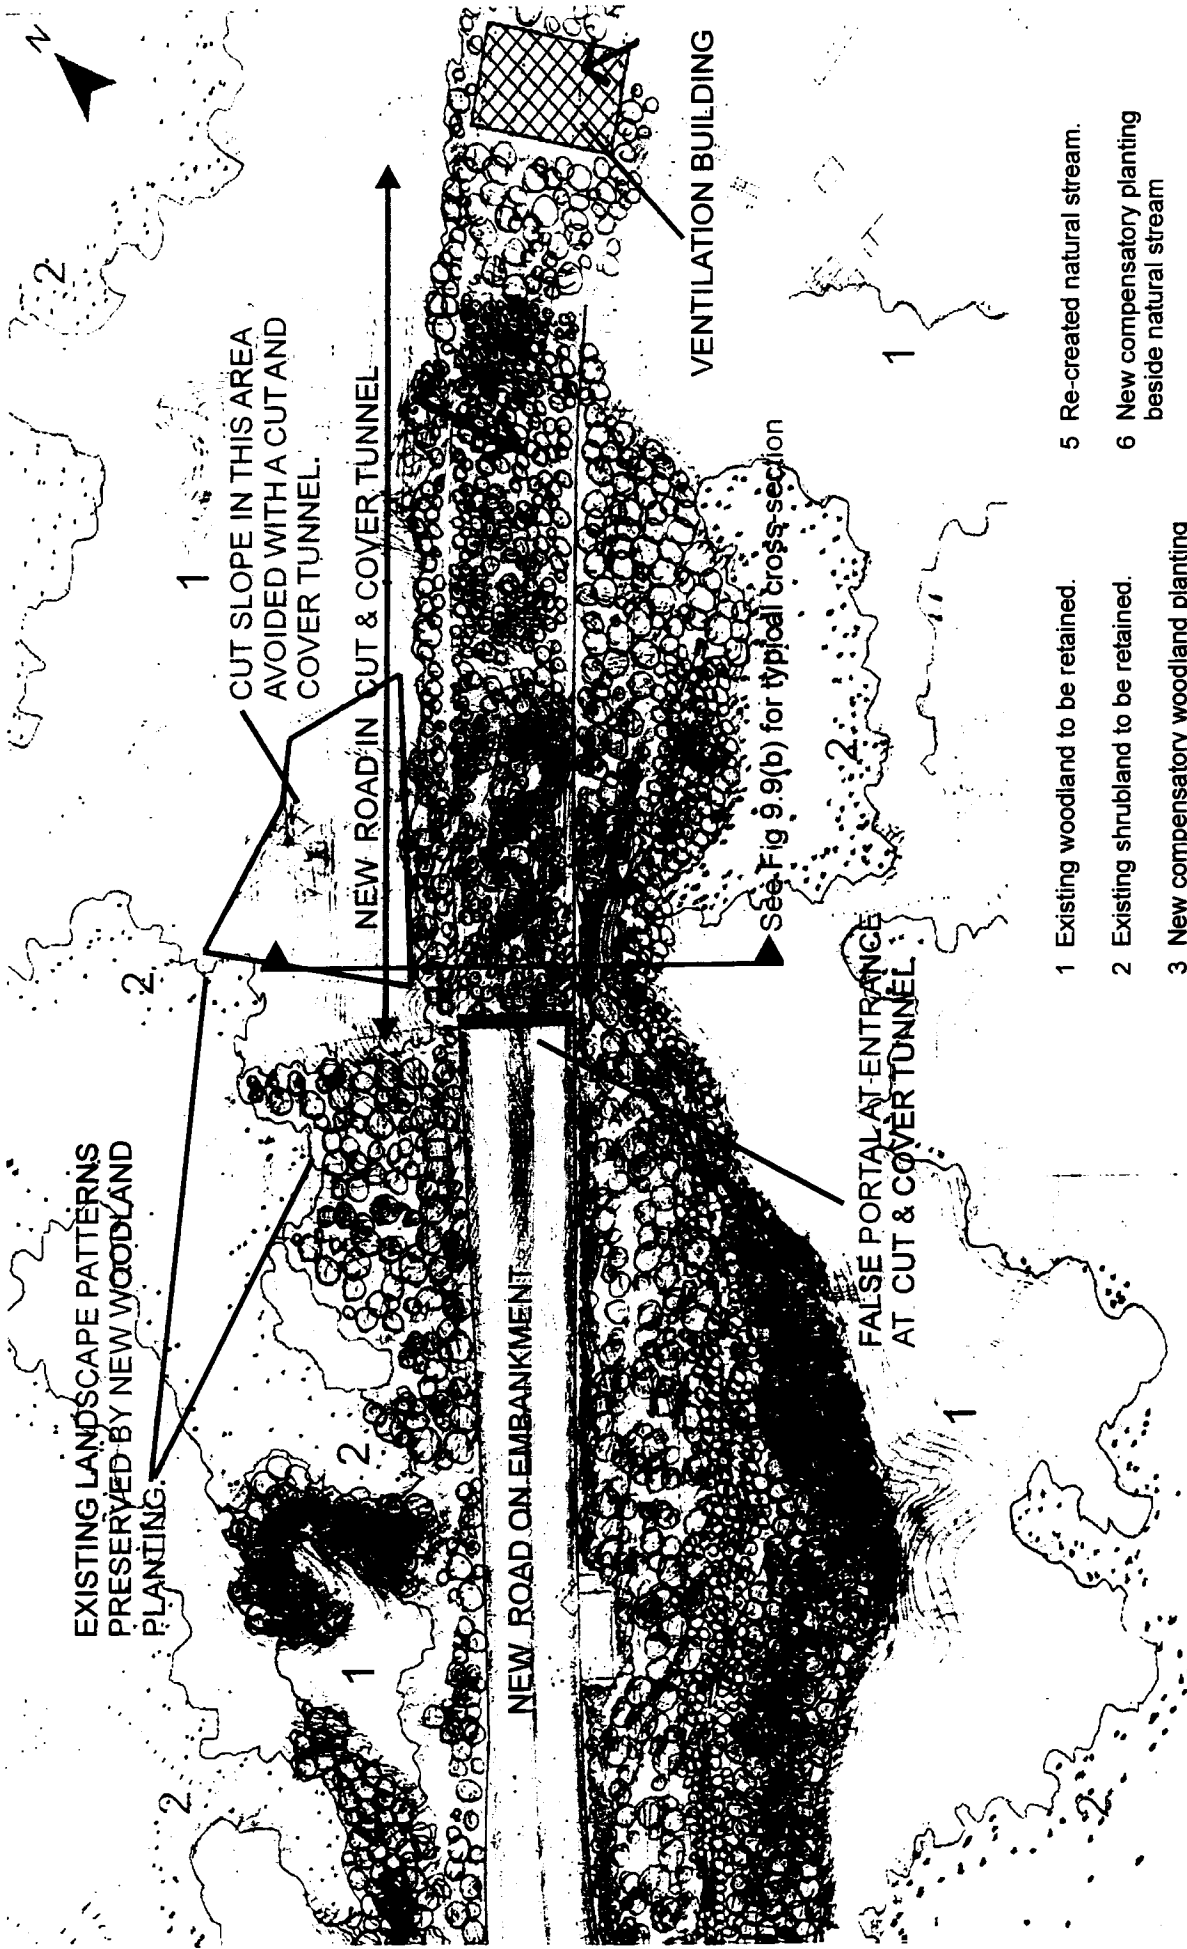
Figure 9.9(a) Typical Landscape Mitigation Measures in Butterfly Valley

- 1 Existing woodland to be retained.
- 2 Existing shrubland to be retained.
- 3 New compensatory woodland planting on new cut and fill slopes
- 4 New compensatory planting in disused villages areas
- 5 Re-created natural stream.
- 6 New compensatory planting beside natural stream
- 7 New compensatory planting on cut and cover tunnel.

- 9.8.25 ***Landscape mitigation measure 10 (LMM10)*** – *Re-creation of stream in Butterfly Valley.* The existing stream should be recreated adjacent to the fill slope in Butterfly Valley (see Figure 9.9a and 9.9b for details).

At detailed design, a cut and cover tunnel should be considered in order to maximize the area of compensatory planting, and to minimize the area of land disturbed by site formation (see Figure 9.9(a) for the location of this cross-section).

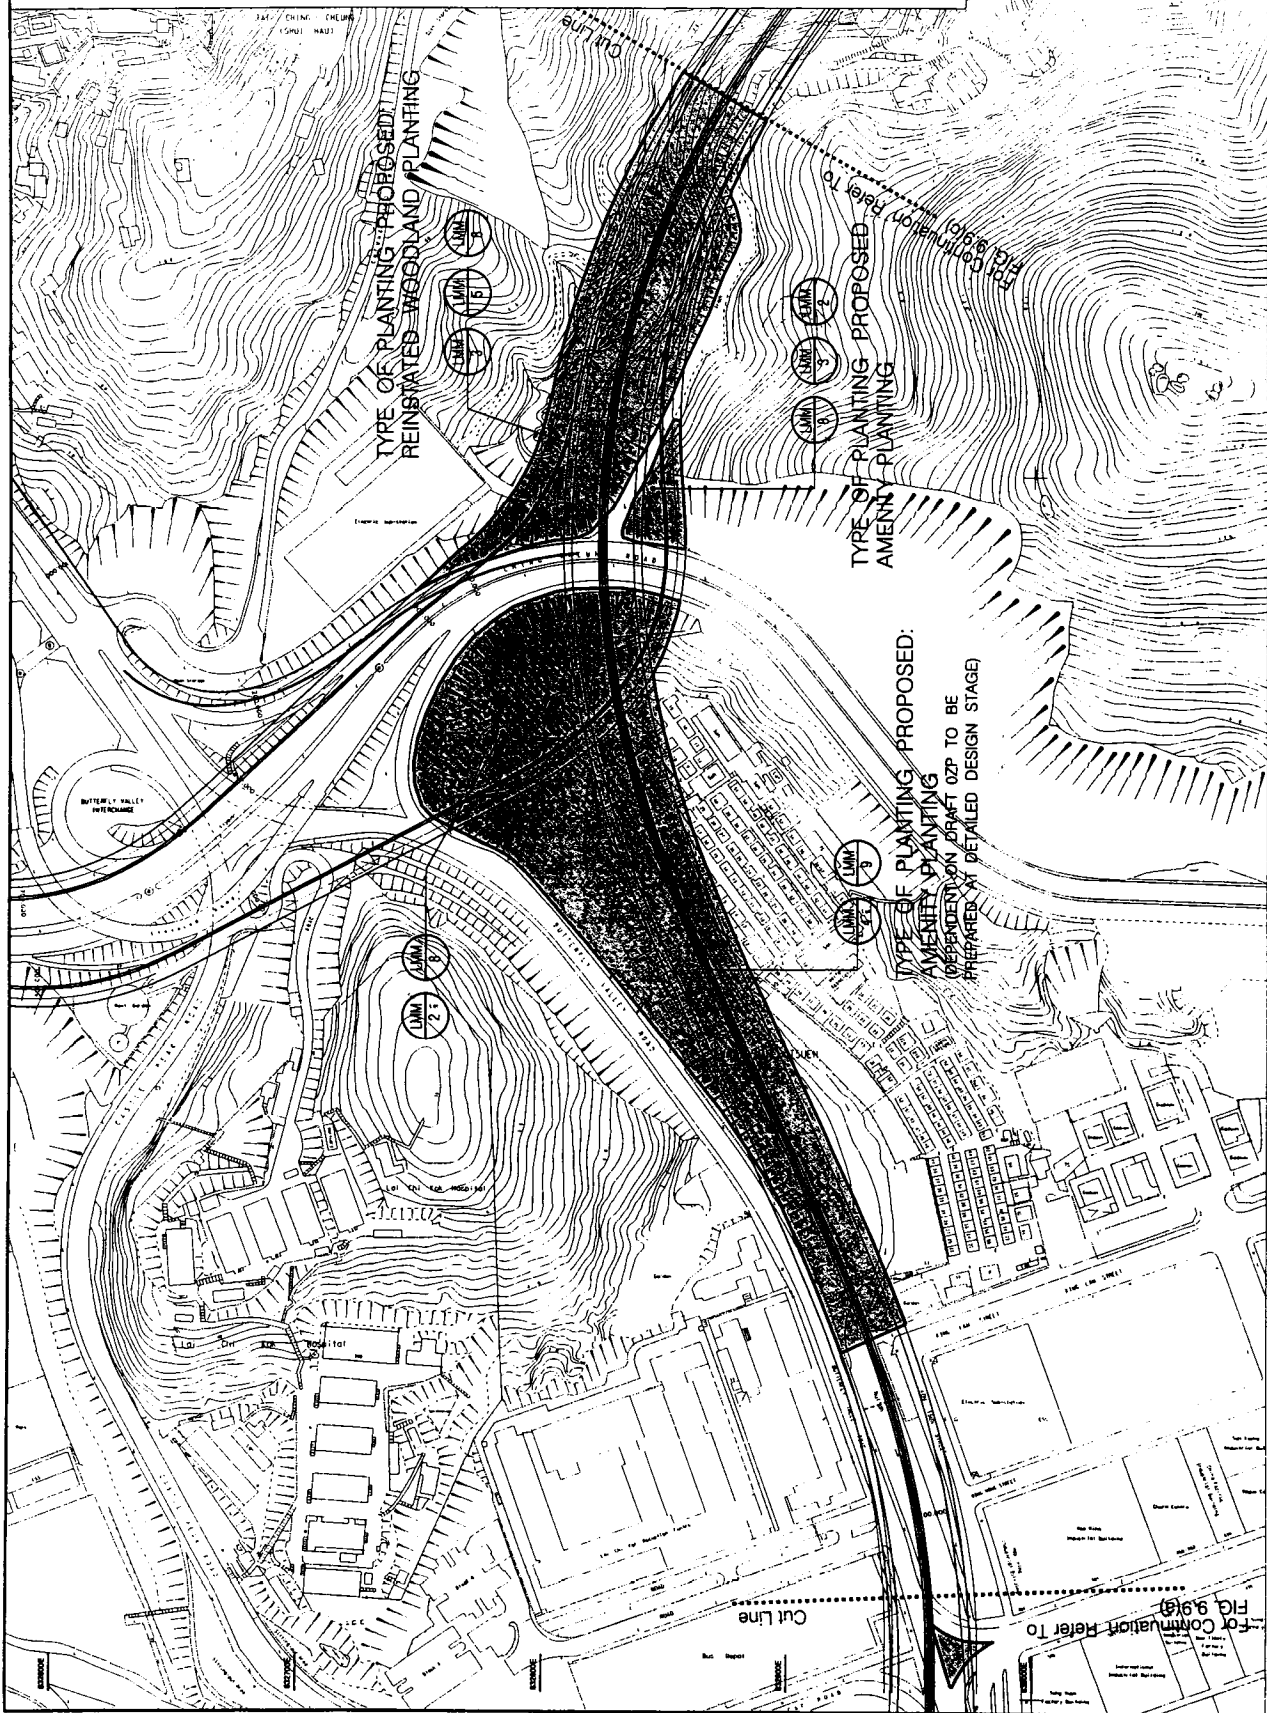
FIGURE 9.9(e)

ROUTE 16 ALTERNATIVE ALIGNMENT
 PROPOSED LANDSCAPE MITIGATION MEASURES
 KOWLOON SECTION
 SHEET 2 OF 3

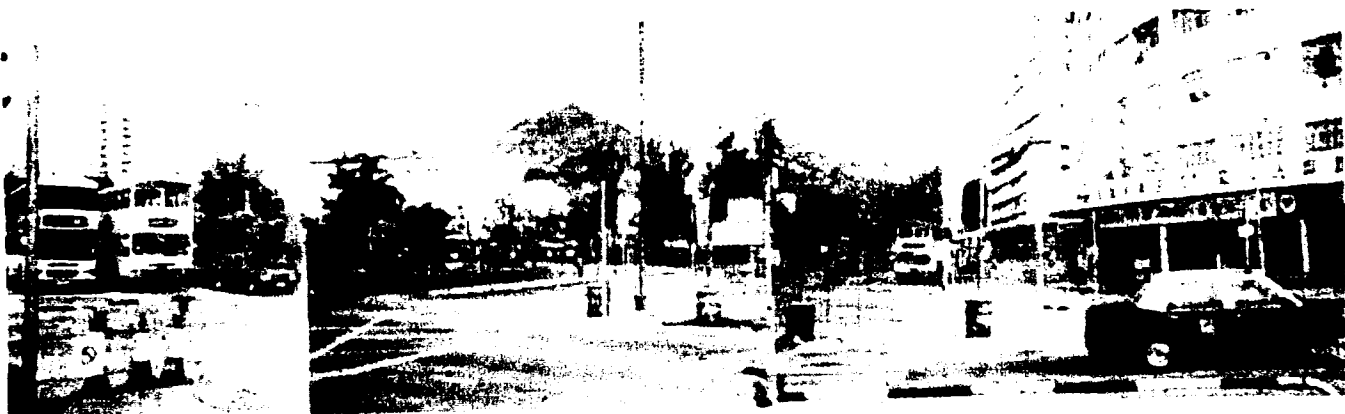
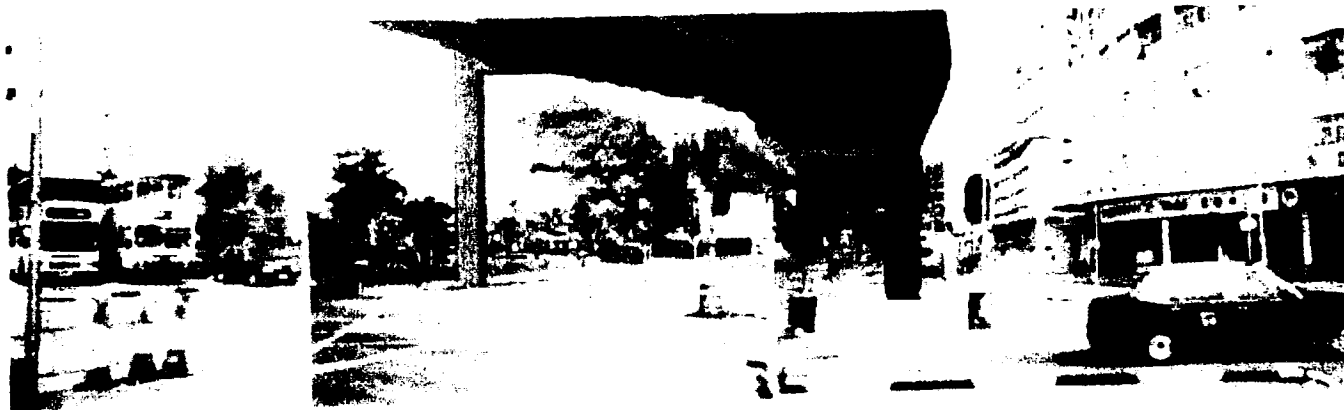
Figure 9.10 (a)

EXISTING VIEW

VIEW WITH PROPOSED BRIDGE

View of Butterfly Valley Road looking north from
Lai Chi Kok Interchange

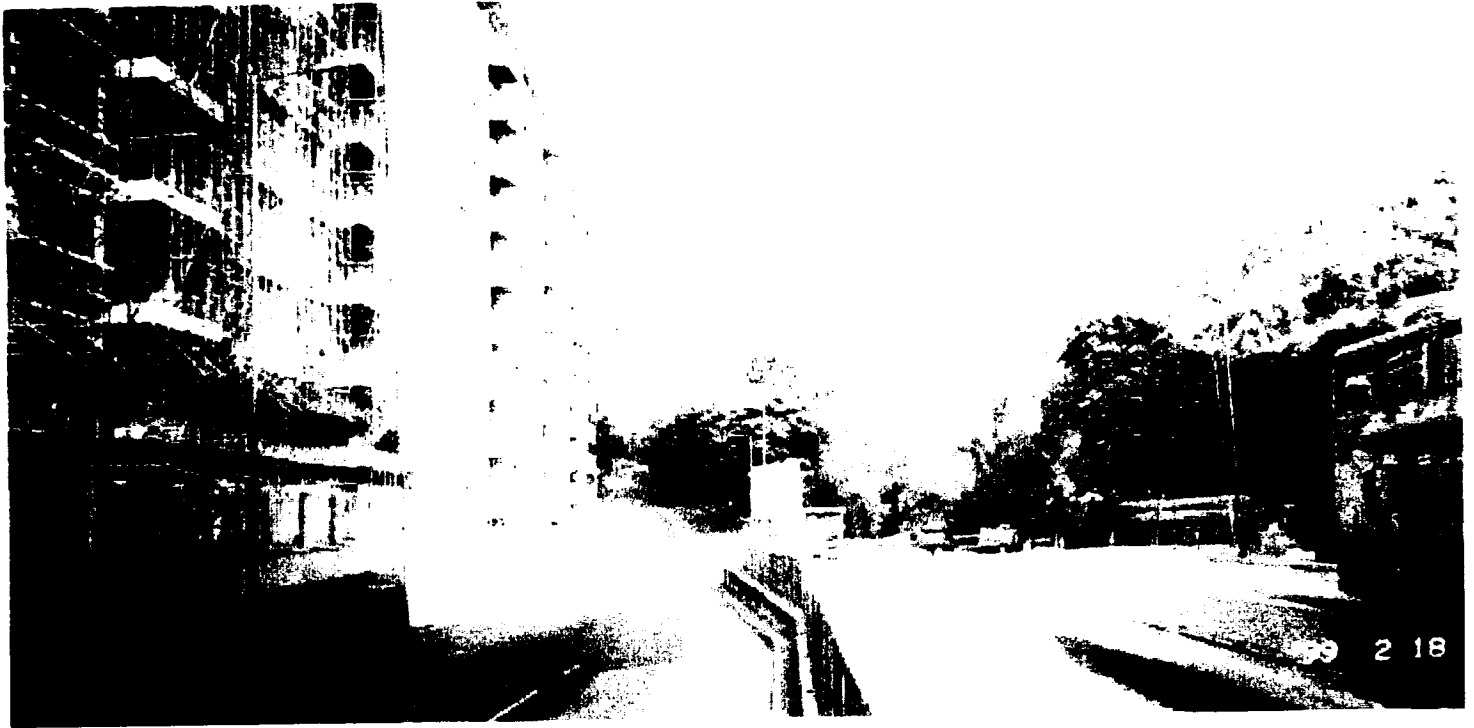
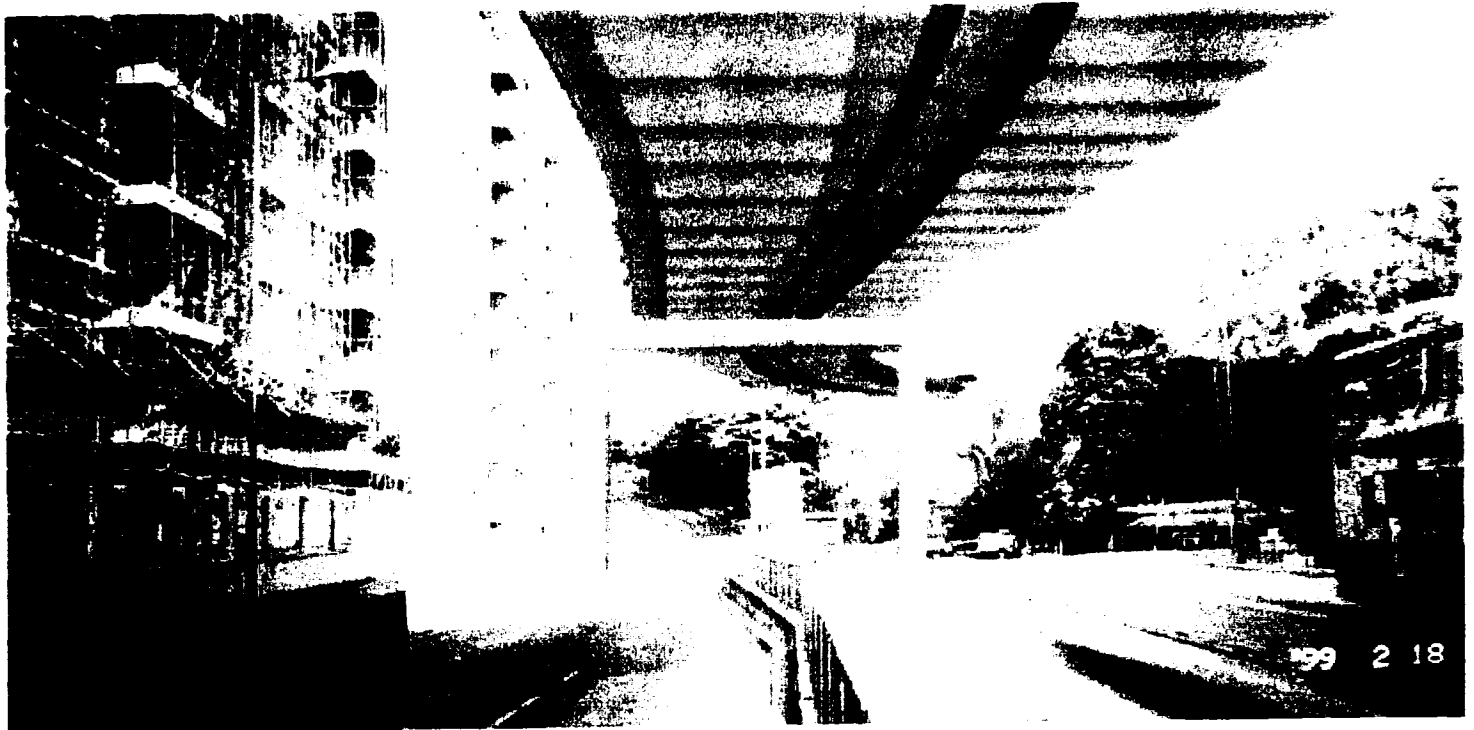
Figure 9 10(b) PHOTMONTAGE FROM VIEWPOINT 2

EXISTING VIEW

VIEW AT DAY 1 OF OPERATION

View of Butterfly Valley Road looking north next to Lai Chi Kok Reception Centre low-rise staff quarters (VSR KV9).

- 9.8.11 Some residents at the LCK Reception Centre low-rise Staff Quarters (KV9) would have unobstructed views of the adjacent road, noise enclosures and ancillary systems. The Alternative alignment would be a conspicuous element completely dominating the immediate foreground. The changes to baseline condition would be severe during the construction period, as an extensive area of the foreground to background view would change to a construction site. From Day 1 to Year 10 and beyond, it is likely that the level of visual impact will remain severe, owing to the residential nature of the SVRs and the proximity of the road (refer to photomontage on Figure 9.10b).

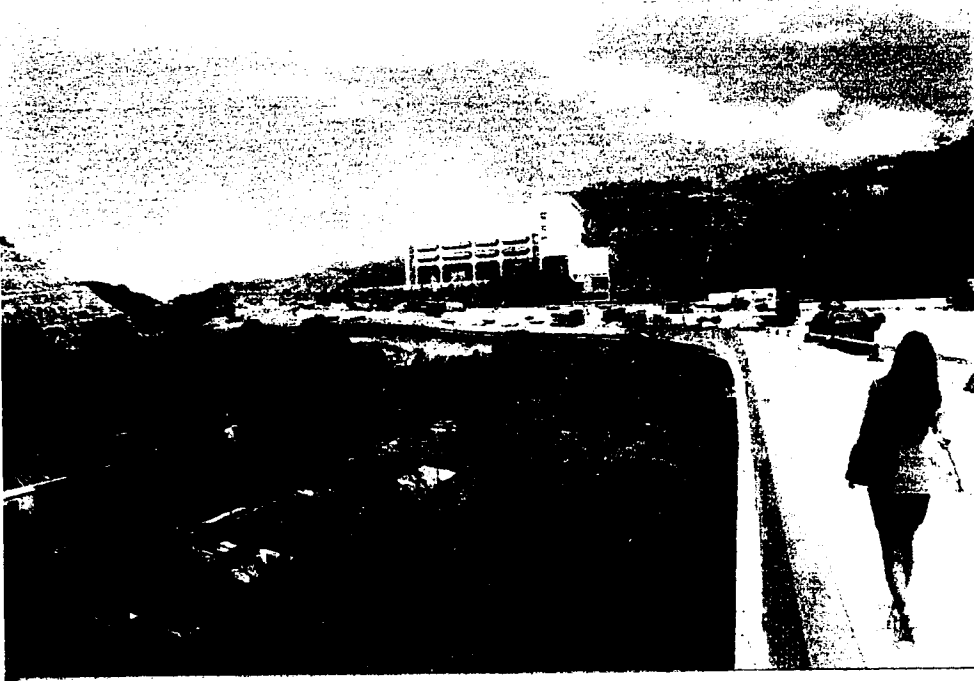
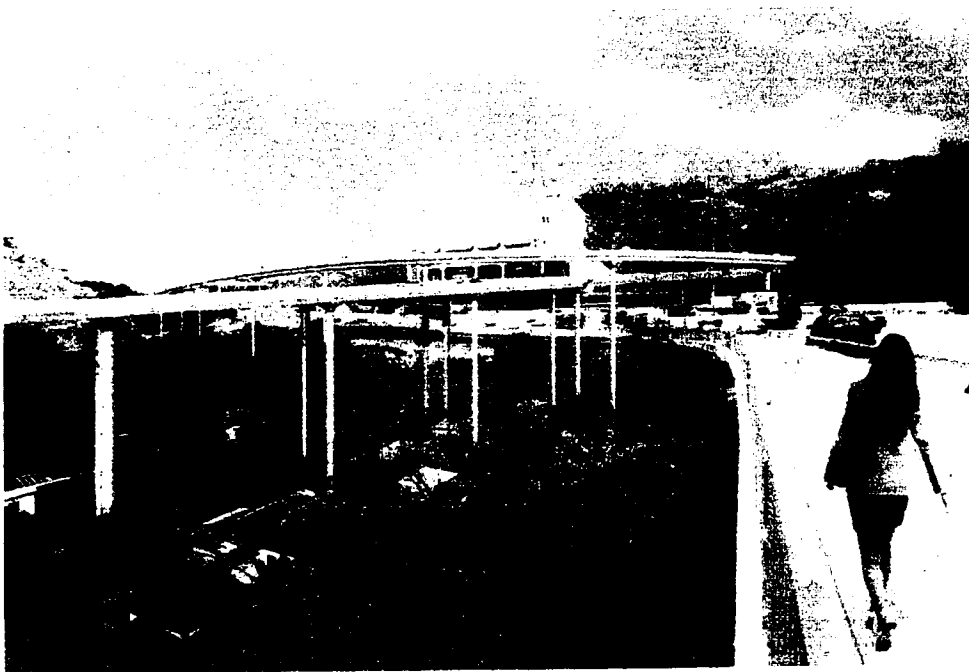
Figure 9.10(c) PHOTOMONTAGE 3

EXISTING VIEW

VIEW AT DAY 1 OF OPERATION

**VIEW FROM CHING CHEUNG ROAD OVERLOOKING
WAI MAN TSUEN VILLAGE**

- 9.8.10 All drivers and pedestrians using Ching Cheung Road (KV5) would have brief transitory views of the high level viaduct as they move towards and under it, changing from a background to a foreground view. The changes to baseline condition would be moderate from the construction period to Year 10 and beyond (refer to photomontage on Figure 9.10c).

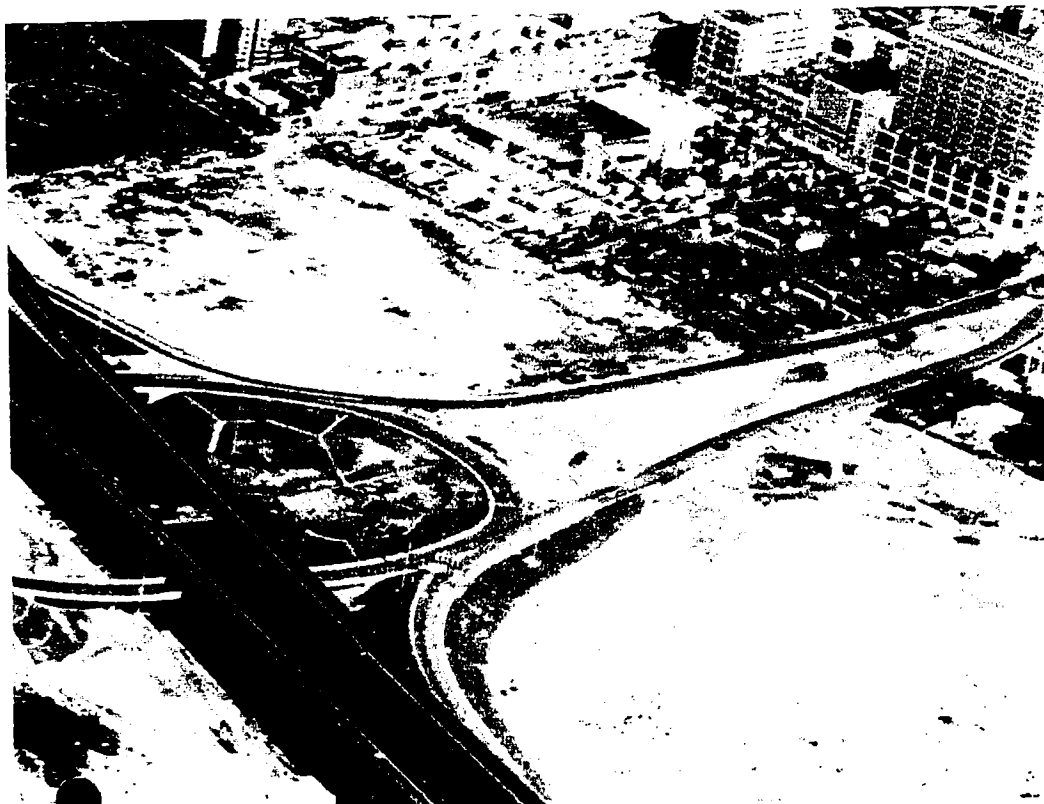
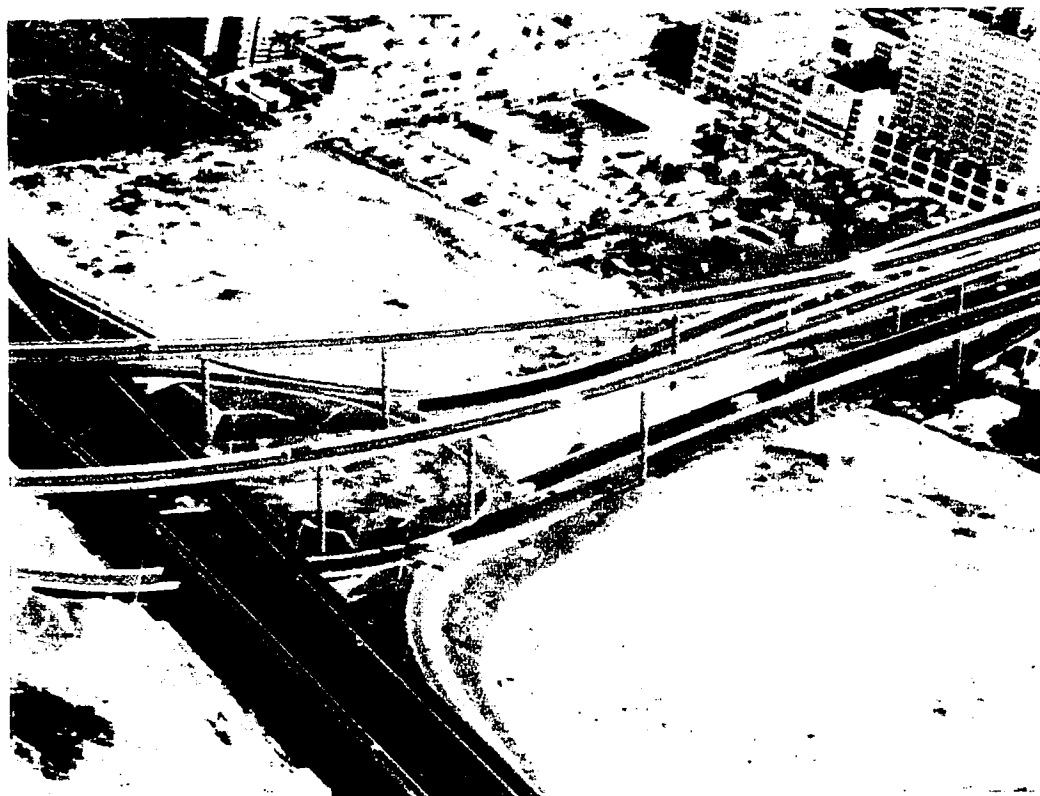
Figure 9.10(d) PHOTOMONTAGE 4

EXISTING VIEW

VIEW AT DAY 1 OF OPERATION

VIEW OF ELEVATED SLIP ROADS AT LAI WAN
Refer to Figure 9.7(a) for layout and location

- 9.8.12 Owing to the construction programming, Route 16 will be most likely already be in construction when the Site 10 housing is completed. Future residents facing south-west in two out of the twelve proposed buildings will see and accept the viaducts as an existing element in the landscape. Owing to the proximity of the scheme to the housing development and the fact that the future residents will have unobstructed views overlooking the adjacent road, noise barriers and ancillary systems, the visual impacts are considered to be moderate during the operation period (refer to photomontage on Figure 9.10d for birds-eye view of proposed scheme in relation to Site 10).

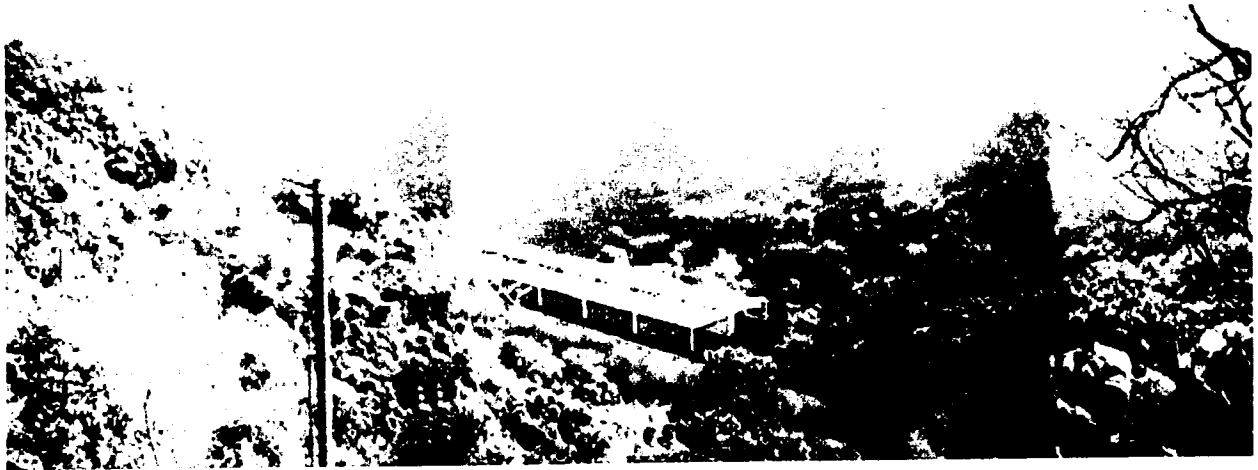
Figure 9.10(e) PHOTOMONTAGE FROM VIEWPOINT 5.

EXISTING VIEW

VIEW AT DAY 1 OF OPERATION

- 9.8.9 Residents of the small villages in Butterfly Valley (BVR3) whose residences are not resumed would have permanent and unobstructed views of the road, noise enclosure and ancillary systems which would be dominating and conspicuous elements in the immediate foreground. The changes to baseline condition would be severe during the construction period, as an extensive area of the foreground view would change to a construction site. From Day 1 to Year 10 and beyond, the level of visual impact would remain high owing to the sensitive nature and proximity of the SVR (refer to photomontage on Figure 9.10e).
