Agreement No. CE 73 / 98
Investigation Study for Widening of Tolo/Fanling Highway
between
Island House Interchange and Fanling
Archaeological Impact Assessment Report

Prepared for the Antiquities and Monuments Office
Home Affairs Bureau
by
ARCHAEOLOGICAL ASSESSMENTS
July 1999

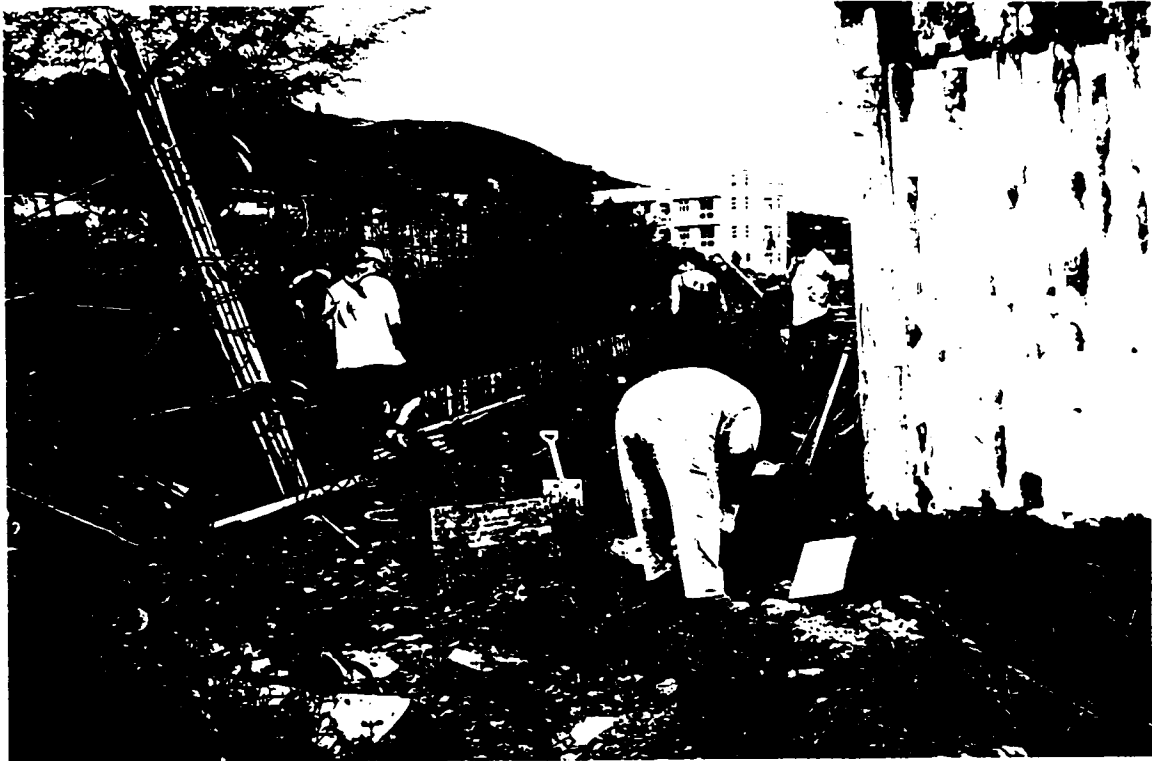
Plate 5 Test Pit 5 : Tai Hang, Unit 23

The results are presented in Table 6 and the section in Fig.25.D ; the location and test pit are illustrated in Plate 5. The test pit consisted of layers of fill with modern debris down to the water table.

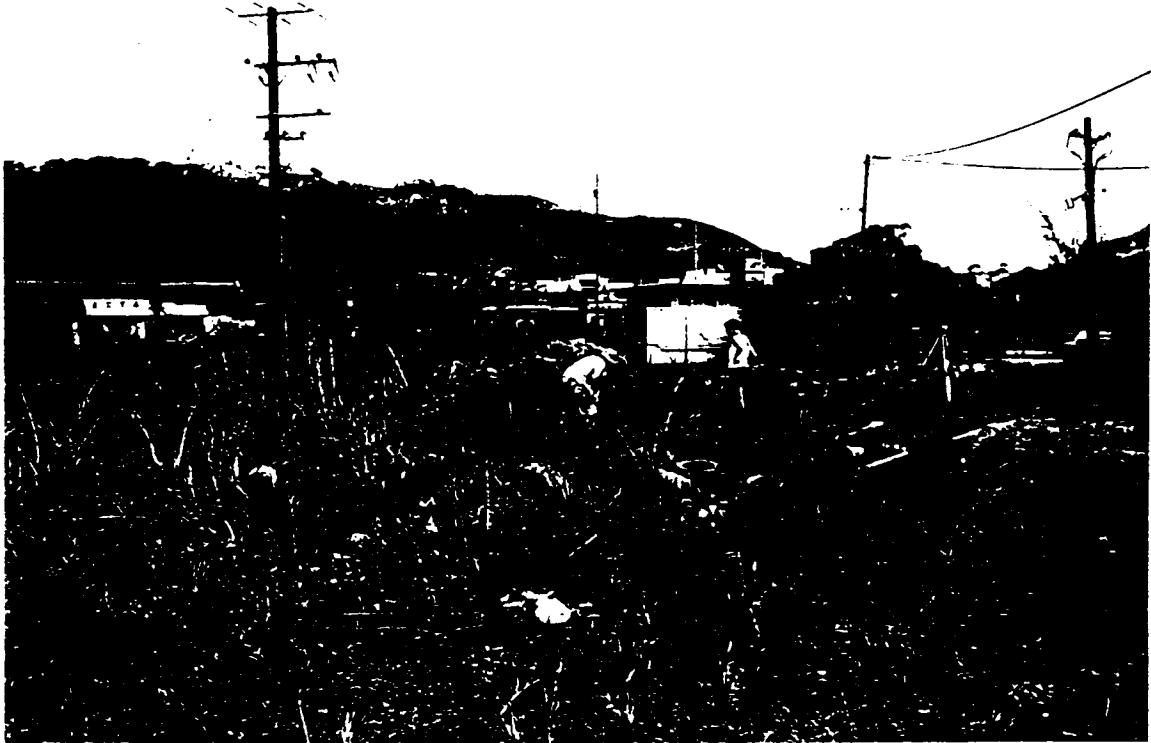
Plate 6 Test Pit 6 : Tai Hang, Unit 23

The results are presented in Table 7 and the section in Fig.25.E; the location and test pit are illustrated in Plate 6. The test pit stratigraphy consisted of green building bricks and other building debris down to the level of the water table. The building debris may have come from repairs to traditional terraced houses to the north-west of the test pit area.
