Drainage Services
Department

Agreement No.
CE 66/2001(EP)

EIA and TIA Studies for the
Stage 2 of PWP Item No.
215DS - Yuen Long and
Kam Tin Sewerage and
Sewage Disposal

Final Environmental Impact
Assessment

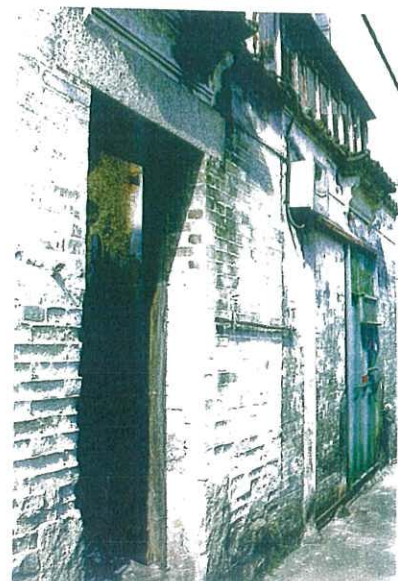
Location: Mong Tseng Tsuen			
Ref: AAHB-0030	Construction Date: c 100 years	Present Use: 1 unit-abandoned, 1 unit-storage	
Recorded on: 10/10/02	Condition: 1 unit-Ruin, 1 unit-fair	Past Uses: 1 unit-abandoned, 1 unit-storage	
Updated on:	Orientation: South east	Historical Associations: None	
Type: Courtyard style terrace units (1 mid, 1 end)	Map Ref: #43 and 44		
General Description: Left hand unit has concrete and tile roof on left hand unit. Pounded earth side wall and green brick façade. Cut granite lintel and threshold. Right hand unit has green brick façade, pounded earth side wall.			
Decorative Features: Canopies over entrances, pattern not discernible.			
Renovations: Right hand unit. 2nd 1/2 floor added, modern metal door.			
Setting: At back of village.			
Additional Notes: None.

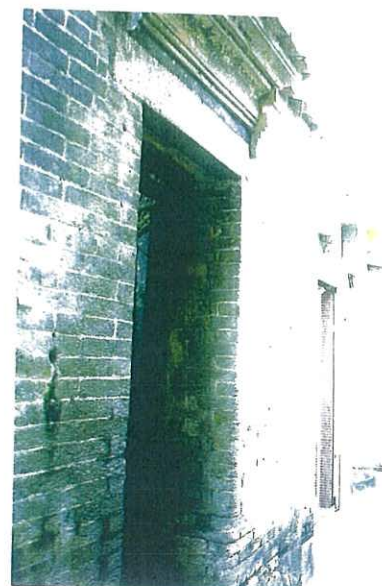
Location: Mong Tseng Tsuen			
Ref: AAHB-0031	Construction Date: c 100 years	Present Use: Abandoned	
Recorded on: 10/10/02	Condition: Ruin	Past Uses: Residential	
Updated on:	Orientation: South east	Historical Associations: None	
Type: Courtyard style terrace unit (mid)	Map Ref: #40		
General Description: Concrete and tile roof (collapsed). Green brick façade and rear wall. Uncut stone foundation. Granite lintel.			
Decorative Features: Canopy over entrance, pattern obscured.			
Renovations: None.			
Setting: Near back of village.			
Additional Notes: None.

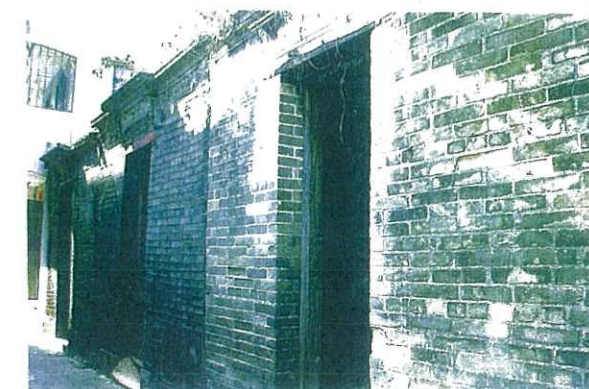
Location: Mong Tseng Tsuen			
Ref: AAHB-0032	Construction Date: c 100 years	Present use: Abandoned	
Recorded on: 10/10/02	Condition: Ruin	Past Uses: Residential	
Updated on:	Orientation: South east	Historical Associations: None	
Type: Courtyard style terrace units (2 mid, 1 end)	Map Ref: To the right of #47)		
General Description: Roof collapsed. Green brick façades. Granite threshold stones, wooden door frames and doors. All three still have stone thresholds.			
Decorative Features: decorative canopies - design indiscernible.			
Renovations: Two have concrete roofs over front portion.			
Setting: Near back of village.			
Additional Notes: None.

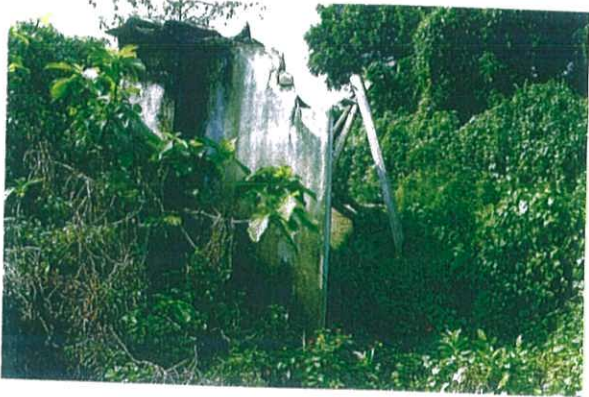
Location: Mong Tseng Tsuen			
Ref: AAHB-33	Construction Date: c 100 years	Present Use: Abandoned	
Recorded on: 10 10 02	Condition: Ruin	Past Uses: residential	
Updated on:	Orientation: South east	Historical Associations: None	
Type: Village house	Map Ref: N/A		
General Description: Portions of pounded earth walls and tile and wood pitched roof heavily overgrown. Pounded earth walls and stucco. Corner piers, bits of side walls and rear wall are still standing. Overgrown.			
Decorative Features: None			
Renovations: None			
Setting: Near back of village			
Additional Notes: None

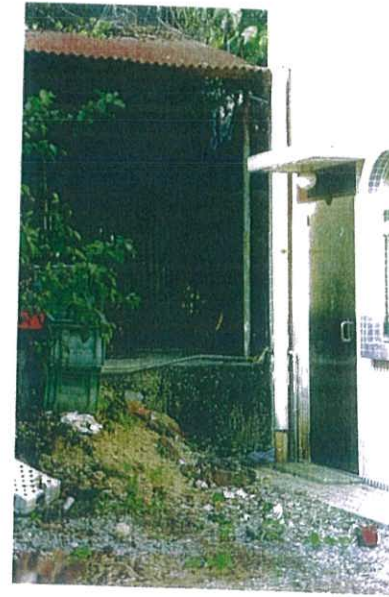
Location: Mong Tseng Tsuen			
Ref: AAHB-00-35	Construction Date: c 100 years	Present Use: Abandoned	
Recorded on: 10 10 02	Condition: Ruin	Past Uses: Storage/ residential	
Updated on:	Orientation: South east	Historical Associations: None	
Type: Village structure	Map Ref: N/A		
General Description: Portions of green brick walls, only portion of walls remain - interior overgrown and filled with rubble.			
Decorative Features: None			
Renovations: Metal structure attached			
Setting: Mid village			
Additional Notes: None

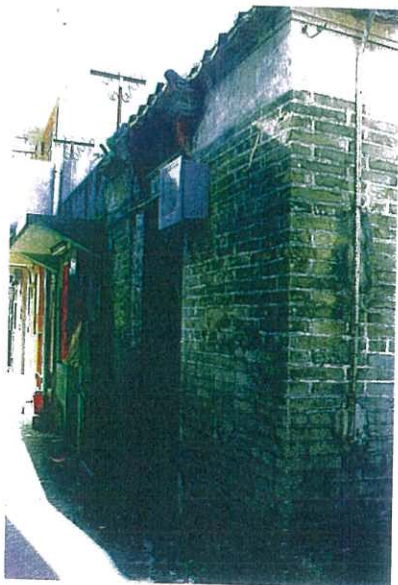
Location: Mong Tseng Tsuen			
Ref: AAHB-0037	Construction Date: c 100 years	Present Use: Residential	
Recorded on: 10 10 02	Condition: Fair	Past Uses: Residential	
Updated on:	Orientation: South east	Historical Associations: None	
Type: Courtyard style terrace units (1 mid, 1 end)	Map Ref: #97 and 98		
General Description: 2 green brick houses. Right: not altered. With roof tile, wood and chu nam ridge, wood window lintel and jambs. Granite threshold and iron fittings.			
Decorative Features: right: canopy in poor condition, molded and painted. Traces of paint on panels.			
Renovations: Modern façade on left hand unit. Electrical fittings added.			
Setting: Mid village			
Additional Notes: None

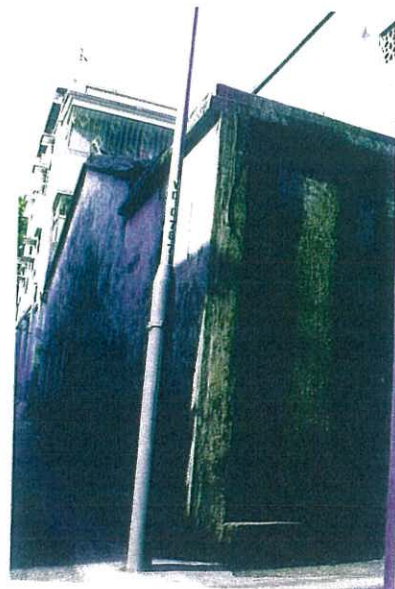
Location: Mong Tseng Tsuen			
Ref: AAHB-0038	Construction Date: c 100 years	Present Use: Storage	
Recorded on: 10 10 02	Condition: Poor	Past Uses: Residential	
Updated on:	Orientation: South east	Historical Associations: None	
Type: Courtyard style terrace unit (1-end)	Map Ref: #98		
General Description: Concrete and tile roof. Pounded earth rear wall.			
Decorative Features: None			
Renovations: Walls covered in concrete render. Windows inserted on side.			
Setting: Mid village			
Additional Notes: None

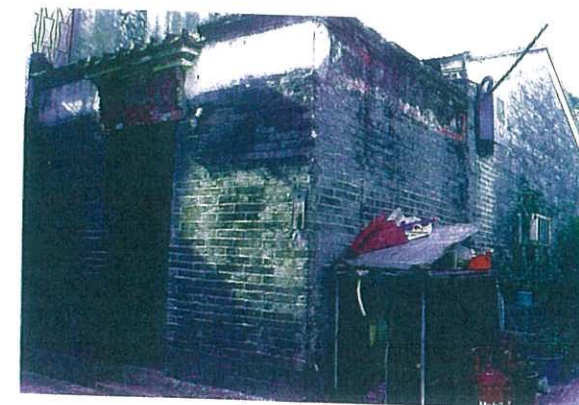
Location: Mong Tseng Wai			
Ref: AAHB-0039	Construction Date: c 100 years	Present Use: Vacant	
Recorded on: 10 10 02	Condition: Fair	Past Uses: Storage	
Updated on:	Orientation: South east	Historical Associations: None	
Type: Courtyard style terrace unit (1-end)	Map Ref: #72		
General Description: Tile and concrete roof. Green brick walls. Granite threshold stone. Double panel wooden door.			
Decorative Features: Traces of decoration on panel below side eaves. Molded lintels over windows (chu nam). Canopy over entrance, pattern obscured.			
Renovations: Concrete around foundation. Air con and electrical fittings added.			
Setting: Mid village			
Additional Notes: None

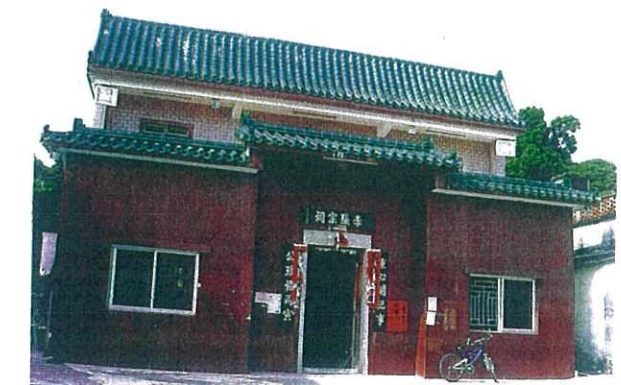
Location: Mong Tseng Tsuen			
Ref: AAHB-0040	Construction Date: Modern	Present Use: Tse Tong	
Recorded on: 10 10 02	Condition: Excellent	Past Uses: Tse Tong	
Updated on:	Orientation: South east	Historical Associations: None	
Type: Tse Tong (Lee and Cheung) 李漢宗祠	Map Ref: Beside #74		
General Description: Modern construction in concrete and tile. 2 storey structure with large concrete platform in front of hall.			
Decorative Features: Green ceramic roof tiles.			
Renovations: Recently built.			
Setting: At front of village			
Additional Notes: None

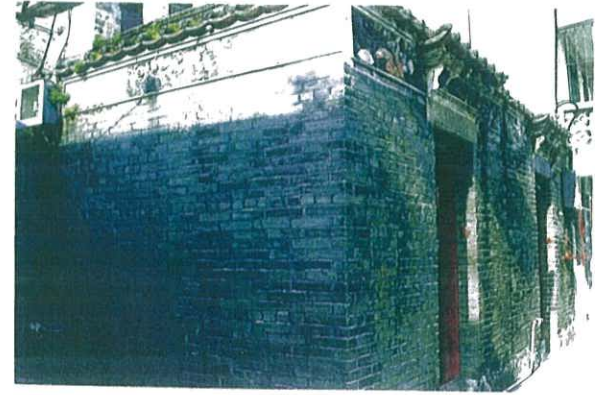
Location Mong Tseng Tsuen			
Ref	AAHB-0041	Construction Date	c 100 years
Recorded on	10 10 02	Condition	Fair
Updated on		Orientation	South east
Type	Courtyard style terrace units (1 end, 1 mid)	Map Ref	#15 and 15
Present Use Storage			
Past Uses Residential			
Historical Associations None			
General Description Tile and concrete roof. Green brick walls. Granite lintels			
Decorative Features Canopies molded and painted, also panels, in very good quality and fair condition. Decoration in side wall and under gable.			
Renovations Concrete around foundation. Wooden door frames. Electrical fittings added.			
Setting Front of village			
Additional Notes None

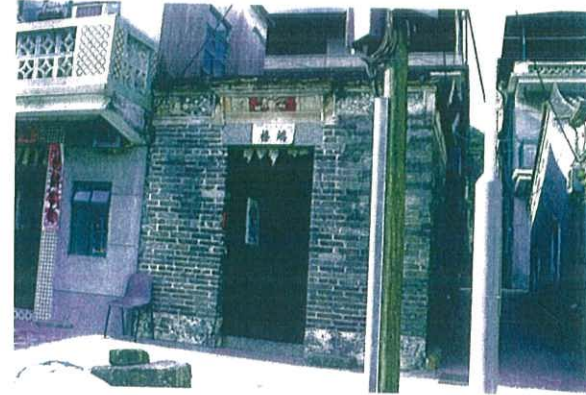
Location Mong Tseng Tsuen			
Ref	AAHB-0042	Construction Date	c 100 years
Recorded on	10 10 02	Condition	Good
Updated on		Orientation	South east
Type	Courtyard style terrace unit (end)	Map Ref	#17
Present Use Residential			
Past Uses Residential			
Historical Associations None			
General Description Tile and concrete roof. Green brick walls. Cut granite lintel and threshold. Double panel wooden door.			
Decorative Features Canopy over entrance and frieze with floral design. Gable frieze design. Floral and landscape pattern.			
Renovations Concrete around foundation. Electrical fittings added.			
Setting Mid village			
Additional Notes None

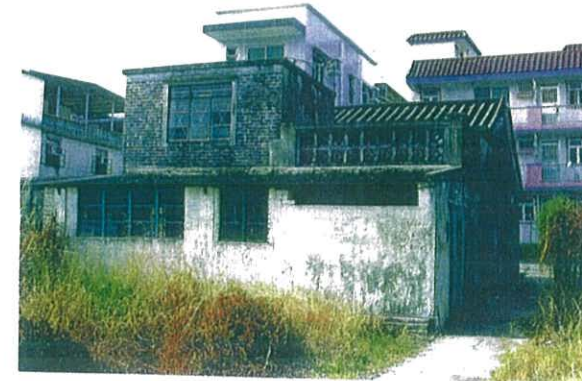
Location Mong Tseng Tsuen			
Ref	AAHB-0043	Construction Date	c 100 years
Recorded on	10 10 02	Condition	Good
Updated on		Orientation	South east
Type	Courtyard style terrace unit (mid)	Map Ref	N/A
Present Use Residential			
Past Uses Residential			
Historical Associations None			
General Description Tile and concrete roof. Green brick walls			
Decorative Features None			
Renovations Original façade fronted by concrete addition with parapet and brick tower. Electrical fittings added.			
Setting Front of village			
Additional Notes None

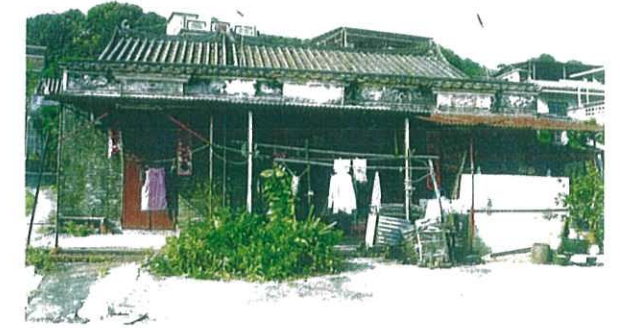
Location Mong Tseng Tsuen			
Ref	AAHB-0044	Construction Date	c 100 years
Recorded on	10 10 02	Condition	Good
Updated on		Orientation	South
Type	Courtyard style terrace units (1 mid, 2 end)	Map Ref	#49, 50, 51
Present Use Residential			
Past Uses Residential			
Historical Associations None			
General Description Two tile and concrete roofs. Green brick walls. Left one has its own roof and ridge. Right two ones share a same roof. Rear wall has moulding under eaves. Long and narrow bricks.			
Decorative Features Roof ridges. Façade has a moulded frieze - floral and schematic.			
Renovations Metal doors. Metal awning on façade. Windows added. Electrical fittings added.			
Setting At front of village			
Additional Notes None

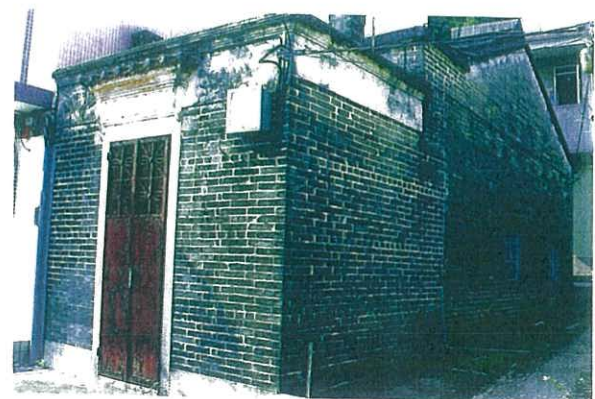
Location Mong Tseng Tsuen			
Ref	AAHB-0045	Construction Date	c 100 years
Recorded on	10 10 02	Condition	Fair
Updated on		Orientation	South east
Type	Courtyard style terrace unit (end)	Map Ref	N/A
Present Use Vacant			
Past Uses Residential			
Historical Associations None			
General Description Tile and concrete roof. Green brick walls. Bare of walls stuccoed.			
Decorative Features Canopy molded and painted. Band under side eaves with no traces of decoration.			
Renovations narrow Metal front door in new frame. Modern windows in concrete frames with projecting lintels. Electrical fittings added.			
Setting Mid village			
Additional Notes Fung shui wall opposite front door.

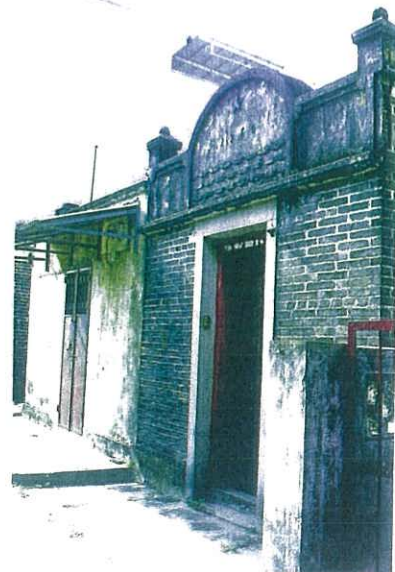
Location Mong Tseng Tsuen			
Ref	AAHB-0046	Construction Date	c 100 years
Recorded on	10 10 02	Condition	Fair
Updated on		Orientation	South east
Type	Courtyard style terrace units (1 mid, 1 end)	Map Ref	#70 and 71
Present Use Residential			
Past Uses Residential			
Historical Associations None			
General Description Tile and concrete roof. Right hand unit - green brick walls, double panel wooden door.			
Decorative Features None			
Renovations Left hand unit is covered in render, with modern door. Concrete parapet on right hand unit. Concrete door frame. Electrical fittings added.			
Setting East side of village			
Additional Notes None

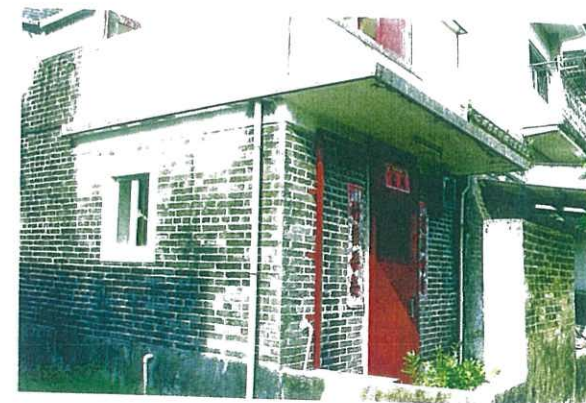
Location Mong Tseng Tsuen			
Ref	AAHB-0047	Construction Date	c 100 years
Recorded on	10 10 02	Condition	Good
Updated on		Orientation	South east
Type	Courtyard style terrace units (1 mid, 1 end)	Map Ref	#65 and 67
Present Use Residential			
Past Uses Residential			
Historical Associations None			
General Description Tile and concrete roof. Green brick walls			
Decorative Features None			
Renovations modern additions on roof of left house and concrete awning on façade. Modern doors and frames. Modern windows. Electrical fittings added.			
Setting East side of village			
Additional Notes Fung shui wall in front of left unit.

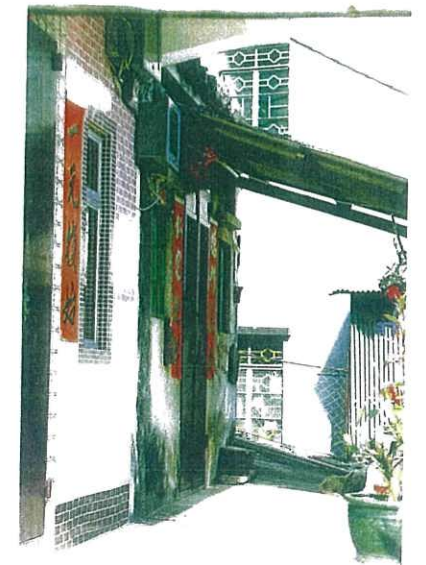
Location Mong Tseng Tsuen			
Ref	AAHB-0048	Construction Date	c 100 years
Recorded on	10 10 02	Condition	Fair
Updated on		Orientation	South east
Type	Courtyard style terrace unit (1-end)	Map Ref	Behind #58
Present Use Residential			
Past Uses Residential			
Historical Associations None			
General Description Concrete and tile roof. Pounded earth walls, built into hillside.			
Decorative Features None			
Renovations Walls covered in render. Modern metal door. Metal awning at front.			
Setting At rear of village			
Additional Notes None

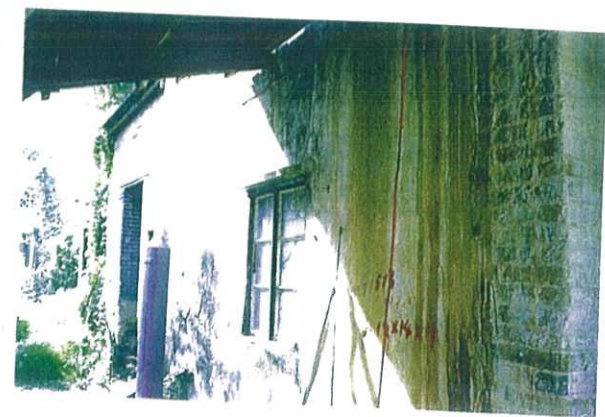
Location: Mong Tseng Tsuen			
Ref: AAHB-0049	Construction Date: c 100 years	Present Use: Abandoned	
Recorded on: 10/10/02	Condition: Ruin	Past Uses: Residential	
Updated on:	Orientation: South east	Historical Associations: None	
Type: Village houses	Map Ref: N/A		
General Description: Walls of green brick and red brick and rammed earth. Roof gone.			
Decorative Features: None			
Renovations: Concrete on façade. Windows. Electrical fittings added.			
Setting: At back of village			
Additional Notes: None

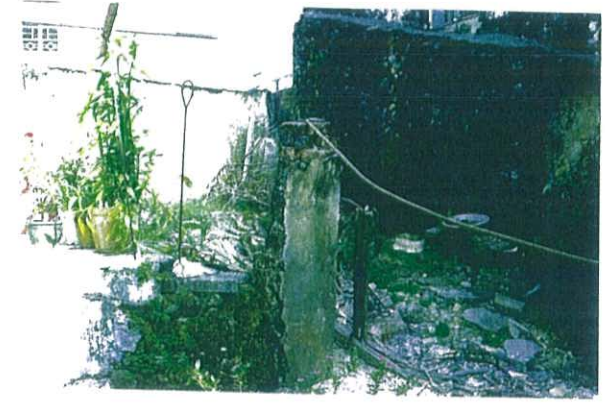
Location: Mong Tseng Tsuen			
Ref: AAHB-0050	Construction Date: c 100 years	Present Use: Abandoned	
Recorded on: 10/10/02	Condition: Ruin	Past Uses: Probably residential	
Updated on:	Orientation: N/A	Historical Associations: None	
Type: Village structure	Map Ref: N/A		
General Description: Rear wall of pounded earth and rubble stone base. Pounded earth has bits of tiles and broken clay etc. in them. Interior filled with rubble, overgrown.			
Decorative Features: None			
Renovations: None			
Setting: At edge of village			
Additional Notes: None

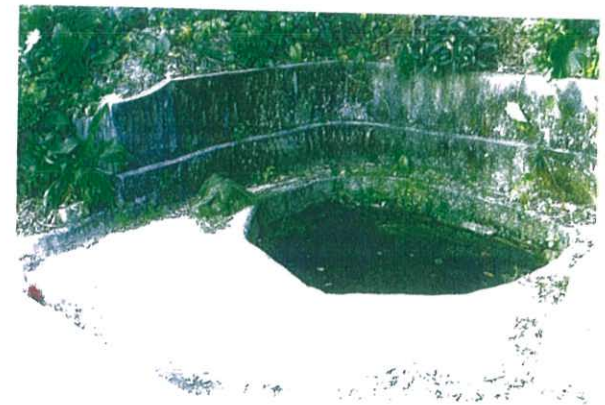
Location: Mong Tseng Tsuen			
Ref: AAHB-0051	Construction Date: Modern	Present Use: Not in use	
Recorded on: 10/10/02	Condition: Fair	Past Uses: Well	
Updated on:	Orientation: Southwest	Historical Associations: None	
Type: Well and shrine	Map Ref: N/A		
General Description: Irregular shaped well enclosed in concrete and chu nam. Rough stone construction visible around edges. Only approx. 25 cm deep. Across path is a small shrine oriented SW. Chu nam with stone on top.			
Decorative Features: None			
Renovations: Concrete enclosure around well			
Setting: At foot of hillside (fung shui woods)			
Additional Notes: None

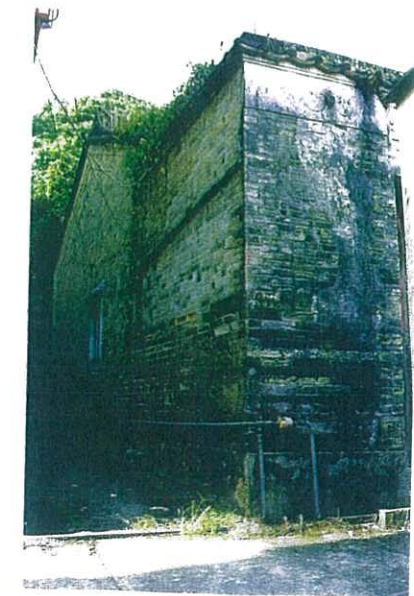
Location: Mong Tseng Tsuen			
Ref: AAHB-0053	Construction Date: c 100 years	Present Use: Abandoned	
Recorded on: 10/10/02	Condition: Fair	Past Uses: Residential	
Updated on:	Orientation: South east	Historical Associations: None	
Type: Courtyard style terrace unit (1-end)	Map Ref: Behind #71		
General Description: Tile and concrete roof. Green brick walls. Cut stone threshold and door step. 3 panel wooden door.			
Decorative Features: Canopy over entrance with bat motif. Frieze panel on façade with flower design.			
Renovations: Concrete around foundation. Window on side wall. Electrical fittings.			
Setting: At rear of village			
Additional Notes: None

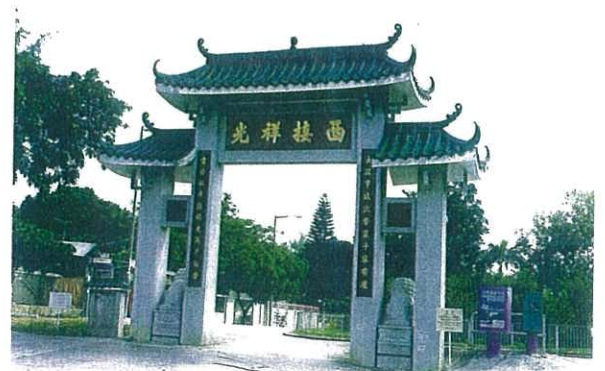
Location: Tai Tong Tsuen			
Ref: AAHB-0054	Construction Date: 1994	Present Use: Gate	
Recorded on: 15/10/02	Condition: Excellent	Past Uses: Gate	
Updated on:	Orientation: East	Historical Associations: None	
Type: Gate	Map Ref: N/A		
General Description: Completely modern structure in pebble concrete and tile. Green tile ridged roof.			
Decorative Features: Two stone lion statues on both sides			
Renovations: None			
Setting: At road entrance to village			
Additional Notes: inscription at front of gate 大寨村 西接祥光

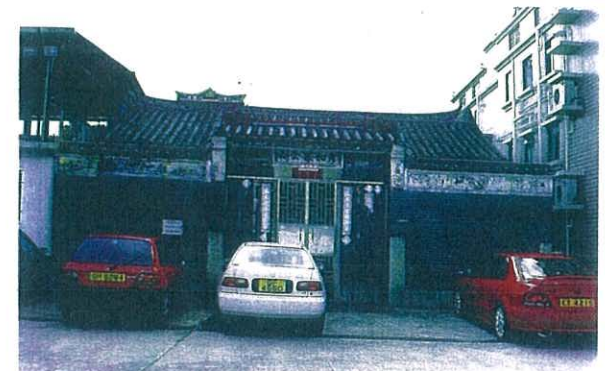
Location: Tai Tong Tsuen			
Ref: AAHB-0055	Construction Date: over 100 years	Present Use: Ancestral hall	
Recorded on: 15/10/02	Condition: Fair	Past Uses: Ancestral hall	
Updated on:	Orientation: North west	Historical Associations: None	
Type: Ancestral hall (Leung family) 廖和順公祠	Map Ref: N/A		
General Description: Green brick structure with tile and concrete pitched roof. 1 course of granite block granite blocks at corners and under eave.			
Decorative Features: Painted frieze with floral designs. Roof ridge decorated.			
Renovations: modern gate			
Setting: At front of village			
Additional Notes: None

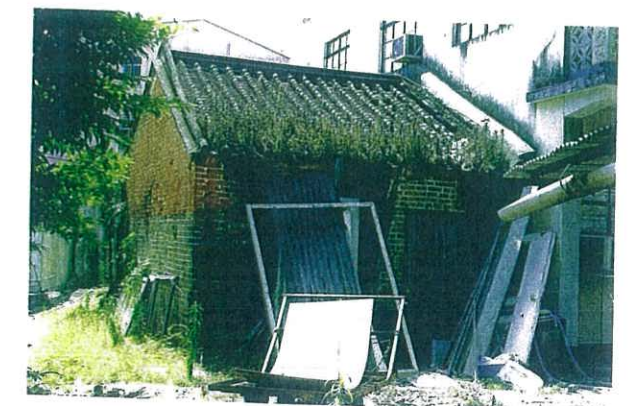
Location: Tai Tong Tsuen			
Ref: AAHB-0056	Construction Date: c 100 years	Present Use: Storage	
Recorded on: 15/10/02	Condition: Poor	Past Uses: Part of study hall?	
Updated on:	Orientation: North west	Historical Associations: None	
Type: Shed	Map Ref: Behind Tse Tong		
General Description: Green and red brick single storey structure. Tile and concrete roof. arched window openings at rear, which are similar to those in the study halls. Interior is used for storage. Large part of back wall is missing.			
Decorative Features: None			
Renovations: None			
Setting: at edge of village			
Additional Notes: None

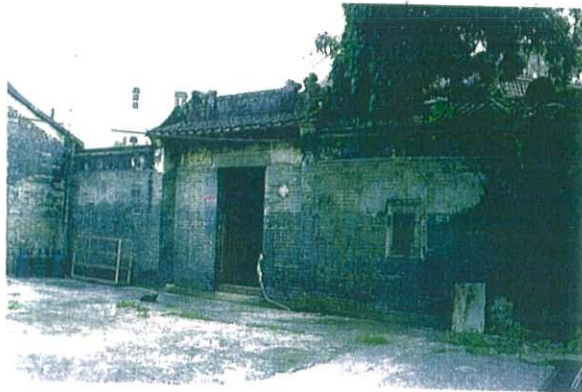
Location Tai Tong Tsuen			
Ref	AAHB-0057	Construction Date	c 100 years
Recorded on	16 10 02	Condition	Poor
Updated on		Orientation	North west
Type	Study hall (used as family hall)	Map Ref	N/A
Present Use	Family hall	Past Uses	Study hall
Historical Associations	None		
General Description: Large green brick building. Concrete and tile roof with plain ridge. Storage shed has mixed bricks - two green ceramic window grilles.			
Decorative Features: Carved wooden board (floral design) and airted frieze over entrance. Geometric roof ridge over entrance.			
Renovations: Concrete patches.			
Setting: At back of village.			
Additional Notes: None.

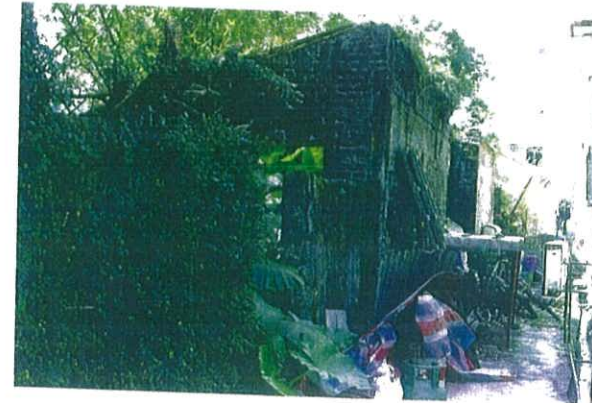
Location Tai Tong Tsuen			
Ref	AAHB-0056	Construction Date	c 100 years
Recorded on	16 10 02	Condition	Ruin
Updated on		Orientation	North west
Type	Study hall	Map Ref	N/A
Present Use	Abandoned	Past Uses	Study hall
Historical Associations	None		
General Description: Façade of green brick. Large granite lintel over entranceway very overgrown and full of rubble.			
Decorative Features: Façade frieze decoration - geometric and landscape in very poor condition.			
Renovations: Concrete patches.			
Setting: At back of village.			
Additional Notes: None.

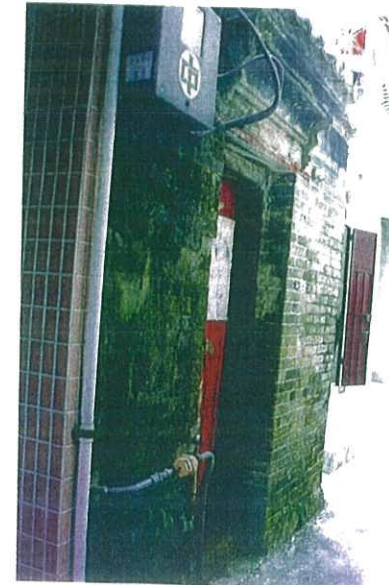
Location Tai Tong Tsuen			
Ref	AAHB-0059	Construction Date	c 100 years
Recorded on	16 10 02	Condition	Poor
Updated on		Orientation	North west
Type	Courtyard style terrace unit (1-end)	Map Ref	Beside # 58
Present Use	Abandoned	Past Uses	Residential
Historical Associations	None		
General Description: Front courtyard portion remaining. Granite threshold stone and double panel wooden door.			
Decorative Features: Canopy in poor condition - decoration obscured. Plain frieze panel painted.			
Renovations: Electrical fittings added.			
Setting: Mid village.			
Additional Notes: None.

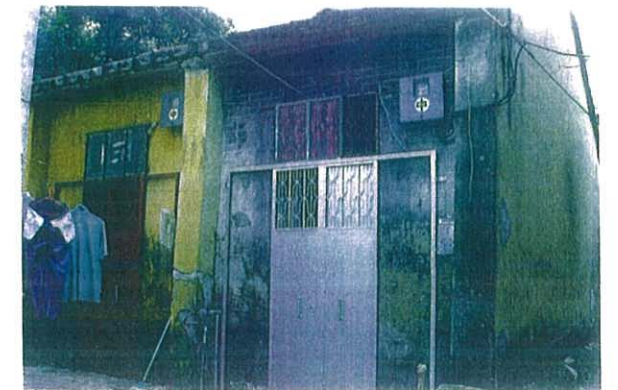
Location Tai Tong Tsuen			
Ref	AAHB-0060	Construction Date	c 100 years
Recorded on	16 10 02	Condition	Poor
Updated on		Orientation	North west
Type	Courtyard style terrace units (2 end)	Map Ref	#69
Present Use	Residential	Past Uses	Residential
Historical Associations	None		
General Description: 2 rectangular pounded earth units with windows at rear and wooden beams under eaves on façade. Tile and concrete roof and projecting bricks under eaves at rear.			
Decorative Features: None.			
Renovations: Exterior is covered in concrete render. Both have modern doors. Electrical fittings added.			
Setting: At rear of village.			
Additional Notes: None.

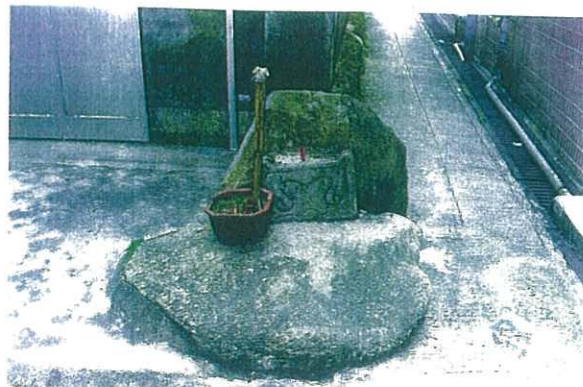
Location Tai Tong Tsuen			
Ref	AAHB-0061	Construction Date	Modern
Recorded on	16 10 02	Condition	Fair
Updated on		Orientation	North west
Type	Dang Fu Shrine	Map Ref	In front of #69
Present Use	Shrine	Past Uses	Shrine
Historical Associations	None		
General Description: Small shrine with dang fu bowl set on concrete platform with stone engraved incense holder placed up against a boulder, flattened at front.			
Decorative Features: None.			
Renovations: None.			
Setting: In front of house.			
Additional Notes: None.

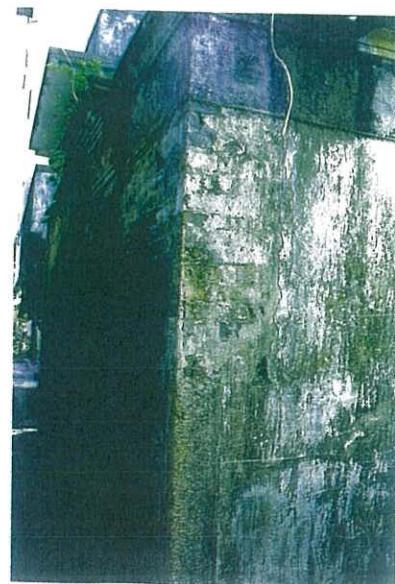
Location Tai Tong Tsuen			
Ref	AAHB-0062	Construction Date	c 100 years
Recorded on	16 10 02	Condition	Ruin
Updated on		Orientation	North west
Type	Courtyard style terrace units (1 end, 1 mid)	Map Ref	Beside #70
Present Use	Abandoned	Past Uses	Residential
Historical Associations	None		
General Description: Facades and front courtyard - standing, rest of building in ruins. Stone thresholds. Granite corner stone on front and rear. Side wall of pounded earth on brick foundation.			
Decorative Features: Canopy on right hand end unit. Frieze design indistinguishable.			
Renovations: Concrete patches. Electrical fittings added.			
Setting: Near back of village.			
Additional Notes: None.

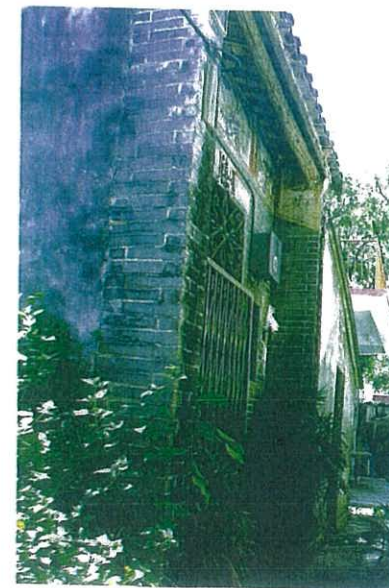
Location Tai Tong Tsuen			
Ref	AAHB-0063	Construction Date	C 100 years
Recorded on	16 10 02	Condition	Fair
Updated on		Orientation	North west
Type	House	Map Ref	#75
Present Use	Storage	Past Uses	Residential
Historical Associations	None		
General Description: Rectangular green brick structure with large double panelled wooden door. Shed at side is a brick and concrete structure but not similar in style, it is much newer.			
Decorative Features: Frieze paintings on façade. Gable frieze indistinguishable. Moulding under eaves with floral decoration at ends.			
Renovations: 2 windows on either side with metal bars. Metal gate. Concrete prender on side wall. Electrical fittings added.			
Setting: At back of village.			
Additional Notes: None.

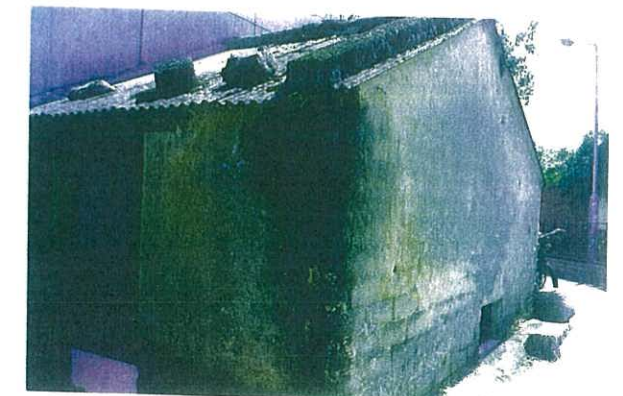
Location Tai Tong Tsuen			
Ref	AAHB-0064	Construction Date	Unknown
Recorded on	16 10 02	Condition	Poor
Updated on		Orientation	North west
Type	Shed	Map Ref	Beside #66
Present Use	Storage	Past Uses	Storage
Historical Associations	None		
General Description: Small one room single storey pounded earth and mud brick structure with wooden support beams and windows at ground level, with metal bars and grilles.			
Decorative Features: None.			
Renovations: Modern roof.			
Setting: At edge of village.			
Additional Notes: None.

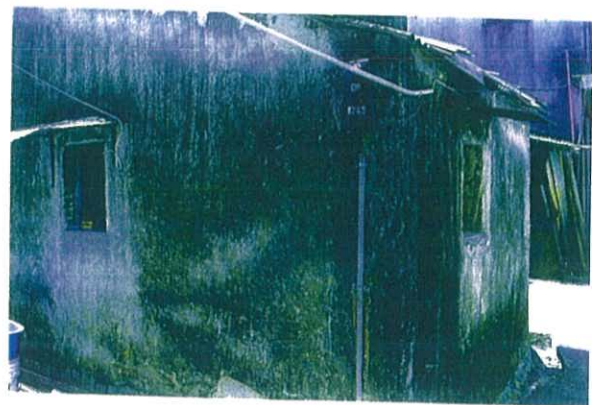
Location Tai Tong Tsuen			
Ref	AAHB-0065	Construction Date	Unknown
Recorded on	16 10 02	Condition	Poor
Updated on		Orientation	North west
Type	Village house	Map Ref	#59
Present Use Residential			
Past Uses Residential			
Historical Associations None			
General Description single storey pounded earth and mud brick structure			
Decorative Features Plaster moulded canopy over entrance			
Renovations Concrete over exterior walls Modern roof Modern addition at rear			
Setting Mid village			
Additional Notes None

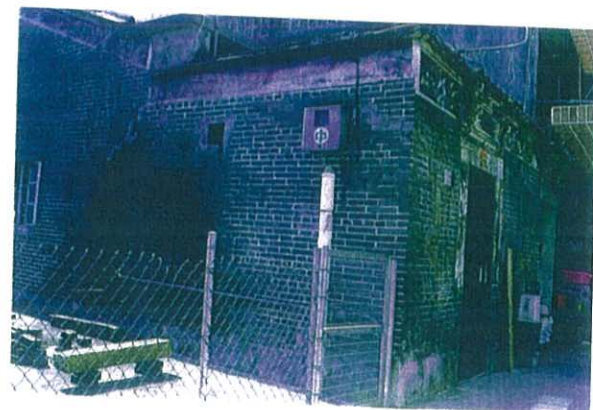
Location Tai Tong Tsuen			
Ref	AAHB-0066	Construction Date	c 100 years
Recorded on	16 10 02	Condition	Fair
Updated on		Orientation	North west
Type	Courtyard style terrace units (1 and 1 mid)	Map Ref	# 54 and 65
Present Use Residential			
Past Uses Residential			
Historical Associations None			
General Description Tile and concrete roof Green brick walls with stone lintels and thresholds			
Decorative Features left unit has gable frieze and moulding under eaves at rear wall Decorative canopy of floral and landscape designs right unit has decorative canopy of floral and geometric designs			
Renovations Concrete and render on exterior rear wall of right unit Electrical fittings added			
Setting Near edge of village			
Additional Notes None

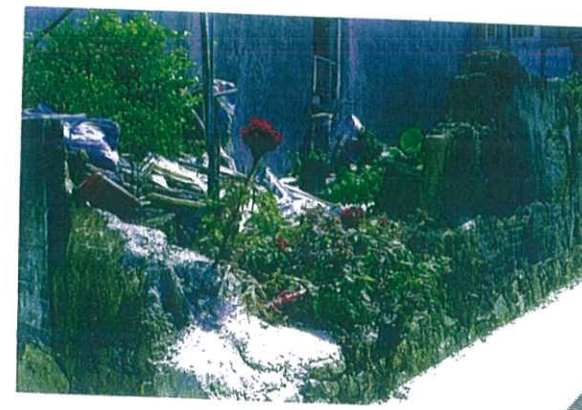
Location Tai Tong Tsuen			
Ref	AAHB-0067	Construction Date	c 100 years
Recorded on	16 10 02	Condition	Ruin
Updated on		Orientation	North west
Type	Village house	Map Ref	Beside # 28
Present Use Abandoned			
Past Uses Residential			
Historical Associations None			
General Description Rubble stone foundation mostly intact Green brick entranceway (partial) pounded earth (matrix contains sherds tile bits and small stones) on right hand side of wall Interior filled with rubble and overgrown			
Decorative Features None			
Renovations Concrete render on wall			
Setting Near front of village			
Additional Notes None

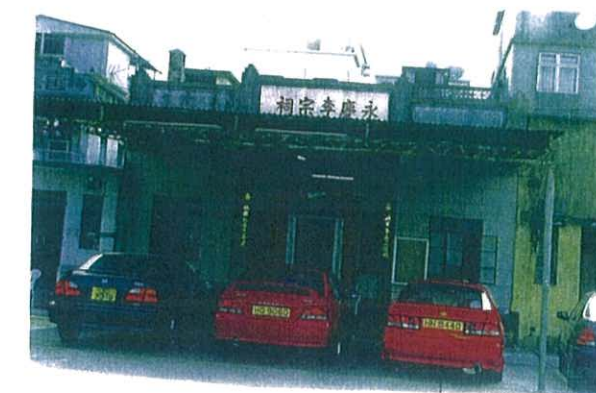
Location Tai Tong Tsuen			
Ref	AAHB-0068	Construction Date	Modern
Recorded on	15 10 02	Condition	Good
Updated on		Orientation	North west
Type	Ancestral hall (Lee Wing Hing tsz tong) 永興李堂祠	Map Ref	N/A
Present Use Ancestral hall			
Past Uses Ancestral hall			
Historical Associations None			
General Description Modern structure in concrete Metal gate and windows			
Decorative Features None			
Renovations None			
Setting At front of village			
Additional Notes None

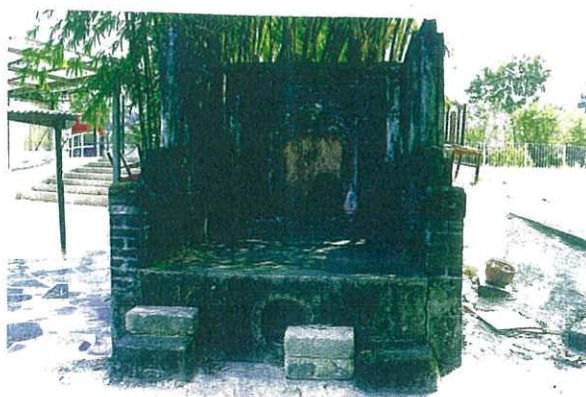
Location Tai Tong Tsuen			
Ref	AAHB-0069	Construction Date	Modern
Recorded on	16 10 02	Condition	Fair
Updated on		Orientation	South west
Type	Shrine (Earth God)	Map Ref	Beside village gate
Present Use Shrine			
Past Uses Shrine			
Historical Associations None			
General Description Green brick shrine with 2 stones placed against rear wall Stone in recess incense holder in front of stones Concrete platform with round burner opening at front brick with concrete moulding at side			
Decorative Features None			
Renovations			
Setting large tree behind shrine			
Additional Notes None

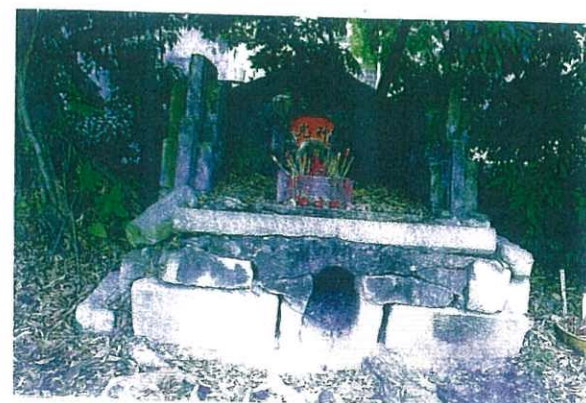
Location Wong Nai Tun Tsuen			
Ref	AAHB-0070	Construction Date	Unknown
Recorded on	15 10 02	Condition	Poor
Updated on		Orientation	South
Type	Pak Kung Shrine 伯公	Map Ref	N/A
Present Use Shrine			
Past Uses Shrine			
Historical Associations None			
General Description Green brick enclosure with large stone placed against rear wall stone platform with round burner opening at front Incense burner in front of the large stone			
Decorative Features None			
Renovations None			
Setting Dang fu shrine set on right of shrine			
Additional Notes inscription at the back 神光 Dang fu shrine to right of shrine

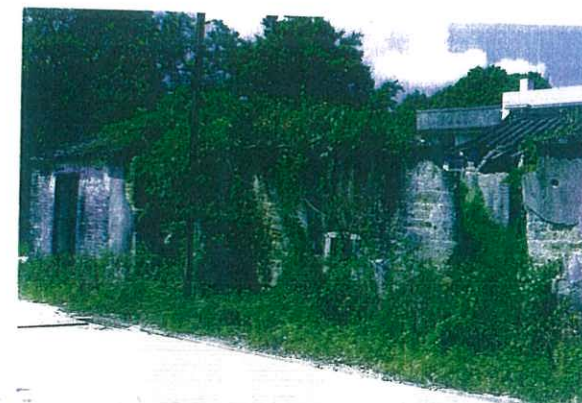
Location Wong Nai Tun Tsuen			
Ref	AAHB-0071	Construction Date	C 70 to 80 years
Recorded on	16 10 02	Condition	Ruins
Updated on		Orientation	South east
Type	Village houses (3 units)	Map Ref	N/A
Present Use Abandoned			
Past Uses Residential			
Historical Associations None			
General Description Single room and single storey structures of pounded earth and mud brick cut stone window frame on middle unit Tile and concrete roof visible in places			
Decorative Features Moulding under eaves visible on façade of left hand unit			
Renovations Concrete render in patches			
Setting At front of village			
Additional Notes None

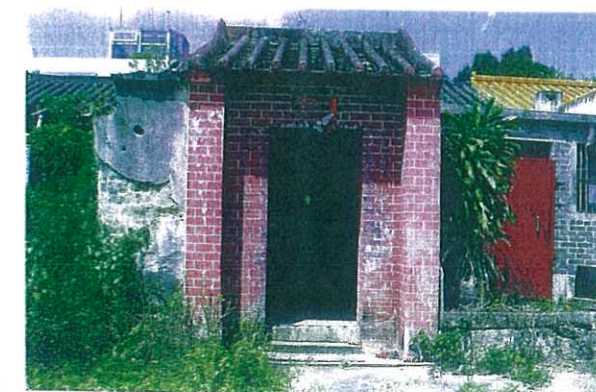
Location Wong Nai Tun Tsuen			
Ref	AAHB-0072	Construction Date	Unknown
Recorded on	15 10 02	Condition	Fair
Updated on		Orientation	South east
Type	Family hall (Ho family) 何家堂	Map Ref	N/A
Present Use Family hall			
Past Uses Family hall			
Historical Associations None			
General Description Single room structure Tile/concrete roof modern tile interior wall with altar Stone threshold, stone step, with no door			
Decorative Features None			
Renovations 'Red brick' painted facade			
Setting At front of village			
Additional Notes None

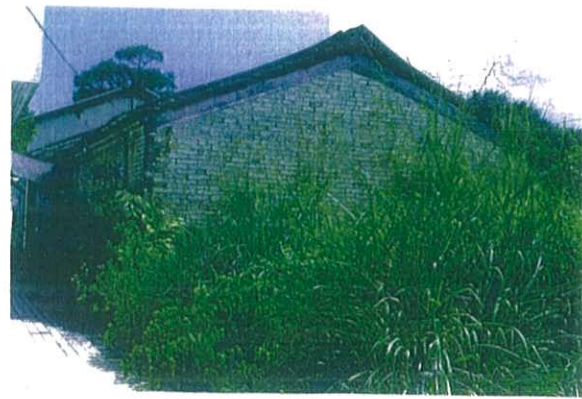
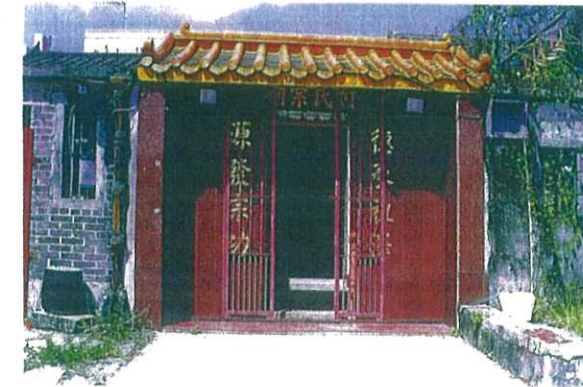
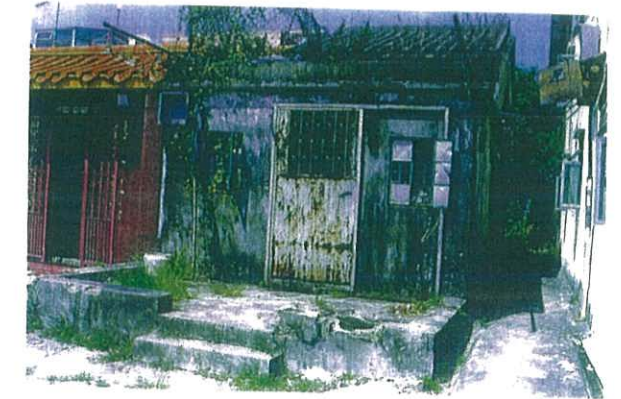
Location Wong Nai Tun Tsuen			
Ref	AAHB-0073	Construction Date	c 100 years
Recorded on	16 10 02	Condition	Run
Updated on		Orientation	South east
Type	Village house	Map Ref	In front of #17, 18
Present Use Abandoned			
Past Uses Residential			
Historical Associations None			
General Description 2 green brick structures with tile and concrete roof. Back and side walls intact - front wall mostly missing. Interior filled with rubble - very overgrown.			
Decorative Features Moulding under rear eaves. Plain gable frieze.			
Renovations None			
Setting At front of village			
Additional Notes None

Location Wong Nai Tun Tsuen			
Ref	AAHB-0074	Construction Date	c 100 years
Recorded on	16 10 02	Condition	Fair
Updated on		Orientation	South east
Type	Courtyard style terrace unit (1-mid)	Map Ref	#34
Present Use Storage			
Past Uses Storage			
Historical Associations None			
General Description Tile and concrete roof. Grey brick walls.			
Decorative Features None			
Renovations Modern door. Ceramic drainage pipe down right hand façade corner. Front of structure covered in concrete. Metal bars on façade windows.			
Setting At front of village			
Additional Notes None

Location Wong Nai Tun Tsuen			
Ref	AAHB-0075	Construction Date	Rebuilt 1989
Recorded on	15 10 02	Condition	Excellent
Updated on		Orientation	South east
Type	Ancestral hall (Ho family) 何氏宗祠	Map Ref	N/A
Present Use Ancestral hall			
Past Uses Ancestral hall			
Historical Associations None			
General Description Completely modern building with metal gate and original stone threshold. Orange tile roof. Reddish brown exterior wall and white tile interior wall.			
Decorative Features Orange tile roof			
Renovations None			
Setting At front of village			
Additional Notes None

Location Wong Nai Tun Tsuen			
Ref	AAHB-0076	Construction Date	c 100 years
Recorded on	15 10 02	Condition	Poor
Updated on		Orientation	South east
Type	Courtyard style terrace unit (end)	Map Ref	N/A
Present Use Storage			
Past Uses Residential			
Historical Associations None			
General Description Concrete and tile roof			
Decorative Features None			
Renovations Façade modified and covered with concrete. 3 windows at side and 1 at rear (metal) modern metal door. Concrete enclosure with steps.			
Setting At front of village			
Additional Notes None

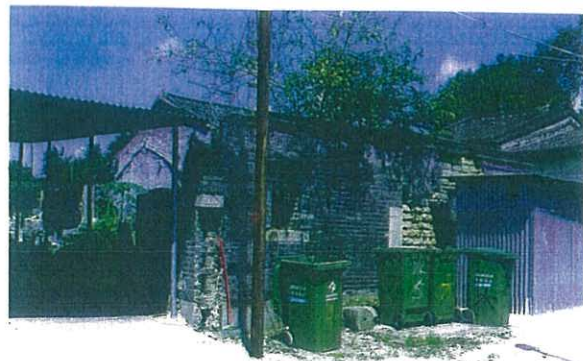
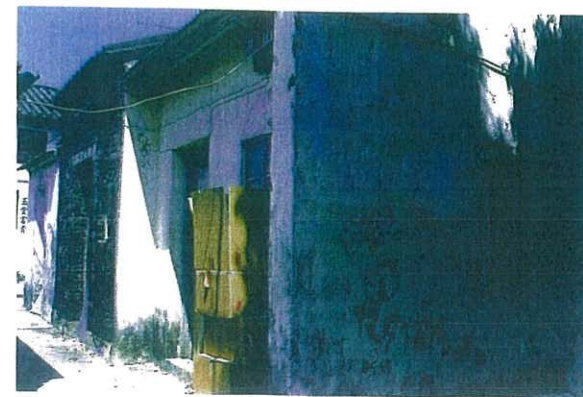
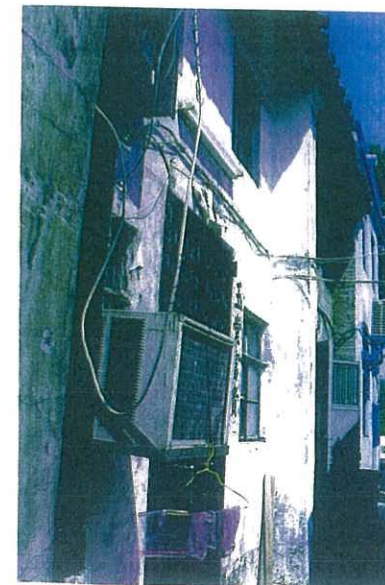
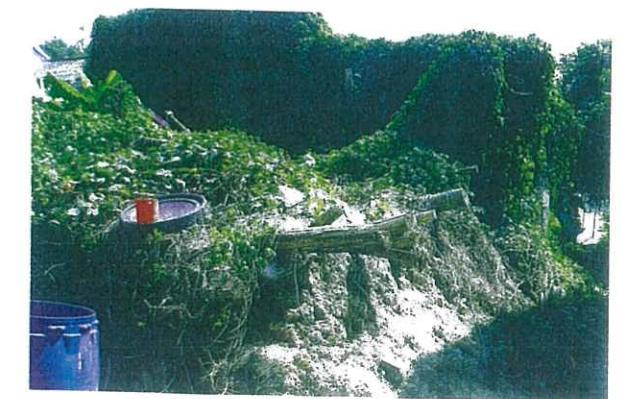
Location Wong Nai Tun Tsuen			
Ref	AAHB-0077	Construction Date	c 100 years
Recorded on	16 10 02	Condition	Ruin
Updated on		Orientation	N/A
Type	Village house	Map Ref	N/A
Present Use Abandoned			
Past Uses Residential			
Historical Associations None			
General Description Green brick and mud brick wall standing in places. Cut granite foundation, single course. Round windows, interior completely ruinous and overgrown.			
Decorative Features None			
Renovations None			
Setting At front of village			
Additional Notes None

Location Wong Nai Tun Tsuen			
Ref	AAHB-0078	Construction Date	c 60-70 years
Recorded on	16 10 02	Condition	Poor
Updated on		Orientation	South west
Type	Courtyard style terrace units (1 mid, 2 end)	Map Ref	N/A
Present Use Abandoned			
Past Uses Residential			
Historical Associations None			
General Description Green brick walls, 1 1/2 storey structures. Central unit is green brick, 2 end ones are of pounded earth and mud brick. Tile and concrete roof.			
Decorative Features Nil			
Renovations Concrete patches on walls. Windows with metal grilles.			
Setting At edge of village			
Additional Notes None

Location Wong Nai Tun Tsuen			
Ref	AAHB-0079	Construction Date	c 60-70 years
Recorded on	16 10 02	Condition	Poor
Updated on		Orientation	South east
Type	2 storey Terrace (2 units)	Map Ref	#23
Present Use Residential			
Past Uses Residential			
Historical Associations None			
General Description Tile and concrete roof. Green brick walls. Three pier dividers on façade. Wooden beams under tile awning on façade.			
Decorative Features Moulded column capitals			
Renovations Left unit has concrete render on façade. Windows with metal grilles and modern metal doors. Air con units and electrical fittings.			
Setting Near back of village			
Additional Notes None

Location Wong Nai Tun Tsuen			
Ref	AAHB-0080	Construction Date	c 100 years
Recorded on	16 10 02	Condition	Ruin
Updated on		Orientation	N/A
Type	Village structure	Map Ref	N/A
Present Use Abandoned			
Past Uses Indeterminate			
Historical Associations None			
General Description Rectangular shaped ruins of 2 separate structures. Interiors completely ruinous - only some parts of walls remaining. Very overgrown with vegetation.			
Decorative Features None			
Renovations None			
Setting Mid village			
Additional Notes None

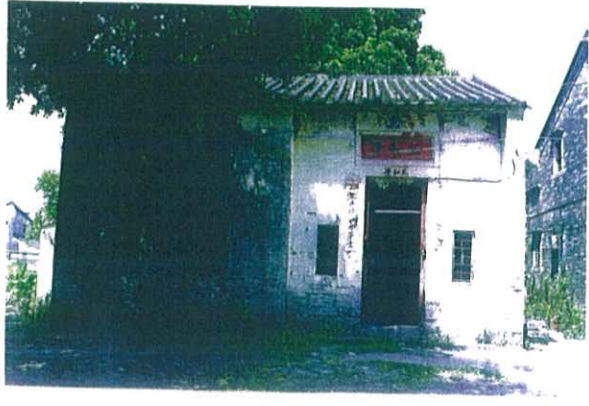
Location: Wong Nai Tun Tsuen			
Ref: AAHB-0081	Construction Date: Modern	Present Use: Ancestral hall	
Recorded on: 16 10 02	Condition: Poor	Past Uses: Ancestral hall	
Updated on:	Orientation: South east	Historical Associations: None	
Type: Two storey detached Structure (in two sections)	Map Ref: #15		
General Description: Tile and concrete roof. Green brick walls. Double height entrance with cut granite washold stone. Windows with metal grilles.			
Decorative Features: Painted landscape façade frieze			
Renovations: Portions of walls covered in render			
Setting: At edge of village			
Additional Notes: Interior is empty and unmaintained apart from a family shrine and dang fu shrine in the main

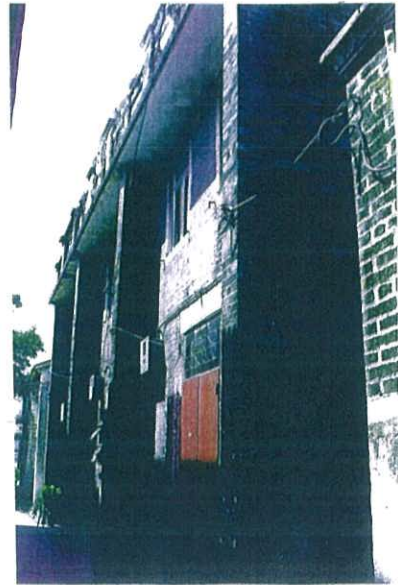
Location: Wong Nai Tun Tsuen			
Ref: AAHB-0082	Construction Date: c. 60 - 70 years	Present Use: Residential	
Recorded on: 16 10 02	Condition: Fair	Past Uses: Residential	
Updated on:	Orientation: South east	Historical Associations: None	
Type: 2 storey terrace (3 units)	Map Ref: #12, 13, 14		
General Description: Green brick units. Parapet with different design over each unit. Four piers along façade (evenly spaced).			
Decorative Features: windows on sides have moulded canopies - 3 on ground floor, 2 on first floor			
Renovations: modern windows and doors on front. Wooden window frames with metal bars. Balcony at rear as well. Concrete railing and concrete drainage channel along outside.			
Setting: Near back of village			
Additional Notes: None

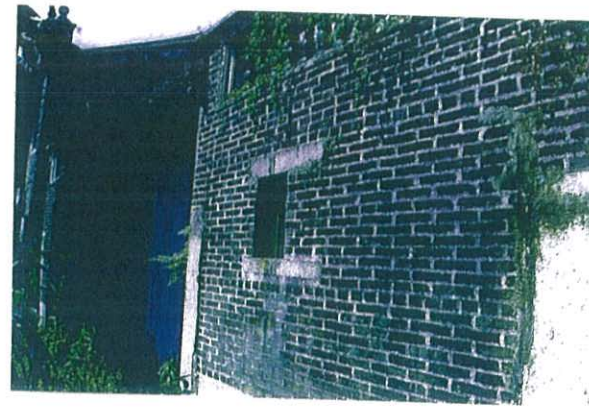
Location: Wong Nai Tun Tsuen			
Ref: AAHB-0083	Construction Date: c. 100 years	Present Use: Abandoned	
Recorded on: 16 10 02	Condition: Poor	Past Uses: Residential	
Updated on:	Orientation: South east	Historical Associations: None	
Type: House (1 1/2 storey)	Map Ref: #11		
General Description: Green brick walls with cut stone foundation course. corner stones. half door frames. window. Drainage channels are cut stone as well.			
Decorative Features: Frieze panel decoration - (painted) over doorway. Gable frieze patterns faded. moulding on left side - floral design. Balustrade with green ceramic 'urn' style railing.			
Renovations: Concrete patching, modern metal door.			
Setting: Near back of village			
Additional Notes: None

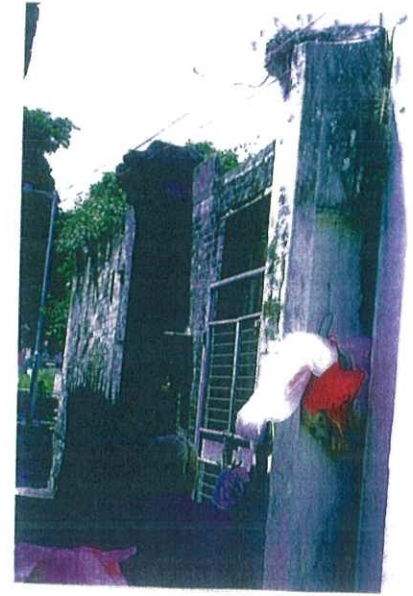
Location: Wong Nai Tun Tsuen			
Ref: AAHB-0084	Construction Date: c. 100 years	Present Use: Storage area	
Recorded on: 16 10 02	Condition: Run	Past Uses: Residential	
Updated on:	Orientation: South east	Historical Associations: None	
Type: Village House	Map Ref: N/A		
General Description: Green brick walls along façade. Pier to left of entrance. Stone foundation.			
Decorative Features: Geometric decoration at top of front pier and also drainage opening.			
Renovations: Concrete around foundation. Front wall patched with concrete.			
Setting: At back of village			
Additional Notes: None

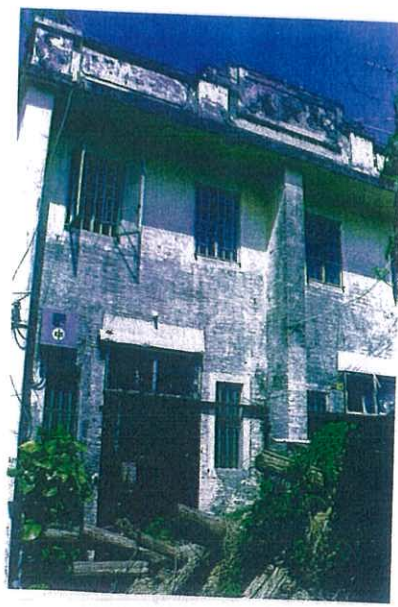
Location: Wong Nai Tun Tsuen			
Ref: AAHB-0085	Construction Date: c. 60 to 70 years	Present Use: Residential	
Recorded on: 16 10 02	Condition: Fair	Past Uses: Residential	
Updated on:	Orientation: South east	Historical Associations: None	
Type: 2 storey, 2 unit	Map Ref: #26		
General Description: Flat roof. Brick walls. Three piers on façade.			
Decorative Features: None			
Renovations: Metal gate at entrance. Exterior walls have render - quite thin in places. Concrete parapet.			
Setting: At back of village			
Additional Notes: None

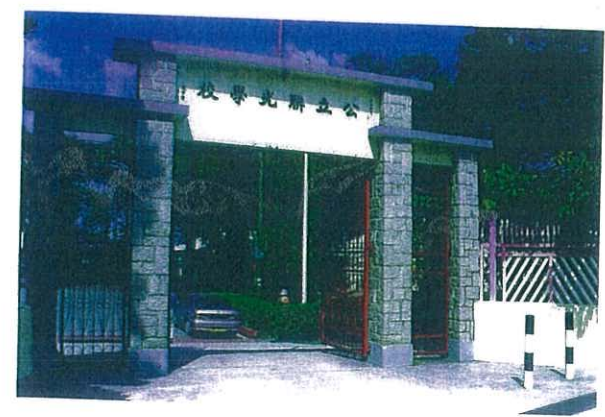
Location: Wong Nai Tun Tsuen			
Ref: AAHB-0086	Construction Date: 1960	Present Use: School	
Recorded on: 16 10 02	Condition: Good	Past Uses: School	
Updated on:	Orientation: South west	Historical Associations: None	
Type: Luen Kwong Public School 公立聯光學校	Map Ref: N/A		
General Description: Single storey concrete classroom units built around inner court. Pale yellow exterior walls. Very well maintained landscape of large trees. Cut granite and concrete gate at entrance with metal doors.			
Decorative Features: Cut stone gate with school name			
Renovations: None			
Setting: Off Tai Tong road, on separate compound.			
Additional Notes: None

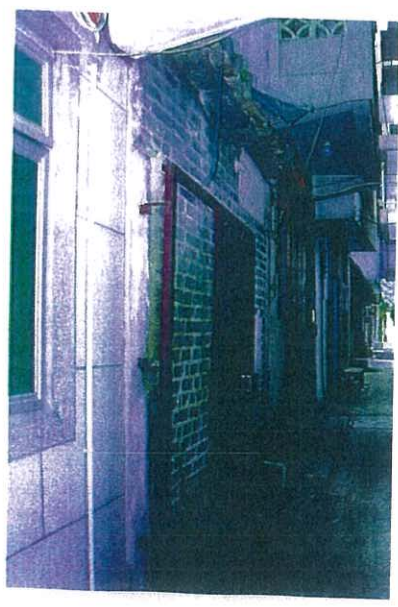
Location: Sham Chung Tsuen			
Ref: AAHB-117	Construction Date: c 100 years	Present Use: Storage	
Recorded on: 16 10 02	Condition: Fair	Past Uses: Residential	
Updated on:	Orientation: South west	Historical Associations: None	
Type: Single storey terrace (1 mid)	Map Ref: # 83		
General Description: Tile and concrete roof. Green brick walls. Uncut stone foundation. Projecting bricks at façade.			
Decorative Features: None			
Renovations: Modern metal door. Window - no glass			
Setting: At edge of village			
Additional Notes: None
