Drainage Services
Department

Agreement No.
CE 66/2001(EP)

EIA and TIA Studies for the
Stage 2 of PWP Item No.
215DS - Yuen Long and
Kam Tin Sewerage and
Sewage Disposal

Final Environmental Impact
Assessment

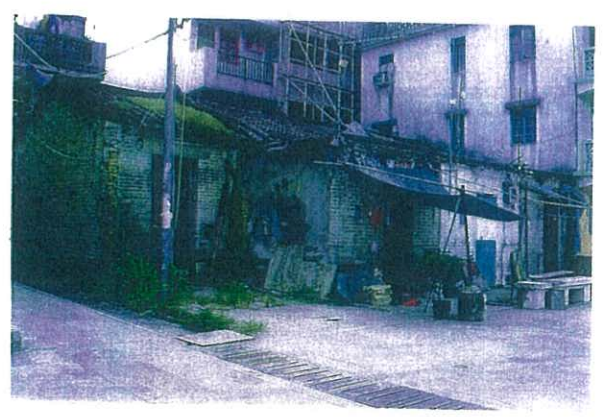
Location: Sham Chung Tsuen			
Ref: AAHB-118	Construction Date: c 100 years	Present Use: Storage	
Recorded on: 16 10 02	Condition: Poor	Past Uses: Residential	
Updated on:	Orientation: North west	Historical Associations: None	
Type: Courtyard style terrace units (1-end, 3-mid)	Map Ref: # 9 - 12		
General Description: Tile and concrete roof. Gray brick walls. Far left hand unit is missing front section. Outer exterior brick wall, inner mud brick. Granite lintel and threshold. 2nd left unit - Granite lintel and threshold, Far right unit - granite lintel and threshold.			
Decorative Features: 2nd left unit - decorative canopy & frieze (landscape design); 2nd right hand unit - frieze with geometric design; far right unit - frieze & canopy designs indistinguishable.			
Renovations: Modern door on 3rd unit from left. Electrical fittings added.			
Setting: At front of village			
Additional Notes: None

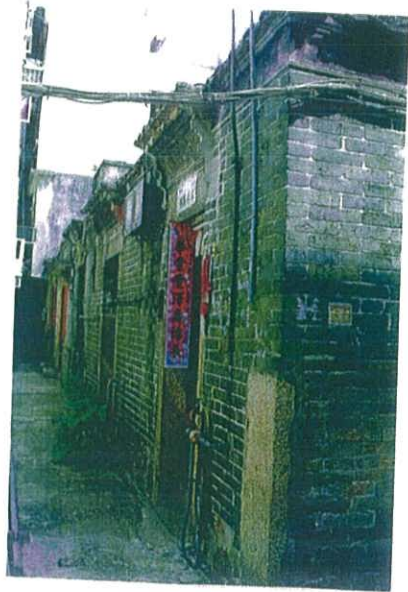
Location Sham Chung Tsuen			
Ref AAHB - 119	Construction Date c 100 years	Present Use Residential	
Recorded on 16 10 02	Condition Poor	Past Uses Residential	
Updated on	Orientation North west	Historical Associations None	
Type Courtyard style terrace units (1 and 5 mid)	Map Ref #29, 30, 31, 32, 33 and 34		
General Description Tile and concrete roof. End unit, green brick walls with cut granite lintel half door frame and corner stone. Next two units have green brick walls, cut granite lintels, half door frames.			
Decorative Features Canopies over four units' entrances' (floral and geometric designs) Painting and moulding.			
Renovations Fourth unit from end has modern façade. Northern most unit has modified façade. Electrical fittings added.			
Setting Mid village			
Additional Notes None

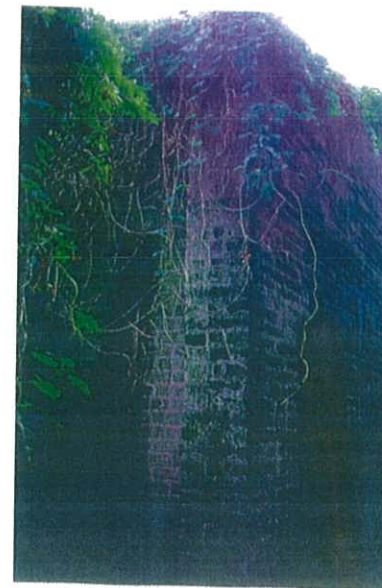
Location Sham Chung Tsuen			
Ref AAHB - 121	Construction Date c 100 years	Present Use Abandoned	
Recorded on 16 10 02	Condition Poor	Past Uses Residential	
Updated on	Orientation North west	Historical Associations None	
Type 2 unit house	Map Ref # 87, 88		
General Description Pale grey brick structure. Double panel wooden doors. Tile concrete roof.			
Decorative Features None			
Renovations None			
Setting Edge of village			
Additional Notes None

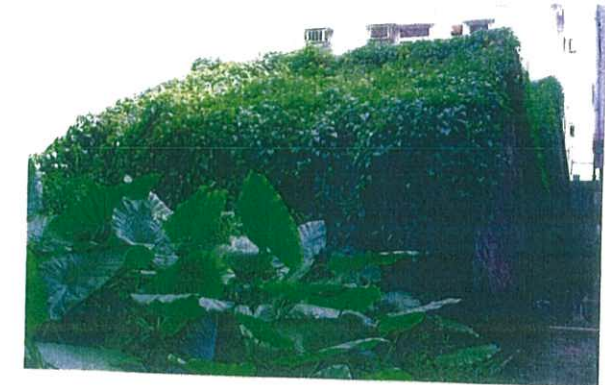
Location Sham Chung Tsuen			
Ref AAHB - 122	Construction Date c 100 years	Present Use Abandoned	
Recorded on 16 10 02	Condition Poor	Past Uses Residential	
Updated on	Orientation North west	Historical Associations None	
Type Single storey unit	Map Ref behind # 87, 88		
General Description Green brick single storey structure. Mud brick at rear. Over grown. Rubble filled.			
Decorative Features None			
Renovations None			
Setting At edge of village			
Additional Notes None

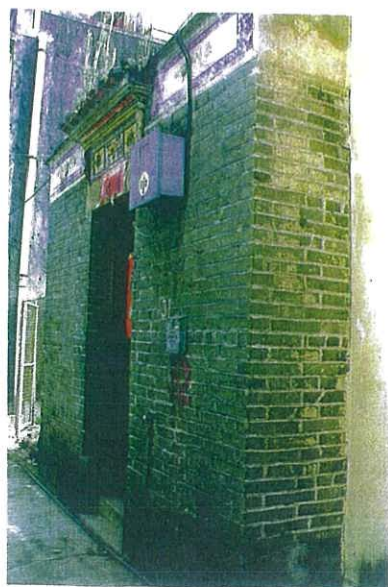
Location Sham Chung Tsuen			
Ref AAHB - 123	Construction Date c 100 years	Present Use Residential	
Recorded on 16 10 02	Condition Fair	Past Uses Residential	
Updated on	Orientation North west	Historical Associations None	
Type Courtyard style terrace unit (1 mid)	Map Ref # 52		
General Description Tile and concrete roof. Green brick walls (Plain roof ridge). Granite lintel. Double panel wooden door. Gable frieze - black.			
Decorative Features Canopy over entrance - floral and bat design painted and moulded. Frieze on façade.			
Renovations Foundation covered in concrete.			
Setting Near back of village			
Additional Notes None

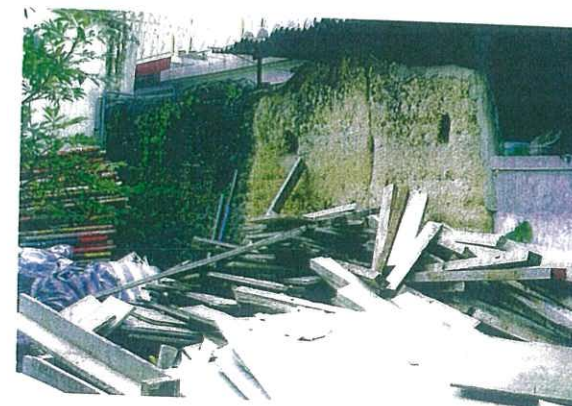
Location Sham Chung Tsuen			
Ref AAHB - 125	Construction Date c 100 years	Present Use Abandoned	
Recorded on 16 10 02	Condition Poor	Past Uses Residential	
Updated on	Orientation N/A	Historical Associations None	
Type Wall	Map Ref in front of # 59		
General Description Pounded earth wall - former rear wall of house. Approx. 2 M high and 4.5 M in length. Pieces of shards and tile are evident in matrix. Some are quite large.			
Decorative Features None			
Renovations None			
Setting Mid village			
Additional Notes None

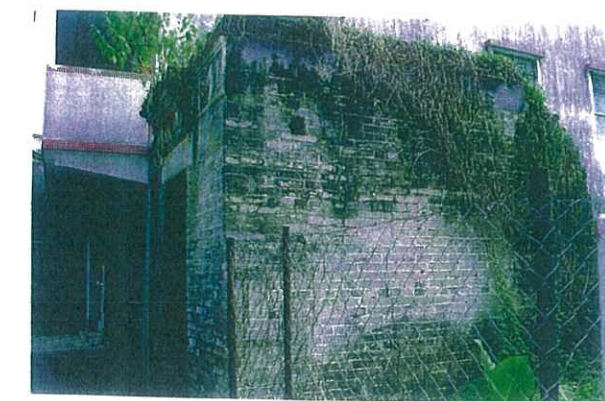
Location Sham Chung Tsuen			
Ref AAHB - 126	Construction Date c 100 years	Present Use Abandoned	
Recorded on 16 10 02	Condition Poor	Past Uses Residential	
Updated on	Orientation North west	Historical Associations None	
Type Courtyard style Terrace unit (1 mid)	Map Ref beside # 55		
General Description Green/ grey brick walls - only front portion standing. Roof collapsing remaining. Green brick facade - granite lintel and threshold. Roof collapsing.			
Decorative Features Decorative canopy - geometric and domestic. Moulded frieze - floral.			
Renovations None			
Setting Edge of village			
Additional Notes None

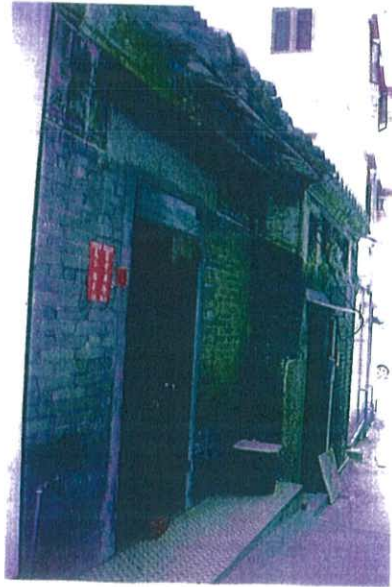
Location Sham Chung Tsuen			
Ref AAHB - 127			
Recorded on 16 10 02	Construction Date c 100 years	Present Use Vacant	
Updated on	Condition Fair	Past Uses Residential	
	Orientation North west	Historical Associations None	
Type Single storey units (2)	Map Ref # 70, 71		
General Description Green brick walls. Left one has large granite lintel and granite corner stone. Tile and concrete roof.			
Decorative Features Left hand unit has painted frieze on façade but concreted over on left hand side. Carved wooden board with float design across façade under eaves. Right hand unit has elaborate moulded frieze across façade - animals and landscape designs. Moulding under eaves.			
Renovations Both have modern doors.			
Setting At edge of village.			
Additional Notes None.

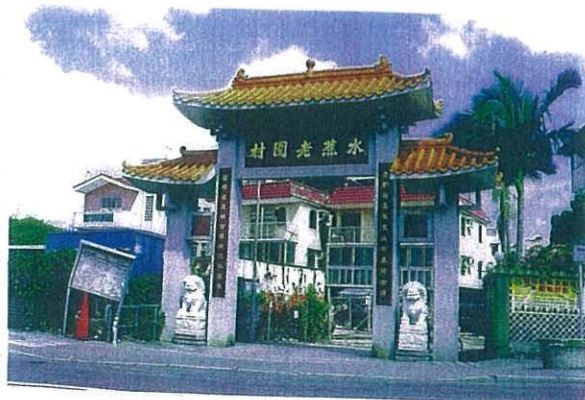
Location Shui Tsui Lo Wai			
Ref AAHB - 131			
Recorded on 16 10 02	Construction Date Modern	Present Use Gate	
Updated on	Condition Excellent	Past Uses Gate	
	Orientation South west	Historical Associations None	
Type Gate	Map Ref. N/A		
General Description Concrete, rectangular pillars with inscribed lintel. Smaller pillar on either side. Brown with gold carved plaques set into structure.			
Decorative Features White stone lions at base on either side. Orange ceramic roof.			
Renovations Recent.			
Setting At road entrance to village on Tai Tong Road.			
Additional Notes None.

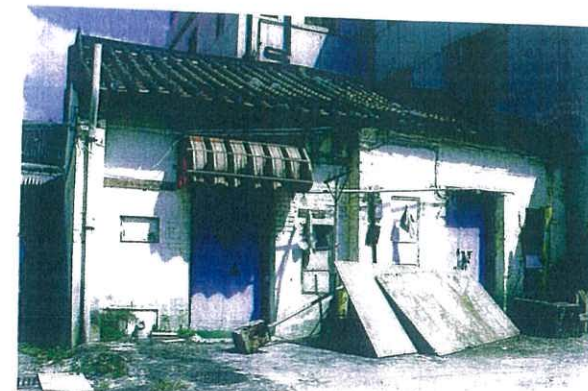
Location Shui Tsui Lo Wai			
Ref AAHB - 132			
Recorded on 16 10 02	Construction Date c 100 years	Present Use Residential	
Updated on	Condition Fair	Past Uses Residential	
	Orientation South west	Historical Associations None	
Type terrace units (2)	Map Ref. beside # 8		
General Description green brick walls. Concrete - tile roofs. Plain ridge. Single storey granite and stone on left hand façade.			
Decorative Features None.			
Renovations Windows added on façade. Blue metal doors.			
Setting At front of village.			
Additional Notes None.

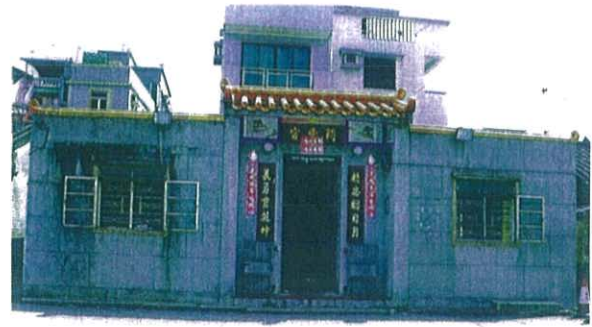
Location: Shui Tsau Lo Wai AAHB - 143			
Recorded on: 16/10/02	Construction Date: rebuilt 1985	Present Use: Temple	
Updated on:	Condition: Very good	Past Uses: Temple	
Ref: Kiran Tai Kung 關帝宮	Orientation: North west	Historical Associations: None	
Map Ref: N/A			
General Description: Modern structure, granite wall, one main hall and side rooms, orange tile roof			
Decorative Features: Frieze paintings (landscape), decorated wooden lintel (carved floral patterns)			
Renovations: Modern			
Setting: Near front of village			
Additional Notes: None

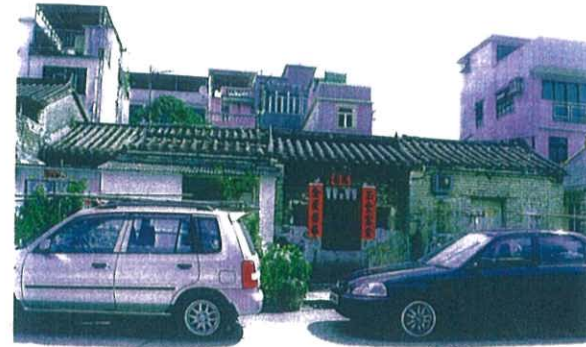
Location: Shui Tsau Lo Wai Ref: AAHB - 144			
Recorded on: 16/10/02	Construction Date: c 100 years	Present Use: Residential	
Updated on:	Condition: Fair	Past Uses: Residential	
Type: Courtyard style terrace units (3-mid, 1-end)	Orientation: North west	Historical Associations: None	
Map Ref: # 81 - 84			
General Description: Tāe and concrete roof. Green brick terrace units. End unit has pale grey bricks			
Decorative Features: None			
Renovations: front bricked over at end unit, far left unit has modern portion at front, 2nd left unit has extension built onto front (but brick façade still visible). 2nd right unit has brick and concrete façade and barred windows at side of entrance. Electrical fittings added.			
Setting: At front of village			
Additional Notes: None

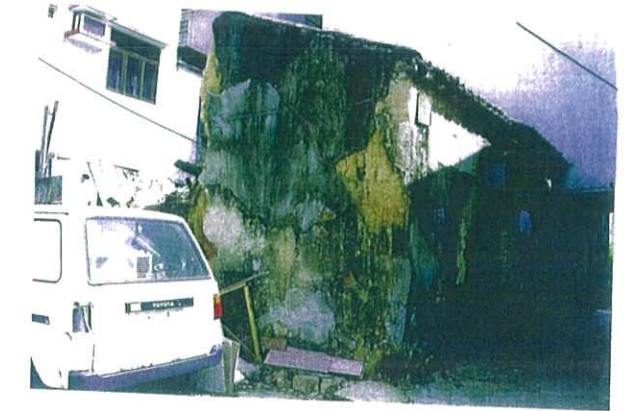
Location: Shui Tsau Lo Wai Ref: AAHB - 146			
Recorded on: 16/10/02	Construction Date: c 100 years	Present Use: Abandoned	
Updated on:	Condition: very poor	Past Uses: Residential	
Type: Terrace units (1 end, 1 mid)	Orientation: North west	Historical Associations: None	
Map Ref: N/A			
General Description: Mud brick house (1 1/2 storey village house), rear portion completely collapsed. Front partially standing but in poor condition. Front portion of roof - tile & concrete rubble stone foundation			
Decorative Features: None			
Renovations: Electrical fittings added			
Setting: Mid village			
Additional Notes: None

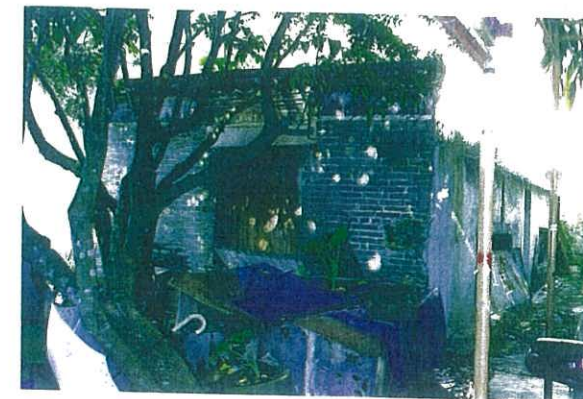
Location Tong Tau Po Tsuen AAHB - 220		
Recorded on 18 10 02	Construction Date c 100 years	Present Use Abandoned
	Condition Fair	Past Uses Residential
	Orientation South west	Historical Associations None
Updated on	Map Ref Beside # 92	
Type Courtyard style terrace unit (1-mid)		
General Description Green brick walls Granite threshold with rectangular indentations for gate poles Inger entranceway also has granite threshold stone		
Decorative Features Canopy over entrance in poor condition Pattern indiscernible		
Renovations Metal front roof and concrete & tile main roof		
Setting Mid village		
Additional Notes None

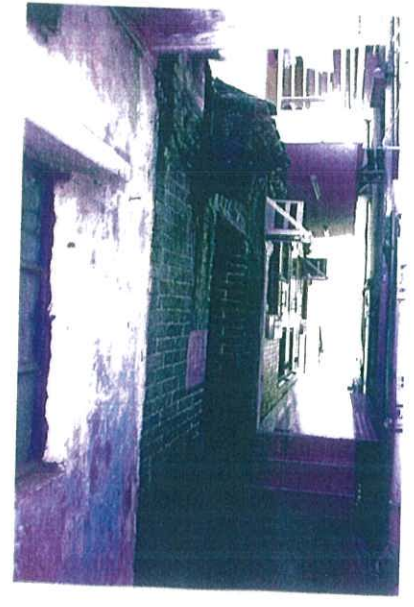
Location Tong Tau Po Tsuen		
Ref AAHB - 221	Construction Date c 100 years	Present Use Left unit abandoned, central unit storage right unit - residential
Recorded on 18 10 02	Condition Poor	Past Uses Residential
Updated on	Orientation South west	Historical Associations None
Type Courtyard style terrace units (3-mid)	Map Ref N/A	
General Description All units have granite threshold stones and lintels Granite door frames on right two units Left unit has wooden frame Tile and concrete roof Green/ grey brick rear walls		
Decorative Features Canopies and façade friezes Left unit - floral, moulded canopy central unit - floral & scroll façade frieze (partially covered by concrete), right unit - moulded floral canopy		
Renovations Metal awning over façade Electrical fittings added		
Setting None		
Additional Notes None

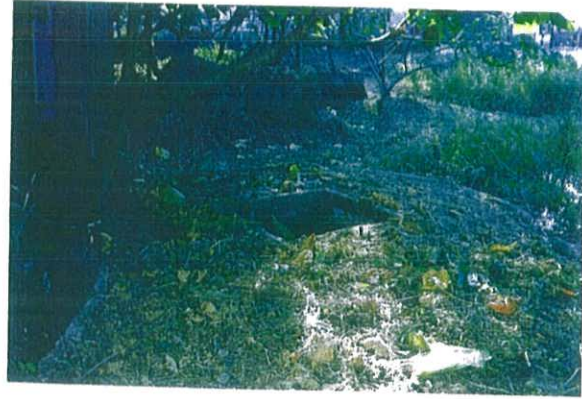
Location	Mai Po Tsuen		
Ref	AAHB - 229	Construction Date	Unknown
Recorded on	19 10 02	Condition	Good
Updated on		Orientation	N/A
Type	Well	Map Ref	N/A
Present Use	Well	Past Uses	Well
Historical Associations: None			
General Description: Six-sided well in circular/irregular concrete setting. Stone slabs around well. Stones visible inside for lining.			
Decorative Features: None			
Renovations: Modern concrete enclosure			
Setting: Near road entrance to village			
Additional Notes: Shrine is oriented to the east

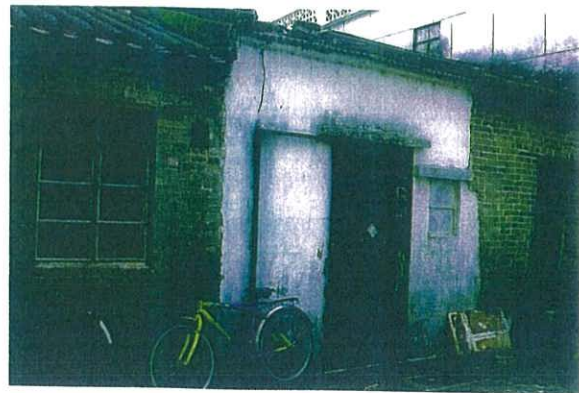
Location: Pak Sha Tsuen			
Ref: AAHB - 276	Construction Date: c. 60 to 70 years	Present Use: Residential/abandoned	
Recorded on: 23 10 02	Condition: Poor	Past Uses: Residential	
Updated on:	Orientation: North	Historical Associations: None	
Type: Sheds	Map Ref: #122 and 123		
General Description: Left hand unit - grey brick structure with bricks under eaves; Middle unit - painted; Right hand unit - large green pale bricks with stone door step, wooden door frame and lintel, also bricks under eaves.			
Decorative Features: None			
Renovations: Left hand unit - Door modified into window; middle unit - modern door, painted, concrete canopy.			
Setting: At edge of village			
Additional Notes: None

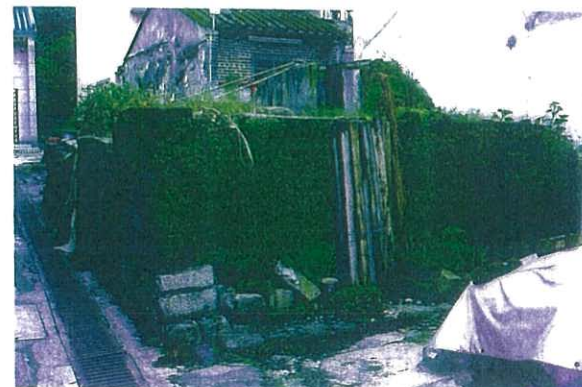
Location: Pak Sha Tsuen			
Ref: AAHB - 277	Construction Date: Unknown	Present Use: Abandoned	
Recorded on: 23 10 02	Condition: Ruin	Past Uses: Residential	
Updated on:	Orientation: N/A	Historical Associations: None	
Type: Village structures 2 units	Map Ref: Beside # 66		
General Description: Uncut stone foundation with some sections of green brick on top, very overgrown and filled with rubble.			
Decorative Features: None			
Renovations: None			
Setting: Mid village			
Additional Notes: None

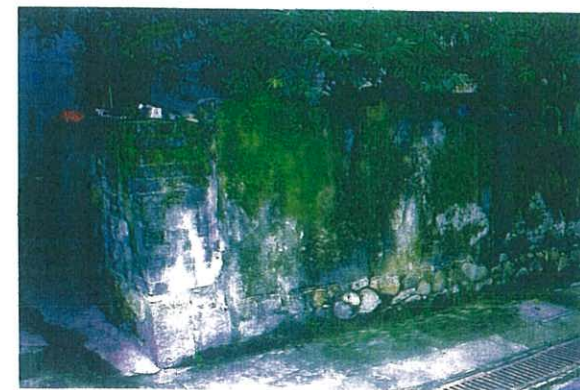
Location: Pak Sha Tsuen			
Ref: AAHB - 278	Construction Date: Unknown	Present Use: Ruins/storage	
Recorded on: 23 10 02	Condition: Ruin	Past Uses: Residential	
Updated on:	Orientation: N/A	Historical Associations: None	
Type: Terrace unit	Map Ref: N/A		
General Description: Uncut stone foundation and large grey bricks at corners. Pounded earth and brick wall. Right hand unit has stone door step.			
Decorative Features: None			
Renovations: Concrete patching			
Setting: Mid village			
Additional Notes: None

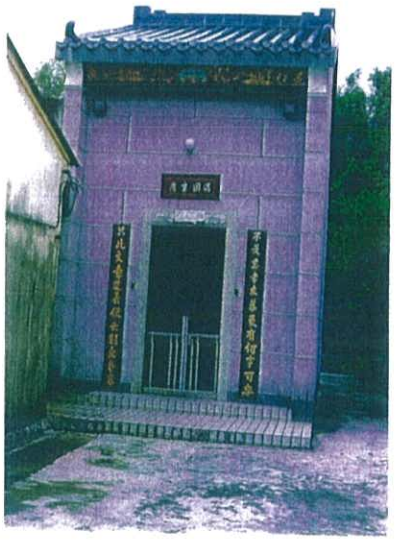
Location Pak Sha Tsuen			
Ref	AAHB - 280	Construction Date	Modern
Recorded on	23 10 02	Condition	Very good
Updated on		Orientation	North
Type	Gods hall	Map Ref	N/A
Present Use: Gods hall			
Past Uses: Gods hall			
Historical Associations: None			
General Description: Modern structure built on location of older demolished one. Stone door frame.			
Decorative Features: Arm stone inscription above door (高麗吉標). Painted frieze under eaves, 3 panels, birds with floral design and inscription.			
Renovations: None			
Setting: At back of village.			
Additional Notes: None

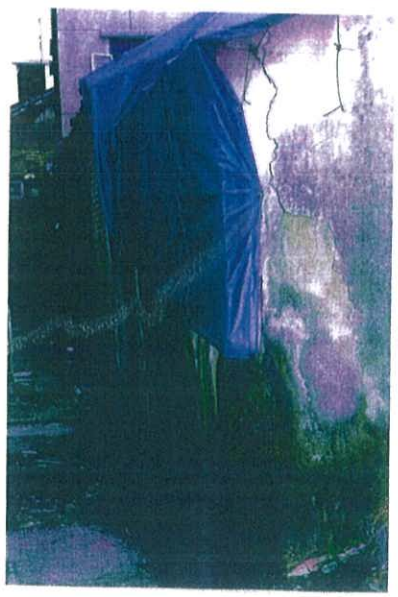
Location Pak Sha Tsuen			
Ref	AAHB - 281	Construction Date	c. 60 to 70 years
Recorded on	23 10 02	Condition	Ruin
Updated on		Orientation	North
Type	Sheds	Map Ref	N/A
Present Use: Storage			
Past Uses: Residential			
Historical Associations: None			
General Description: Row of green and mixed brick structures. 4 original units with projecting tile eaves on facade in part. Left hand unit has granite threshold stone and round roof beams and concrete and tile roof of right hand unit collapsed.			
Decorative Features: None			
Renovations: Concrete addition on right end - 2 end ruinous structures. Other one abandoned. Rear door of right hand unit sealed.			
Setting: At back of village.			
Additional Notes: None

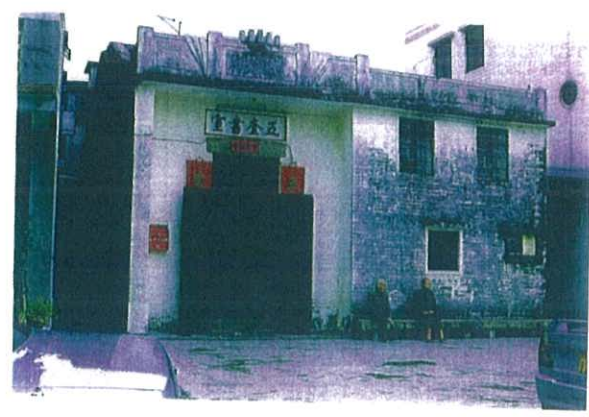
Location Pak Sha Tsuen			
Ref	AAHB - 282	Construction Date	over 100 years
Recorded on	23 10 02	Condition	Fair
Updated on		Orientation	South
Type	Ng Fui Study Hall 五富書室	Map Ref	N/A
Present Use: Community hall			
Past Uses: Study hall			
Historical Associations: None			
General Description: Green brick and yellowish red brick structure with threshold stone and stone step. 2 storey chamber with arch and metal gate. Interior painted.			
Decorative Features: Cut granite block above door.			
Renovations: Metal door on left hand side. 3 windows with metal frames on facade right. Painted and white washed facade wall.			
Setting: At back of village.			
Additional Notes: None

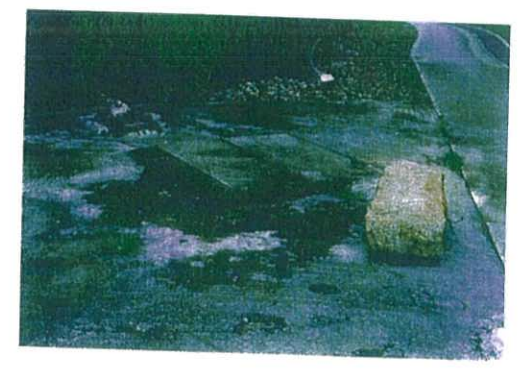
Location Pak Sha Tsuen			
Ref	AAHB - 283	Construction Date	Unknown
Recorded on	23 10 02	Condition	Fair
Updated on		Orientation	N/A
Type	Well	Map Ref	N/A
Present Use: Unused			
Past Uses: Well			
Historical Associations: None			
General Description: Concrete covered opening in concrete enclosure. Shrine facing NW - small stone set in concrete enclosure with concrete incense holder in front.			
Decorative Features: None			
Renovations: Concrete slabs covering well.			
Setting: In open area at back of village.			
Additional Notes: None

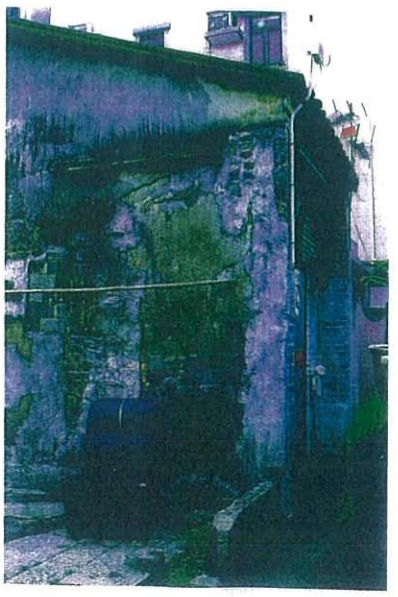
Location Pak Sha Tsuen			
Ref	AAHB - 284	Construction Date	c. 60 to 70 years
Recorded on	23 10 02	Condition	Very poor
Updated on		Orientation	North
Type	Terrace unit (end)	Map Ref	Beside #85
Present Use: Residential			
Past Uses: Residential			
Historical Associations: None			
General Description: Green brick facade with piers at front. Rounded beam under eave and brick under eaves at rear. Pounded earth side and rear walls. Stone paving inside courtyard, partly preserved with stone turning points.			
Decorative Features: None			
Renovations: Concrete patching. Modern metal door. Electrical fitting added.			
Setting: Mid village.			
Additional Notes: None

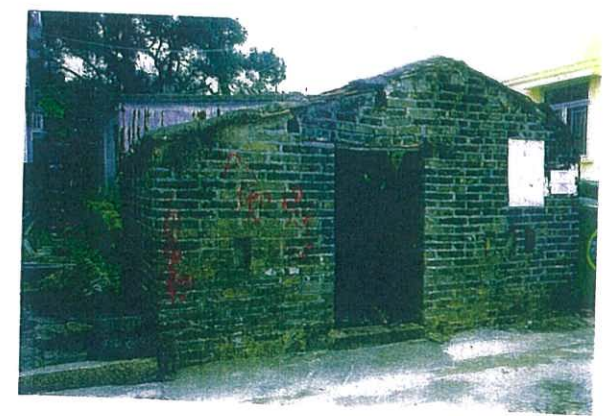
Location Shing Uk Tsuen			
Ref	AAHB - 285	Construction Date	Unknown
Recorded on	23 10 02	Condition	Ruin
Updated on		Orientation	South west
Type	Shed	Map Ref	N/A
Present Use: Abandoned			
Past Uses: Shed			
Historical Associations: None			
General Description: Green brick walls. Front of structure partially intact. Portions of tile roof remaining.			
Decorative Features: None			
Renovations: Concrete patching.			
Setting: Mid village.			
Additional Notes: None

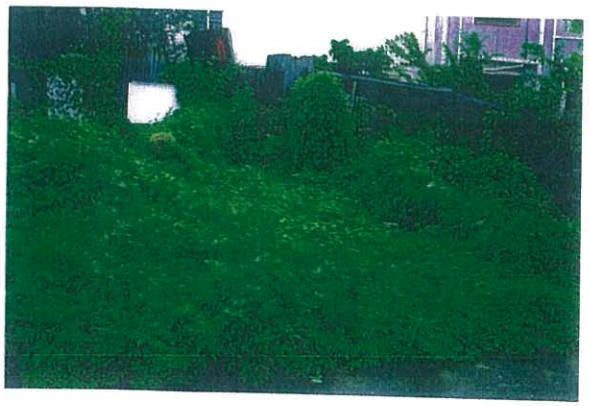
Location Shing Uk Tsuen			
Ref	AAHB - 286	Construction Date	Unknown
Recorded on	23 10 02	Condition	Ruin
Updated on		Orientation	N/A
Type	Village structure	Map Ref	N/A
Present Use: Abandoned			
Past Uses: Prob. Residential			
Historical Associations: None			
General Description: Green brick walls. Partial walls are the only remaining features. Cut stone pieces in vicinity. Very overgrown.			
Decorative Features: None			
Renovations: None			
Setting: At rear of village.			
Additional Notes: None

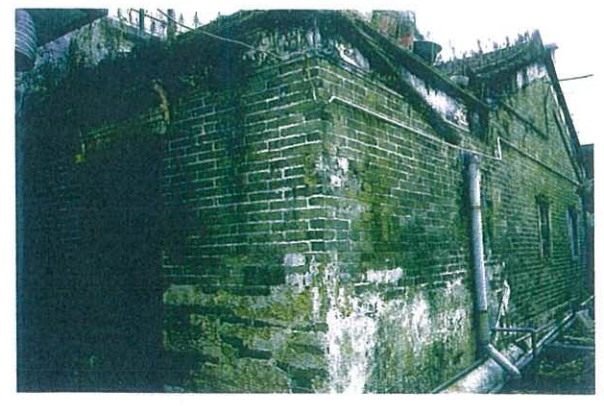
Location Shing Uk Tsuen			
Ref	AAHB - 287	Construction Date	c. 100 years
Recorded on	23 10 02	Condition	Fair
Updated on		Orientation	South west
Type	Courtyard style terrace unit (1-end)	Map Ref	#11
Present Use: Residential			
Past Uses: Residential			
Historical Associations: None			
General Description: Green brick and pounded earth walls and stone at front foundation level. Stone threshold.			
Decorative Features: Canopy over entranceway - floral and geometric designs. Frieze on facade and right side - black & white, geometric. Moulded eaves under tile.			
Renovations: Wooden door frame. 2 windows on right side. Tile and concrete roof, plain ridge. 2 windows added in rear wall - render on part.			
Setting: Near back of village.			
Additional Notes: None

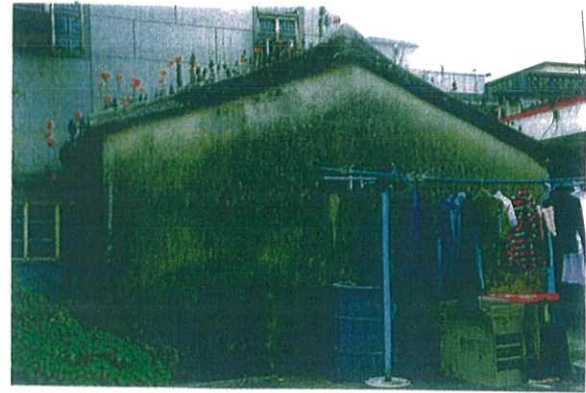
Location	Shing Uk Tsuen		
Ref	AAHB - 288	Construction Date	c 60 to 70 years
Recorded on	23 10 02	Condition	Poor
Updated on		Orientation	South west
Type	Terrace unit	Map Ref	N/A
Present Use	Abandoned	Past Uses	Residential
Historical Associations: None			
General Description: Pounded earth, single storey structure. Recessed front with square wooden beam supporting eaves. Remains of double panelled wooden door and wooden window frames on front.			
Decorative Features: None			
Renovations: Metal bars in windows (2 at front and 2 on left side), tile and concrete roof			
Setting: Near back of village			
Additional Notes: None

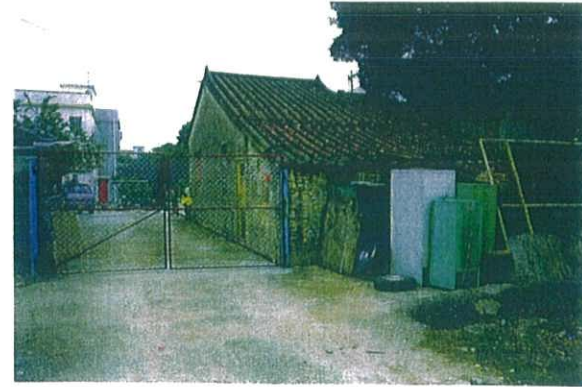
Location	Shing Uk Tsuen		
Ref	AAHB - 289	Construction Date	c 100 years
Recorded on	23 10 02	Condition	Fair
Updated on		Orientation	South west
Type	House and compound	Map Ref	#48
Present Use	Residential	Past Uses	Residential
Historical Associations: None			
General Description: Green brick structure with tile and concrete roof. Façade has double panel wooden door. Additional sections appear to have been used for storage animal pens. Two round openings on façade of house on either side of main door. Remains of red brick wall to left of house.			
Decorative Features: None			
Renovations: Concrete door frame			
Setting: At back of village			
Additional Notes: None

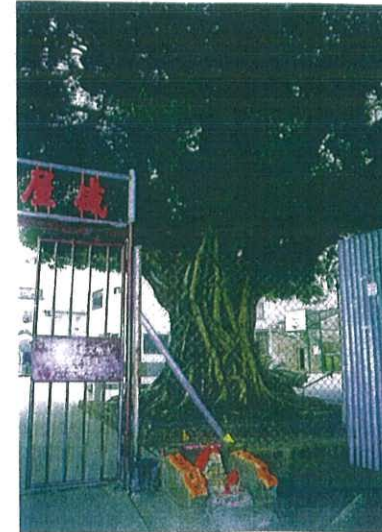
Location	Shing Uk Tsuen		
Ref	AAHB - 290	Construction Date	N/A
Recorded on	23 10 02	Condition	Fair
Updated on		Orientation	N/A
Type	Shrine	Map Ref	N/A
Present Use	Tree shrine	Past Uses	Tree shrine
Historical Associations: None			
General Description: Large Banyan tree - evidence of remains of fire crackers (for New Year) and red paper. No visible altar - incense holder etc. on tree but Earth God shrine about 1 M away at village entrance. White stone with concrete sides enclosure and incense holder.			
Decorative Features: None			
Renovations: Concrete enclosure of shrine			
Setting: At back of village			
Additional Notes: Shrine is oriented to North east

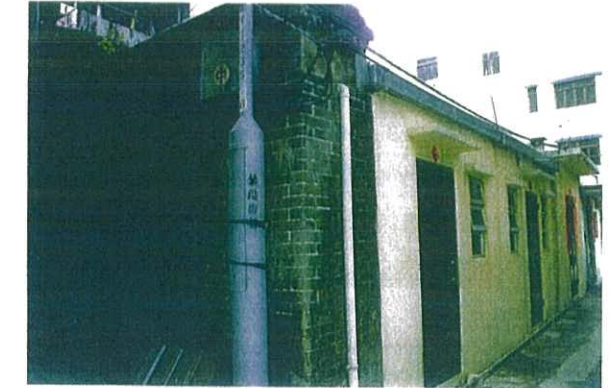
Location	Shing Uk Tsuen		
Ref	AAHB - 291	Construction Date	c 100 years
Recorded on	23 10 02	Condition	Fair
Updated on		Orientation	South west
Type	Terrace units (1 and, 4 mid)	Map Ref	#8 and 9
Present Use	Residential	Past Uses	Residential
Historical Associations: None			
General Description: Green brick wall on end terrace. Stone foundation visible. The main portions (interior) appear to maintain green brick. Traditional eaves.			
Decorative Features: None			
Renovations: Facades have all been renovated - 70's style. 3 windows inserted at side of left hand unit. Windows inserted at rear of all units except the end one.			
Setting: Near back of village			
Additional Notes: None

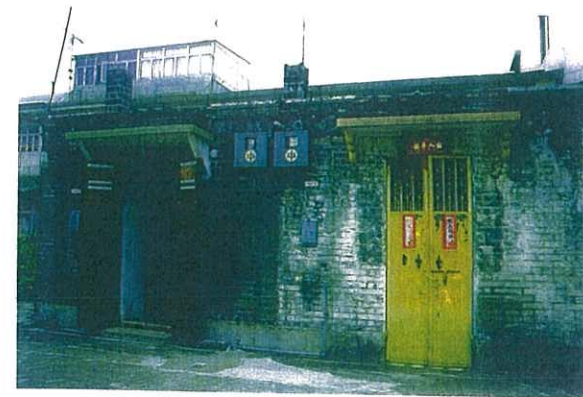
Location	Shing Uk Tsuen		
Ref	AAHB - 293	Construction Date	c 100 years
Recorded on	23 10 02	Condition	Poor
Updated on		Orientation	South west
Type	Courtyard style terrace units (1-mid, 1-end)	Map Ref	#3 and 4
Present Use	Residential	Past Uses	Residential
Historical Associations: None			
General Description: Green brick walls. Rear section has flat roof.			
Decorative Features: Decorative moulding under eaves of façade. Frieze panels, floral and landscape pattern.			
Renovations: Modern doors and canopies. All windows are modern. Electrical fittings added.			
Setting: Near back of village			
Additional Notes: None

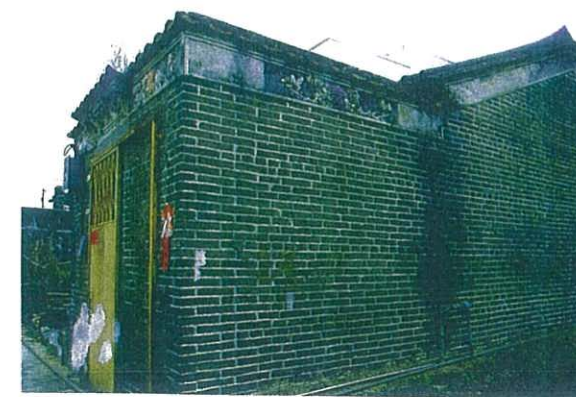
Location	Shing Uk Tsuen		
Ref	AAHB - 294	Construction Date	c 100 years
Recorded on	23 10 02	Condition	Fair
Updated on		Orientation	South west
Type	Courtyard style terrace unit (1-end)	Map Ref	#2
Present Use	Residential	Past Uses	Residential
Historical Associations: None			
General Description: Green brick walls with tile and concrete roof.			
Decorative Features: Canopy and frieze panels on facade, floral and landscape patterns.			
Renovations: Windows on one side. Modern metal door. Electrical fittings added.			
Setting: Near back of village			
Additional Notes: Only unit of row remaining

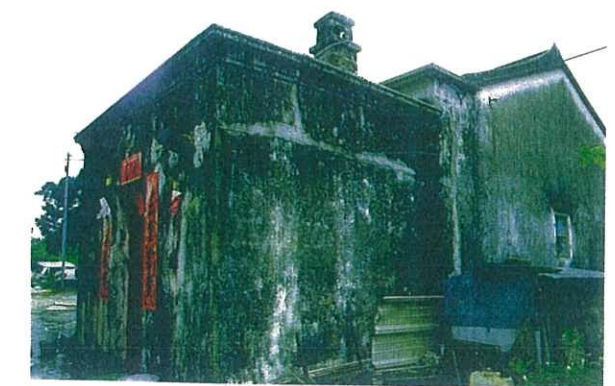
Location	Shing Uk Tsuen		
Ref	AAHB - 295	Construction Date	c 100 years
Recorded on	23 10 02	Condition	Fair
Updated on		Orientation	South west
Type	Courtyard style terrace unit (1-end)	Map Ref	#1
Present Use	Residential	Past Uses	Residential
Historical Associations: None			
General Description: Pounded earth walls and tile and concrete roof.			
Decorative Features: Concave moulding in concrete below eaves on façade.			
Renovations: Concrete covering over walls. Concrete door frame and threshold. Windows with metal grilles and concrete canopies.			
Setting: At back of village			
Additional Notes: None

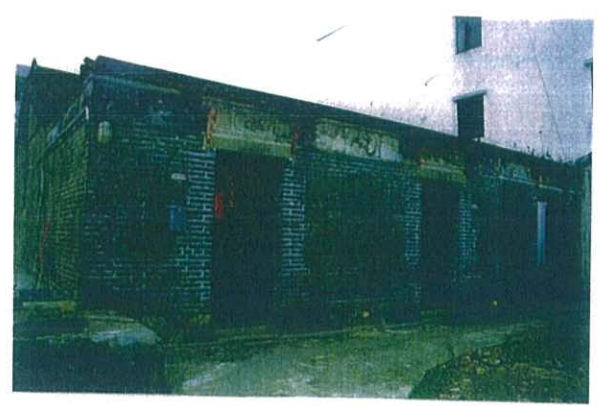
Location Shing Uk Tsuen AAHB - 296		
Recorded on 23 10 02	Construction Date c 100 years	Present Use Vacant
Updated on	Condition Poor/ Ruin	Past Uses Residential
	Orientation South west	Historical Associations None
Type Courtyard style terrace units (1-end, 2 mid)	Map Ref # 25-28	
General Description Green brick walls House #25 in ruinous state with front section collapsed Double panel wooden doors with stone thresholds and lintels Tile and concrete roof		
Decorative Features Moulded and painted canopies over doors Frieze panels on façade, floral and landscape		
Renovations side and rear windows with plain concrete canopies		
Setting Mid village		
Additional Notes None

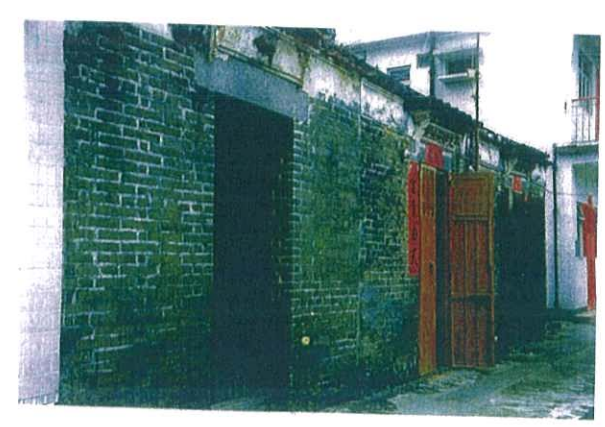
Location Shing Uk Tsuen Ref AAHB - 297		
Recorded on 23 10 02	Construction Date c 100 years	Present Use Residential
Updated on	Condition Fair	Past Uses Residential
Type Courtyard style terrace units (2-mid, 1 end)	Orientation South west	Historical Associations None
Map Ref #23, 24 and 25		
General Description 3 green brick units with original wooden doors, stone thresholds and lintels Tile and concrete roof		
Decorative Features Moulded canopies, 1 painted, 2 moulded and frieze, landscape patterns		
Renovations 2 units have modern metal doors		
Setting Mid village		
Additional Notes None

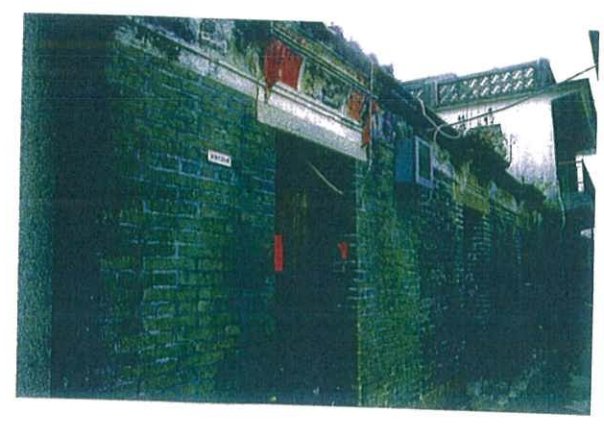
Location Shing Uk Tsuen Ref AAHB - 298		
Recorded on 23 10 02	Construction Date c 100 years	Present Use Residential
Updated on	Condition Fair	Past Uses Residential
Type Courtyard style terrace units (4-mid)	Orientation South west	Historical Associations None
Map Ref #20, 21, 22 and 23		
General Description Green brick walls with wooden doors, stone lintels and thresholds Single course of granite blocks along base of façade		
Decorative Features Canopies over entrances, landscape and floral patterns		
Renovations Concrete patching, Electrical fittings added		
Setting Mid village		
Additional Notes None

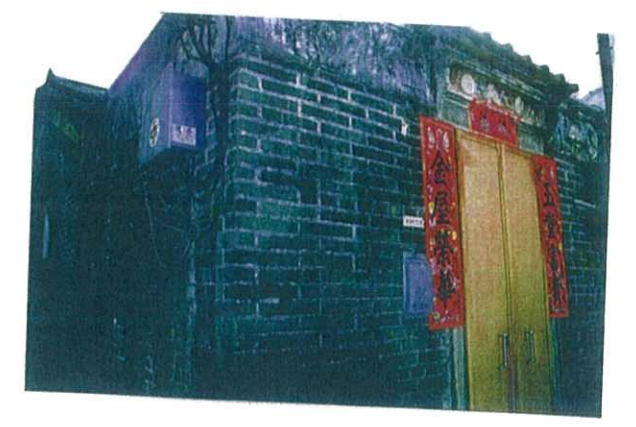
Location Shing Uk Tsuen Ref AAHB - 299		
Recorded on 23 10 02	Construction Date c 100 years	Present Use Residential
Updated on	Condition Fair	Past Uses Residential
Type Courtyard style terrace unit (1-end)	Orientation South west	Historical Associations None
Map Ref #15		
General Description Green brick walls with stone door frame, stone lintels and tile and concrete roof		
Decorative Features Canopy over entrance, domestic and lung shui pattern Frieze panel, landscape pattern		
Renovations Concrete patching, Modern metal door, Electrical fittings added		
Setting Mid village		
Additional Notes None

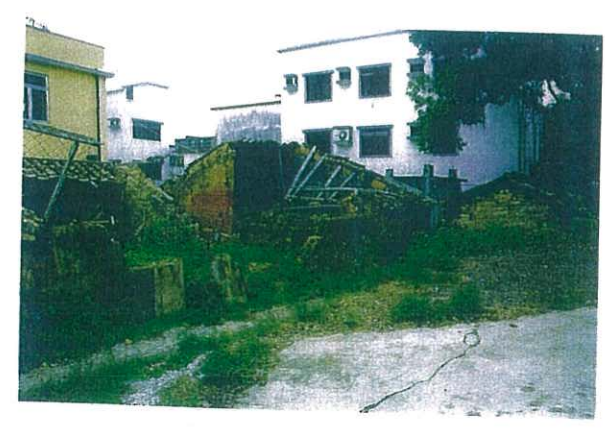
Location Shing Uk Tsuen Ref AAHB - 301		
Recorded on 23 10 02	Construction Date Unknown	Present Use Abandoned
Updated on	Condition Ruin	Past Uses Animal pens
Type Animal pens	Orientation N/A	Historical Associations None
Map Ref N/A		
General Description Tile roof (partially collapsed) and grey/ green brick pounded earth walls, with shell		
Decorative Features None		
Renovations None		
Setting At edge of village		
Additional Notes None

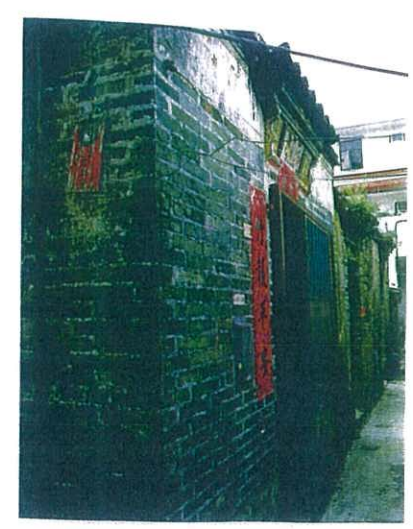
Location Shing Uk Tsuen Ref AAHB - 302		
Recorded on 23 10 02	Construction Date c 100 years	Present Use 1 in use, 2 ruins
Updated on	Condition Fair/ Ruin	Past Uses Residential
Type Courtyard style terrace units (1-end, 2 mid)	Orientation South west	Historical Associations None
Map Ref #32		
General Description Green brick and pounded earth. Wooden doors, stone thresholds. Tile and concrete roof Stone thresholds. Tile and concrete roof		
Decorative Features Canopies over entrances, floral and landscape patterns		
Renovations Concrete patching, Modern metal door on end unit, Windows added on rear wall		
Setting Mid village		
Additional Notes None

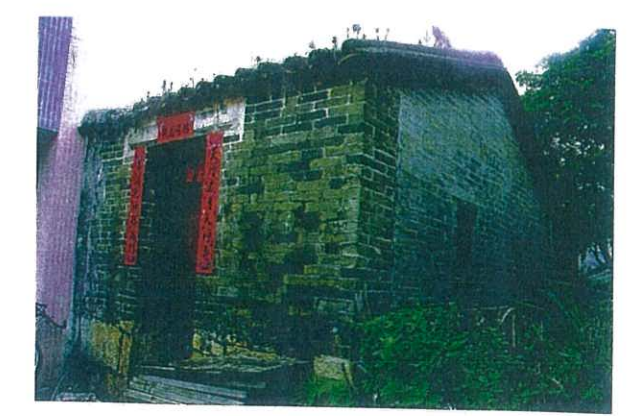
Location Shing Uk Tsuen Ref AAHB - 303		
Recorded on 23 10 02	Construction Date Unknown	Present Use Storage
Updated on	Condition Poor	Past Uses Residential
Type Terrace unit (end)	Orientation South west	Historical Associations None
Map Ref Besdie #30		
General Description Green brick walls on double row cut stone foundation brick doorstep and wooden frame / door/ lintel Tile and concrete roof		
Decorative Features None		
Renovations Concrete patching, Brick work replaced on side wall		
Setting Near front of village		
Additional Notes None

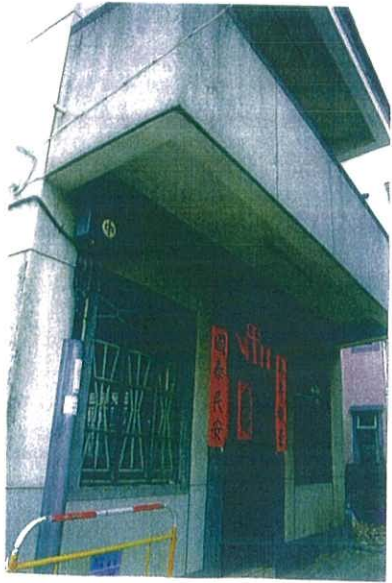
Location: Shing Uk Tsuen			
Ref: AAHB - 304	Construction Date: c. 1970	Present Use: Tsz tong	
Recorded on: 23 10 02	Condition: Very good	Past Uses: Tsz tong	
Updated on:	Orientation: South west	Historical Associations: None	
Type: Chang Ka Tsz 盛家祠	Map Ref: N/A		
General Description: 2 storey building, completely modern with inscription above door			
Decorative Features: None			
Renovations: None			
Setting: Near front of village			
Additional Notes: None

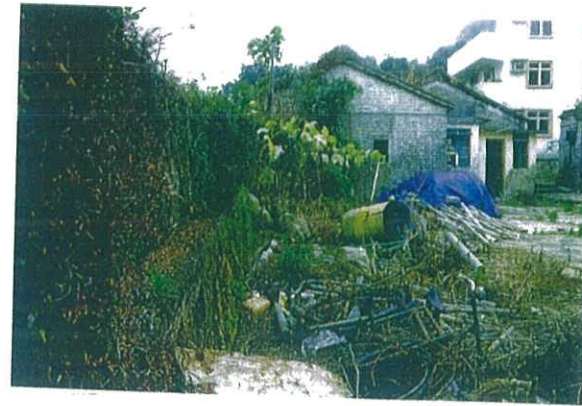
Location: Shing Uk Tsuen			
Ref: AAHB - 305	Construction Date: c. 60 to 70 years	Present Use: Abandoned	
Recorded on: 23 10 02	Condition: Poor	Past Uses: Residential	
Updated on:	Orientation: South west	Historical Associations: None	
Type: Houses/ wall	Map Ref: N/A		
General Description: Grey brick walls. 2 houses and 1 modern addition			
Decorative Features: None			
Renovations: Left hand unit has wooden door and frame. Windows with metal grilles			
Setting: Near front of village			
Additional Notes: None

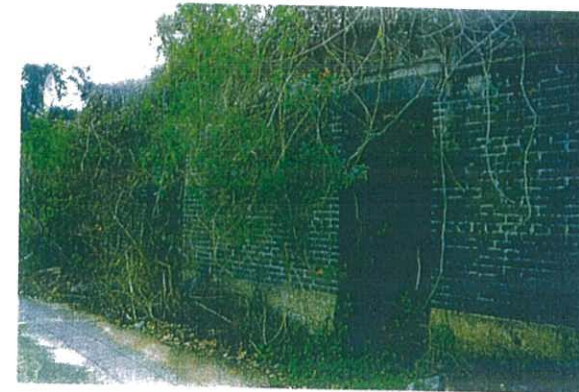
Location: Shing Uk Tsuen			
Ref: AAHB - 306	Construction Date: c. 100 years	Present Use: Abandoned	
Recorded on: 23 10 02	Condition: Poor	Past Uses: Residential	
Updated on:	Orientation: South west	Historical Associations: None	
Type: Courtyard terrace units (1 end, 1 mid)	Map Ref: N/A		
General Description: Green brick walls with stone foundation. Roofs collapsed and interior overgrown. Green brick on stone foundation. Stone step and lintel. Wooden door and frame. Front roofs have collapsed, heavily overgrown.			
Decorative Features: Canopy over entrance and frieze panel on façade, landscape pattern.			
Renovations: None			
Setting: Near front of village			
Additional Notes: None

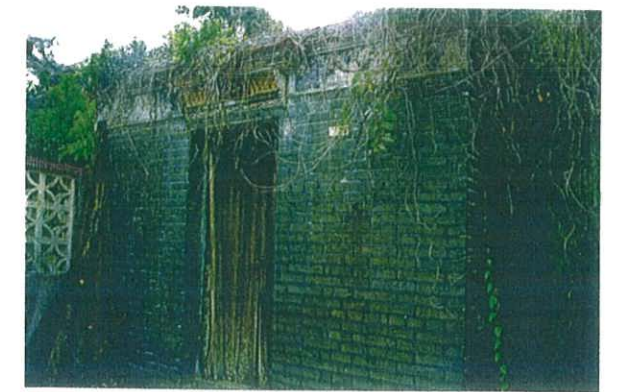
Location: Shing Uk Tsuen			
Ref: AAHB - 307	Construction Date: c. 100 years	Present Use: Abandoned	
Recorded on: 23 10 02	Condition: Ruin	Past Uses: Residential	
Updated on:	Orientation: South west	Historical Associations: None	
Type: Courtyard style terrace unit (1-mid)	Map Ref: #29		
General Description: Green brick walls with stone door step, double panel wooden door/lintel and frame. Concrete and tile roof at front. Overgrown.			
Decorative Features: Frieze, landscape pattern. Moulded canopy above door with writing.			
Renovations: None			
Setting: Front of village			
Additional Notes: None

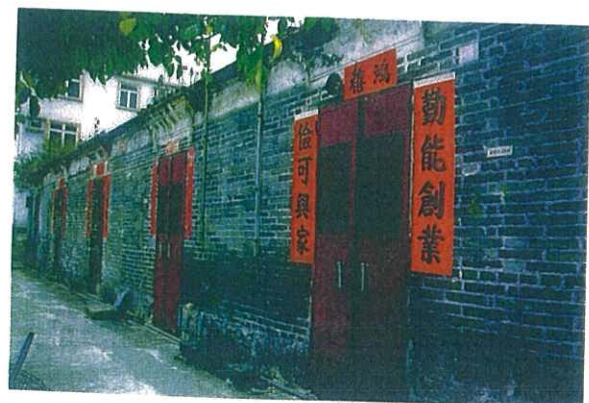
Location: Shing Uk Tsuen			
Ref: AAHB - 308	Construction Date: c. 100 years	Present Use: Residential	
Recorded on: 23 10 02	Condition: Fair	Past Uses: Residential	
Updated on:	Orientation: South west	Historical Associations: None	
Type: Courtyard style terrace units (5)	Map Ref: # 39-41		
General Description: Green brick walls, tile and concrete roof with plain ridge. Stone foundations. Stone step and stone lintels for the 3 left units.			
Decorative Features: Canopies above doors, some patterns obscured, others are landscape. Frieze patterns on façade are obscured.			
Renovations: Units on far right end have metal doors on façade. Electrical fittings added.			
Setting: At front of village			
Additional Notes: None

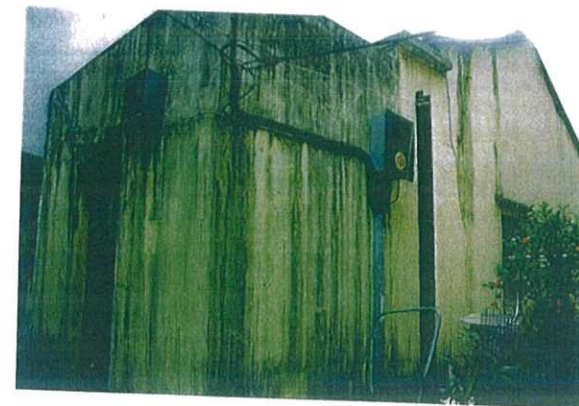
Location: Tai Tseng Wai			
Ref: AAHB - 322	Construction Date: Unknown	Present Use: Residential	
Recorded on: 23.10.02	Condition: Fair	Past Uses: Residential	
Updated on:	Orientation: North east	Historical Associations: None	
Type: Courtyard style terrace unit (1-and)	Map Ref.: # 54		
General Description: Green brick rear wall. Tile and concrete roof.			
Decorative Features: None			
Renovations: Render on all but rear wall. Electrical fitting added.			
Setting: At edge of village			
Additional Notes: None

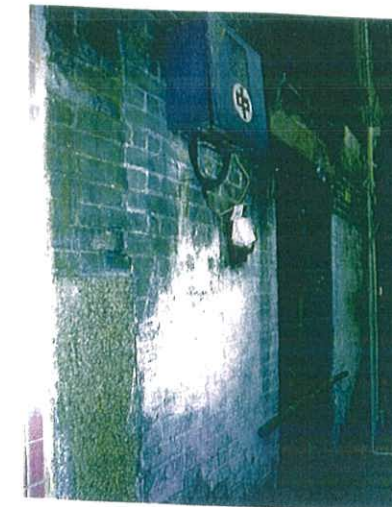
Location: Tai Tseng Wai			
Ref: AAHB - 323	Construction Date: c. 100 years	Present Use: Vacant	
Recorded on: 23.10.02	Condition: Poor	Past Uses: Residential	
Updated on:	Orientation: North east	Historical Associations: None	
Type: Courtyard style terrace unit (1-mid)	Map Ref.: #41		
General Description: Green brick walls with corner stone and stone foundation. Granite lintel and threshold. Incense burners on side of door.			
Decorative Features: Canopy above door. Moulded frieze on facade. Patterns indiscernible.			
Renovations: Modern corrugated roof. Modern door and frame.			
Setting: Mid village			
Additional Notes: None

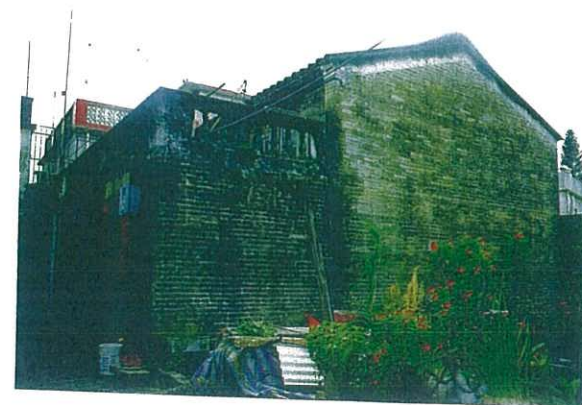
Location: Tai Tseng Wai			
Ref: AAHB - 325	Construction Date: c. 60 to 70 years	Present Use: Left - in use; right - closed	
Recorded on: 23.10.02	Condition: Fair	Past Uses: Residential	
Updated on:	Orientation: North east	Historical Associations: None	
Type: Terrace units (1-and, 2-mid)	Map Ref.: N/A		
General Description: Two storey green brick units (piers on facades). Single storey fore units added. Flat roof on fore units with balustrade. Stone lintels and thresholds.			
Decorative Features: Ceramic balustrade (green, 'urn' style).			
Renovations: Metal grille windows. Electrical fittings added.			
Setting: At edge of village			
Additional Notes: None

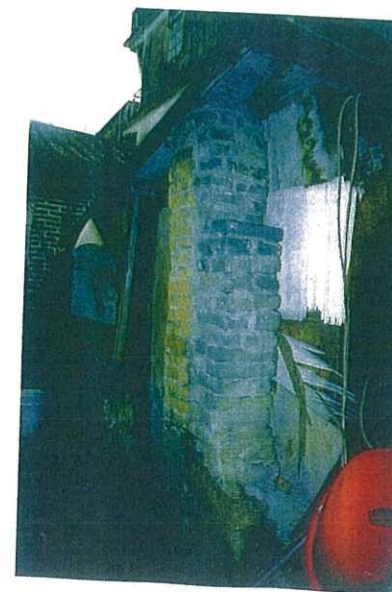
Location: Tai Tseng Wai			
Ref: AAHB - 326	Construction Date: Unknown	Present Use: Abandoned	
Recorded on: 23.10.02	Condition: Ruin	Past Uses: Residential	
Updated on:	Orientation: North east	Historical Associations: None	
Type: Terrace unit	Map Ref.: N/A		
General Description: Partial green brick walls with stone threshold and lower frame. Some stone foundation.			
Decorative Features: None			
Renovations: Metal roof added.			
Setting: Mid village			
Additional Notes: None

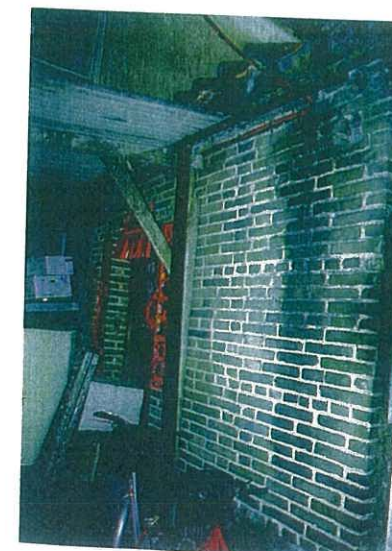
Location: Tai Tseng Wai			
Ref: AAHB - 327	Construction Date: c. 60 to 70 years	Present Use: Vacant	
Recorded on: 23.10.02	Condition: Fair	Past Uses: Residential	
Updated on:	Orientation: North east	Historical Associations: None	
Type: Terrace unit	Map Ref.: N/A		
General Description: Green brick walls. Tile and concrete roof.			
Decorative Features: None			
Renovations: Lower walls have cement over brickwork. Metal awning at front. Electrical fittings added.			
Setting: Near back of village			
Additional Notes: None

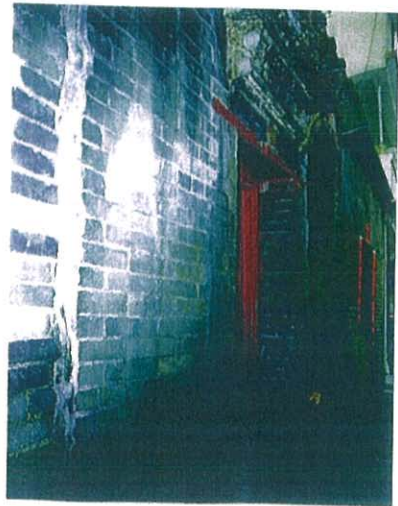
Location: Tai Tseng Wai			
Ref: AAHB - 328	Construction Date: c. 100 years	Present Use: Abandoned	
Recorded on: 23 10 02	Condition: Ruin	Past Uses: Residential	
Updated on:	Orientation: North east	Historical Associations: None	
Type: Courtyard style terrace units (2 mid)	Map Ref: #60		
General Description: Green brick walls. Left side facade walls intact, rear wall intact. Interior filled with collapsed material from building. Double panel wooden door and unit.			
Decorative Features: Canopy over left hand doorway in poor condition (stylised characters)			
Renovations: Windows inserted in rear wall. Concrete patching.			
Setting: At back of village			
Additional Notes: None

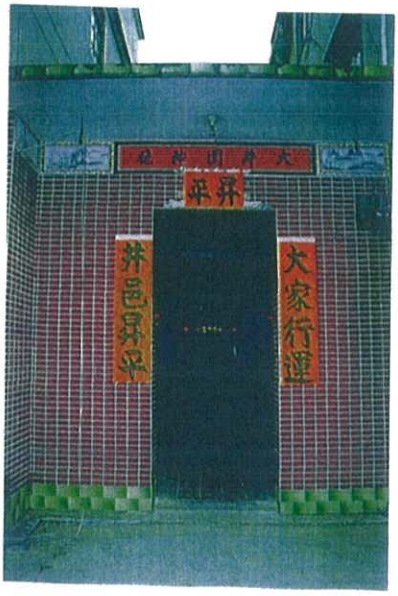
Location: Tai Tseng Wai			
Ref: AAHB - 329	Construction Date: Modern	Present Use: Gods Hall	
Recorded on: 23 10 02	Condition: Very good	Past Uses: Gods hall	
Updated on:	Orientation: North east	Historical Associations: None	
Type: Tai Tseng Wai Gods Hall 大井圍神廳	Map Ref: N/A		
General Description: Modern building with red tile facade. Cut stone threshold set in modern materials. Village banner on right hand wall. Modern altar shrine at rear.			
Decorative Features: Frieze panels on facade			
Renovations: None			
Setting: At back of village			
Additional Notes: None

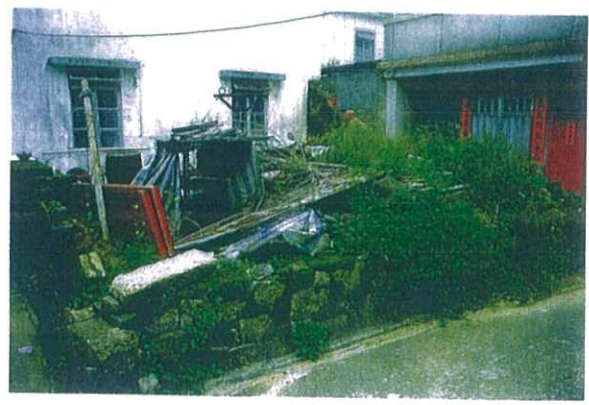
Location: Tai Tseng Wai			
Ref: AAHB - 330	Construction Date: Unknown	Present Use: Storage	
Recorded on: 23 10 02	Condition: Ruin	Past Uses: Residential	
Updated on:	Orientation: N/A	Historical Associations: None	
Type: Terrace unit (end)	Map Ref: N/A		
General Description: Portions of green brick wall with one stone doorstep and stone foundations still visible			
Decorative Features: None			
Renovations: None			
Setting: Near back of village			
Additional Notes: None

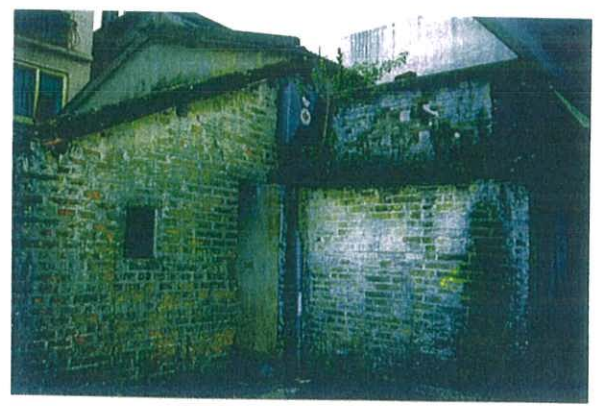
Location: Tai Tseng Wai			
Ref: AAHB - 331	Construction Date: c. 60 to 70 years	Present Use: Community Hall	
Recorded on: 23 10 02	Condition: Poor	Past Uses: Study hall	
Updated on:	Orientation: North east	Historical Associations: None	
Type: Yee Hing Tong (Cheng) 禧慶堂	Map Ref: N/A		
General Description: Gray brick structure. Door off centre to left with wooden door and frame			
Decorative Features: Painted frieze panels on facade (floral + inscriptions). Inscription painted above door			
Renovations: Concrete door step & lintel. Modern tiles inside. Corrugated roof. Kitchen attachment to right			
Setting: Near back of village			
Additional Notes: None
