Drainage Services
Department

Agreement No.
CE 66/2001(EP)

EIA and TIA Studies for the
Stage 2 of PWP Item No.
215DS - Yuen Long and
Kam Tin Sewerage and
Sewage Disposal

Final Environmental Impact
Assessment

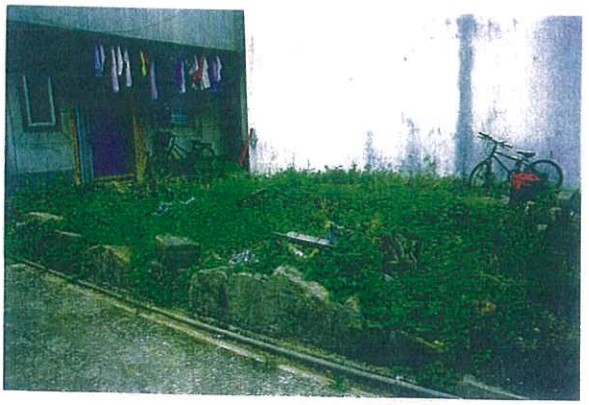
Location: Tai Tseng Wai			
Ref: AAHB - 333	Construction Date: Unknown	Present Use: Abandoned	
Recorded on: 23 10 02	Condition: Ruin	Past Uses: Residential?	
Updated on:	Orientation: N/A	Historical Associations: None	
Type: Terrace unit	Map Ref: N/A		
General Description: Stone and rubble foundation. Some traces of green brick stone thresholds in situ. Overgrown			
Decorative Features: None			
Renovations: Concrete flooring			
Setting: At rear of village			
Additional Notes: None

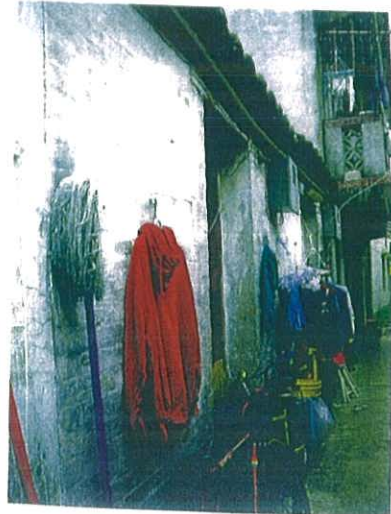
Location	Tai Tseng Wai		
Ref	AAHB - 337	Construction Date	c. 100 years
Recorded on	23 10 02	Condition	Poor
Updated on		Orientation	North east
Type	Terrace units (2-mid)	Map Ref	N/A
Present Use	Residential	Past Uses	Residential
Historical Associations	None		
General Description: Green brick walls. Facades have been whitewashed. Double panel wooden doors closed up. Bricks have white washed on facade. Both have double panel wooden door & frame.			
Decorative Features: None			
Renovations: Rear wall has window & aircon added. Wooden door frames.			
Setting: Mid village			
Additional Notes: None

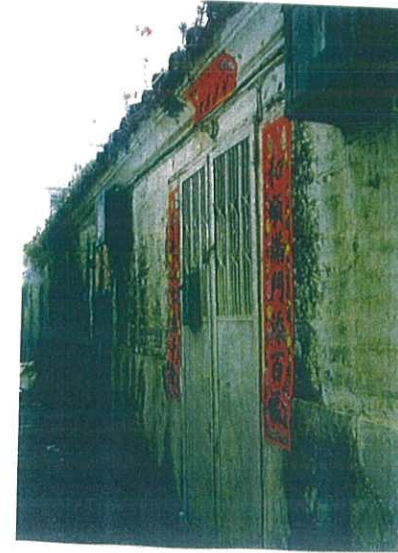
Location	Tai Tseng Wai		
Ref	AAHB - 338	Construction Date	c. 100 years
Recorded on	23 10 02	Condition	Fair
Updated on		Orientation	North east
Type	Terrace units (2 and, 3 mid)	Map Ref	N/A
Present Use	Vacant	Past Uses	Residential
Historical Associations	None		
General Description: Brick walls with stone doorsteps. Stone foundations. Tile and concrete roof. Plain ridge.			
Decorative Features: Moulding under eaves on facade.			
Renovations: Modern metal doors. Concrete patching. Walls whitewashed.			
Setting: Mid village			
Additional Notes: None

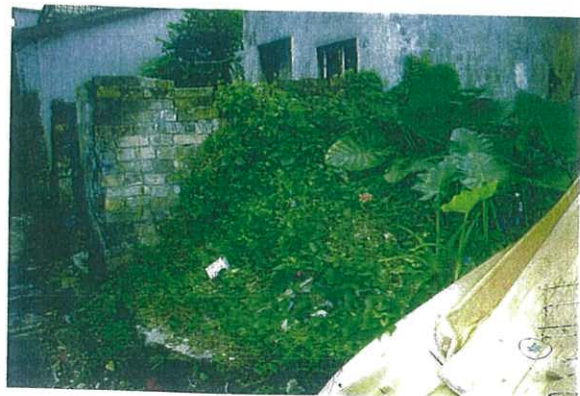
Location	Tai Tseng Wai		
Ref	AAHB - 340	Construction Date	Unknown
Recorded on	23 10 02	Condition	Ruin
Updated on		Orientation	N/A
Type	Terrace unit (mid)	Map Ref	N/A
Present Use	Abandoned	Past Uses	Residential
Historical Associations	None		
General Description: Remains of green brick walls with evidence of stone thresholds and lower courses of facade. Full of rubbish and overgrown.			
Decorative Features: None			
Renovations: Recent concrete building in centre, re-used bricks for front enclosure wall. Part of rear wall standing but heavily patched.			
Setting: Mid village			
Additional Notes: None

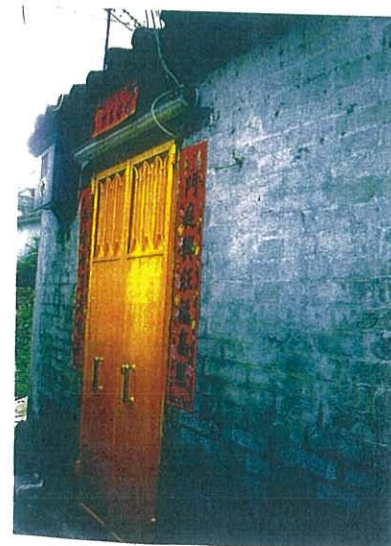
Location	Tai Tseng Wai		
Ref	AAHB - 341	Construction Date	Unknown
Recorded on	23 10 02	Condition	Fair
Updated on		Orientation	North east
Type	Terrace unit (1-end)	Map Ref	N/A
Present Use	Residential	Past Uses	Residential
Historical Associations	None		
General Description: Green brick walls, whitewashed, stone foundation. Concrete and tile roof. Bricks under eaves at front and rear.			
Decorative Features: None			
Renovations: Modern door gate, front alterations for electric fittings. Wooden lintel with light added.			
Setting: Mid village			
Additional Notes: None

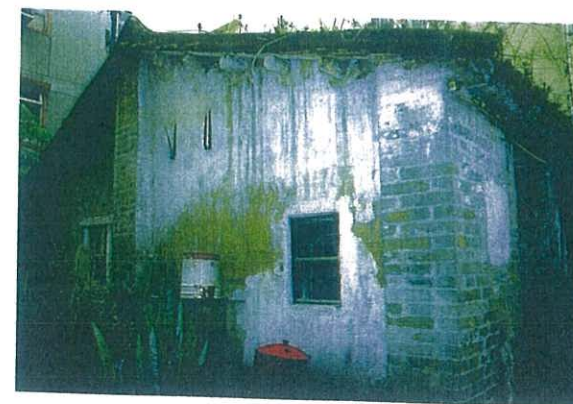
Location	Tai Tseng Wai		
Ref	AAHB - 342	Construction Date	c. 60 to 70 years
Recorded on	23 10 02	Condition	Poor
Updated on		Orientation	North east
Type	Terrace unit (1-end)	Map Ref	N/A
Present Use	Abandoned	Past Uses	Residential
Historical Associations	None		
General Description: Mixed bricks on facade and rear. Side wall has concrete sections. Rammed earth side walls. Wood and tile pitched roof (partially collapsed). Interior full of debris.			
Decorative Features: None			
Renovations: Windows in left wall, door removed. Concrete patching.			
Setting: At edge of village			
Additional Notes: None

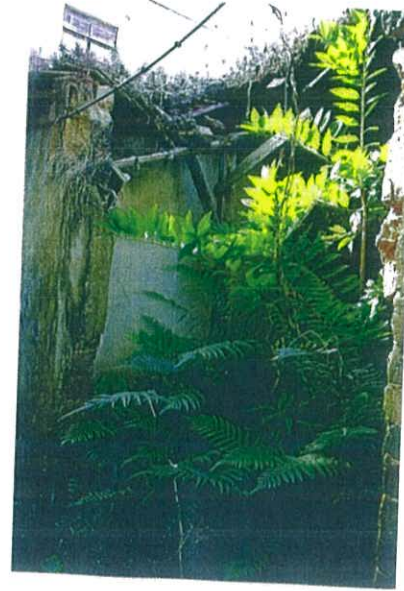
Location: Tai Tseng Wai			
Ref: AAHB - 345	Construction Date: c 100 years	Present Use: Abandoned	
Recorded on: 23 10 02	Condition: Ruin	Past Uses: Residential	
Updated on:	Orientation: N/A	Historical Associations: None	
Type: Terrace unit (mid)	Map Ref: N/A		
General Description: Mud brick and grey brick walls in very poor condition. Some wooden beams remain with no roof but some tiles. Interior overgrown.			
Decorative Features: None			
Renovations: None			
Setting: Mid village			
Additional Notes: None

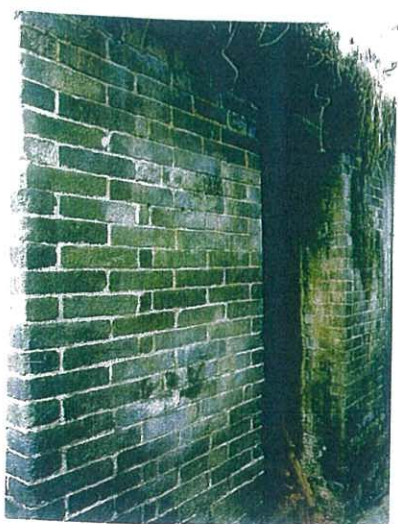
Location: Tai Tseng Wai			
Ref: AAHB - 347	Construction Date: c 100 years	Present Use: Abandoned/storage	
Recorded on: 23 10 02	Condition: Very poor	Past Uses: Residential	
Updated on:	Orientation: North east	Historical Associations: None	
Type: Terrace unit (1-mid)	Map Ref: N/A		
General Description: Green brick walls with sandstone foundation and doorstep. Brick under eave. Tile and concrete roof with vegetation on roof. Round wooden beams inside. Second storey at rear. Supported roof with round beams.			
Decorative Features: None			
Renovations: None			
Setting: Mid village			
Additional Notes: None

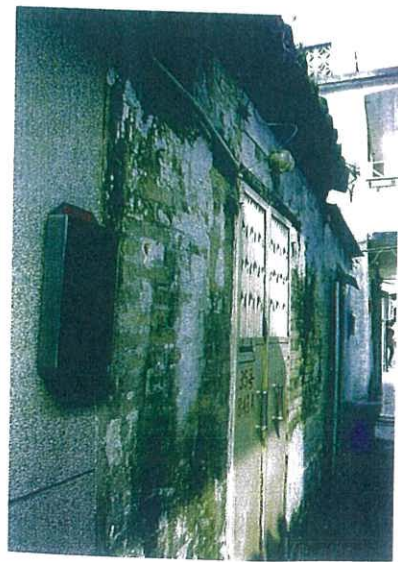
Location: Tai Tseng Wai			
Ref: AAHB - 348	Construction Date: c 100 years	Present Use: Vacant	
Recorded on: 23 10 02	Condition: Poor	Past Uses: Residential	
Updated on:	Orientation: North east	Historical Associations: None	
Type: Terrace unit (1-mid)	Map Ref: # 34A, 35		
General Description: Mixed brick walls with tile and concrete roof.			
Decorative Features: None			
Renovations: Metal door.			
Setting: Mid village			
Additional Notes: None

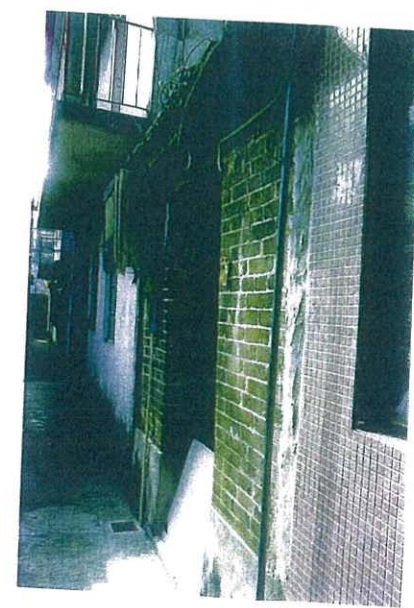
Location: Tai Tseng Wai			
Ref: AAHB - 349	Construction Date: c 100 years	Present Use: Residential	
Recorded on: 23 10 02	Condition: Poor	Past Uses: Residential	
Updated on:	Orientation: North east	Historical Associations: None	
Type: Terrace unit (mid)	Map Ref: N/A		
General Description: Green, grey brick walls. Tile and concrete roof. Stone threshold, wood door. Tile and cement roof.			
Decorative Features: None			
Renovations: concrete around foundation. Electrical fittings added.			
Setting: Mid village			
Additional Notes: None

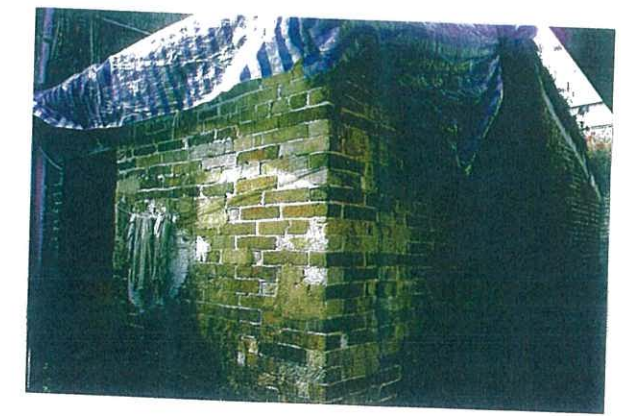
Location: Tai Tseng Wai			
Ref: AAHB - 350	Construction Date: Unknown	Present Use: Abandoned	
Recorded on: 23 10 02	Condition: Very poor	Past Uses: Residential	
Updated on:	Orientation: North east	Historical Associations: None	
Type: Terrace unit (end)	Map Ref: N/A		
General Description: Mixed brick walls. Uncut stone foundation. Tile and concrete roof.			
Decorative Features: None			
Renovations: Concrete patching.			
Setting: Near front of village			
Additional Notes: None

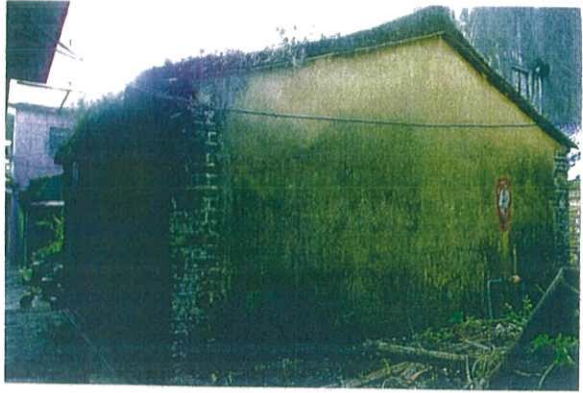
Location	Tai Tsang Wai		
Ref	AAHB - 351	Construction Date	< 100 years
Recorded on	23 10 02	Condition	Poor
Updated on		Orientation	North east
Type	Terrace units (1 end, 1 mid)	Map Ref	N/A
Present Use	Abandoned	Past Uses	Residential
Historical Associations	None		
General Description: Grey brick and pounded earth walls. Right hand unit has sandstone and tile foundation, mud brick front and stone threshold doorstep. Left hand unit has stone foundation (some sandstone). Left hand unit has stone foundation (some are sandstone), brick walls and stone threshold. Tile and concrete roof.			
Decorative Features: None			
Renovations: Render on side walls. Concrete patches. Electrical fittings added.			
Setting: Near front of village.			
Additional Notes: None

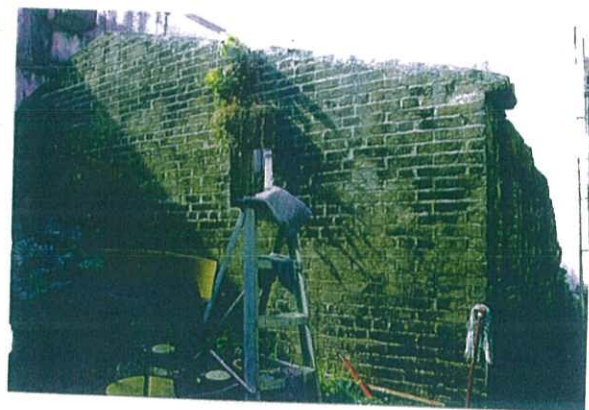
Location: Tai Tsang Wai			
Ref: AAHB - 353	Construction Date: c 100 years	Present Use: Abandoned	
Recorded on: 23 10 02	Condition: Run	Past Uses: Residential	
Updated on:	Orientation: North east	Historical Associations: None	
Type: Terrace unit (mid)	Map Ref: N/A		
General Description: Partial green brick side walls, no roof. Interior overgrown.			
Decorative Features: None			
Renovations: Window with metal bars in right hand side wall			
Setting: Near front of village			
Additional Notes: None

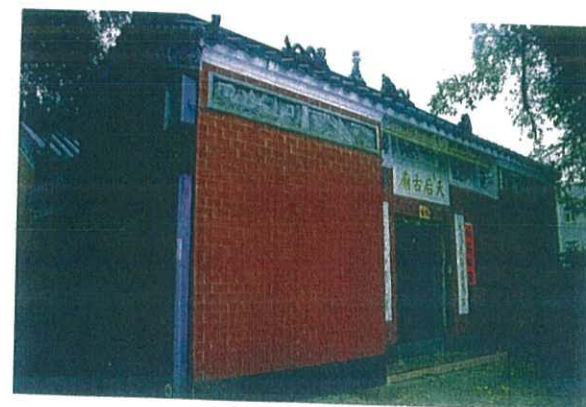
Location: Ng Uk Tsuen			
Ref: AAHB - 355	Construction Date: last renovated 1981	Present Use: Temple	
Recorded on: 23 10 02	Condition: very good	Past Uses: Temple	
Updated on:	Orientation: South east	Historical Associations: Belongs to Tai Tsang wai Ng Uk Tsuen & Shing Uk Tsuen	
Type: Tin Hau Temple	Map Ref: N/A		
General Description: Rebuilt/renovated temple. Last renovation in 1981. Originally built in late Qing Dynasty. Red brick on granite foundation.			
Decorative Features: Painted frieze on facade. Green ceramic end and drip tiles. Roof ridge with dragon and ball figures.			
Renovations: None			
Setting: Pond in front, surrounded by villas. Fung shui wall in front knocked down. Fish farm behind temple.			
Additional Notes: None

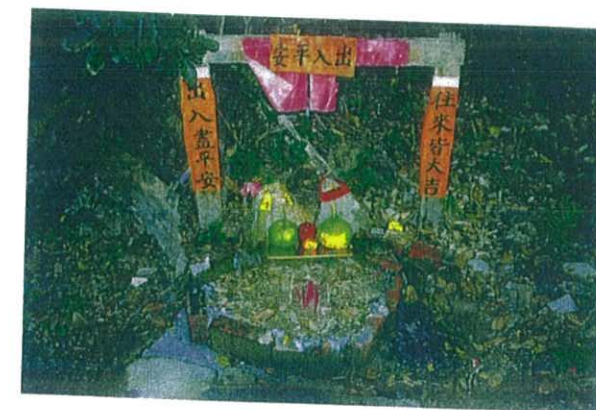
Location: Ng Uk Tsuen			
Ref: AAHB - 356	Construction Date: Unknown	Present Use: Shrine	
Recorded on: 23 10 02	Condition: Fair	Past Uses: Shrine	
Updated on:	Orientation: South	Historical Associations: None	
Type: Earth God shrine	Map Ref: N/A		
General Description: 2 stones - rough wooden frame over it. Brick enclosure for incense in front.			
Decorative Features: None			
Renovations: None			
Setting: Large Banyan tree behind. At edge of village			
Additional Notes: None

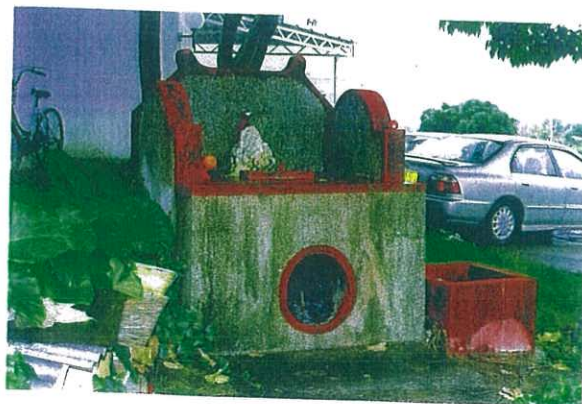
Location: Fung Shun Street			
Ref: AAHB - 357	Construction Date: Recent	Present Use: Shrine	
Recorded on: 23 10 02	Condition: Good	Past Uses: Shrine	
Updated on:	Orientation: South east	Historical Associations: None	
Type: Shrine	Map Ref: N/A		
General Description: Concrete and tile enclosure with white stone set at rear wall. Burner underneath. Rounded side walls.			
Decorative Features: Platform, rim around burner opening and top edges of sides have orange red paint.			
Renovations: None			
Setting: At corner of roads near modern buildings, apart from the villages			
Additional Notes: None

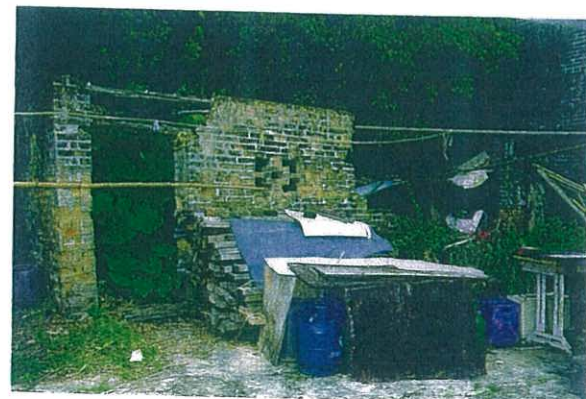
Location: Ng Uk Tsuen			
Ref: AAHB - 358	Construction Date: Unknown	Present Use: Abandoned	
Recorded on: 23 10 02	Condition: poor	Past Uses: Storage	
Updated on:	Orientation: South west	Historical Associations: None	
Type: Village structure	Map Ref: N/A		
General Description: Mixed bricks - eroded. Walls only partially intact. Some wooden roof beams, no roof.			
Decorative Features: Lattice brick opening on façade			
Renovations: None			
Setting: At back of village			
Additional Notes: None

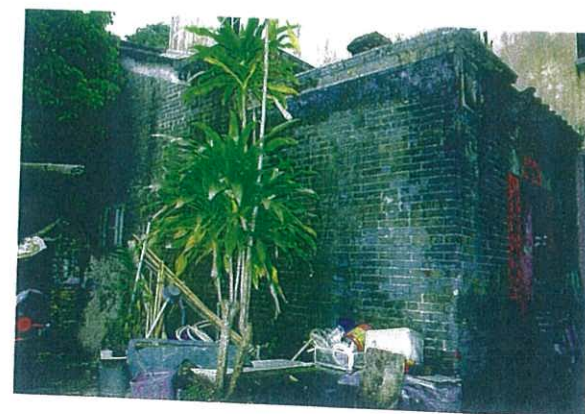
Location: Ng Uk Tsuen			
Ref: AAHB - 359	Construction Date: c 100 years	Present Use: Vacant	
Recorded on: 23 10 02	Condition: Fair	Past Uses: Residential	
Updated on:	Orientation: South west	Historical Associations: None	
Type: Courtyard style terrace unit (1-end)	Map Ref: N/A		
General Description: Green brick walls; granite threshold stone, lintel and foundation. Double panel wooden door.			
Decorative Features: Canopy above door, painted. Moulded frieze on façade			
Renovations: Concrete patching. Window added on side.			
Setting: Near back of village			
Additional Notes: None

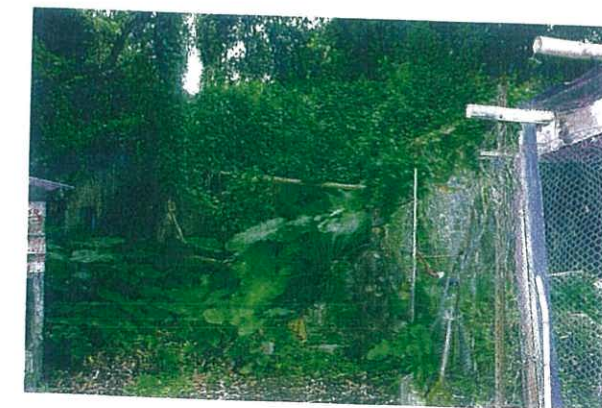
Location: Ng Uk Tsuen			
Ref: AAHB - 360	Construction Date: Unknown	Present Use: Abandoned	
Recorded on: 23 10 02	Condition: Ruin	Past Uses: Residential	
Updated on:	Orientation: N/A	Historical Associations: None	
Type: Village structure	Map Ref: N/A		
General Description: Grey brick and pounded earth wall portions. Very overgrown.			
Decorative Features: None			
Renovations: Concrete render. Metal doors and windows. Roof is partly metal and partly tile and cement.			
Setting: Near back of village			
Additional Notes: None

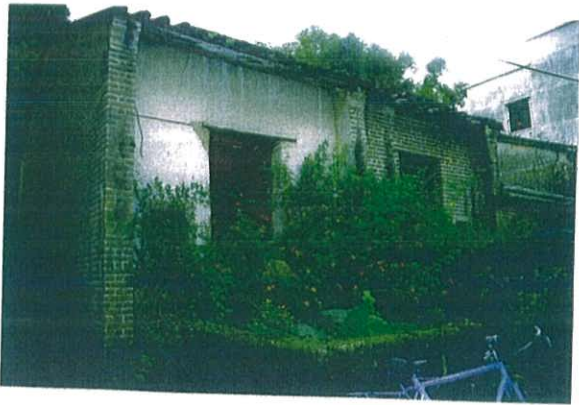
Location	Ng Uk Tsuen		
Ref	AAHB - 361	Construction Date	c 100 years
Recorded on	23 10 02	Condition	Fair
Updated on		Orientation	South west
Type	Courtyard style terrace (1 end, 1 mid)	Map Ref	#68
Present Use	Vacant	Past Uses	Residential
Historical Associations	None		
General Description: Grey brick walls, Double panel wooden doors with stone thresholds. Tile and concrete roof. Forecourts in front with low walls.			
Decorative Features: Moulding under eaves.			
Renovations: Render on façade of left unit. Window on façade of right unit. Wooden door frames.			
Setting: Near back of village.			
Additional Notes: Only rear sections of the buildings are intact. Front courtyard sections have been demolished.

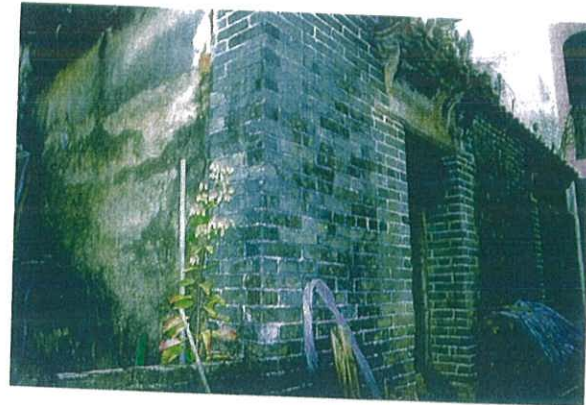
Location	Ng Uk Tsuen		
Ref	AAHB - 362	Construction Date	c 100 years
Recorded on	23 10 02	Condition	Poor
Updated on		Orientation	South west
Type	Courtyard style terrace units (2 mid)	Map Ref	N/A
Present Use	Abandoned	Past Uses	Residential
Historical Associations	None		
General Description: Green brick on façade and pounded earth on side and rear walls. Stone threshold. Part of roof remaining.			
Decorative Features: Moulded canopies in very poor condition.			
Renovations: Concrete on side wall over pounded earth.			
Setting: Near back of village.			
Additional Notes: None.

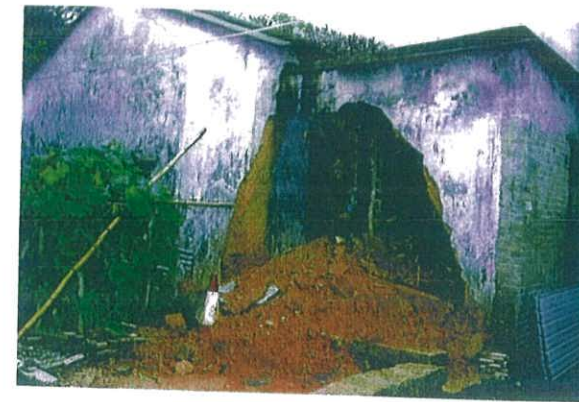
Location	Ng Uk Tsuen		
Ref	AAHB - 363	Construction Date	c 100 years
Recorded on	23 10 02	Condition	Run
Updated on		Orientation	South west
Type	Courtyard style terrace unit (1-end)	Map Ref	N/A
Present Use	Abandoned	Past Uses	Residential
Historical Associations	None		
General Description: Green and mixed brick façade with rammed earth side walls. Stone thresholds. Collapsing tile and cement roof. Left side wall collapsed.			
Decorative Features: None.			
Renovations: Concrete render on walls.			
Setting: Near back of village.			
Additional Notes: None.

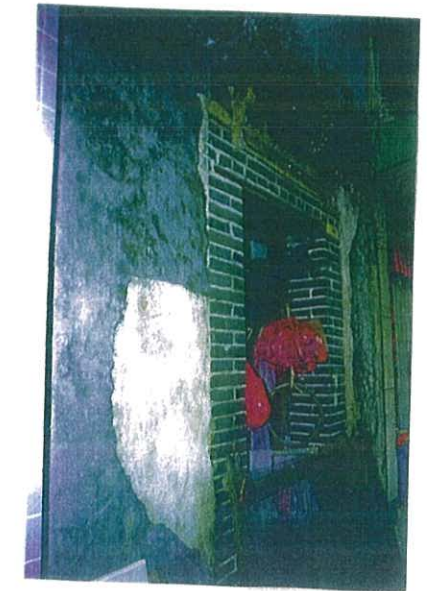
Location	Ng Uk Tsuen		
Ref	AAHB - 364	Construction Date	c 100 years
Recorded on	23 10 02	Condition	Very poor
Updated on		Orientation	South west
Type	Courtyard style terrace unit (1-mid)	Map Ref	#64
Present Use	Storage	Past Uses	Residential
Historical Associations	None		
General Description: Green brick walls stone threshold. Tile and concrete roof collapsing. tile and cement roof collapsing.			
Decorative Features: Moulded canopy, painted floral design.			
Renovations: Concrete covering on façade.			
Setting: Near back of village.			
Additional Notes: None.

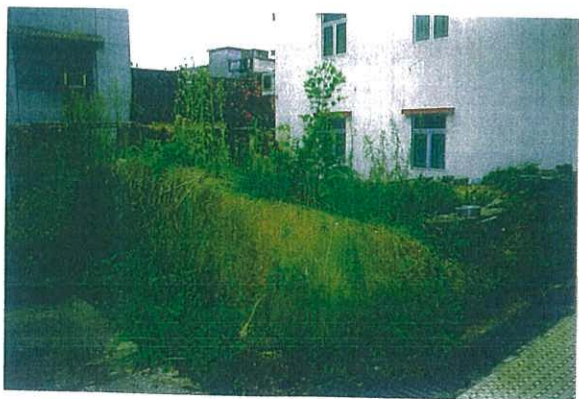
Location	Ng Uk Tsuen		
Ref	AAHB - 365	Construction Date	Unknown
Recorded on	23 10 02	Condition	Ruin
Updated on		Orientation	N/A
Type	Terrace units (1 mid, 1 end)	Map Ref.	N/A
Present Use	Abandoned	Past Uses	Residential?
Historical Associations	None		
General Description: Brick and pounded earth wall partially standing. Double panel wooden door/left unit. Right hand wall of thick pounded earth - above 1-1.5 M height remaining. Façade of green brick with corner stone on right end side.			
Decorative Features: None.			
Renovations: None.			
Setting: Near back of village.			
Additional Notes: None.

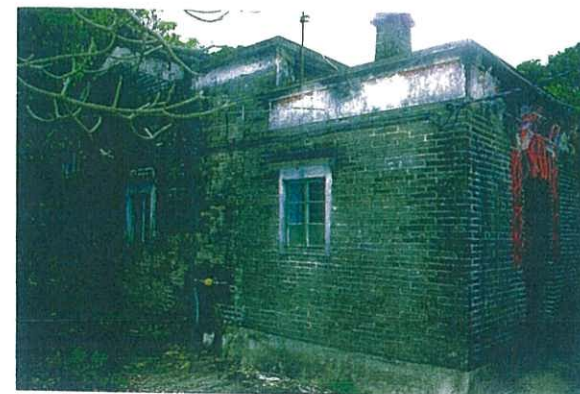
Location	Ng Uk Tsuen		
Ref	AAHB - 366	Construction Date	c 60 to 70 years
Recorded on	23 10 02	Condition	Fair
Updated on		Orientation	South west
Type	Courtyard style terrace unit (1-end)	Map Ref.	N/A
Present Use	Vacant	Past Uses	Residential
Historical Associations	None		
General Description: Green/ grey brick walls. Tile and concrete roof.			
Decorative Features: Plain painted (white) frieze under gable, moulded frieze on façade. Canopy, floral landscape pattern.			
Renovations: Concrete door frame/ doorstep/ lintel and metal door. Windows on left hand side. Stopped roof from front unit to main section.			
Setting: Near back of village.			
Additional Notes: None.

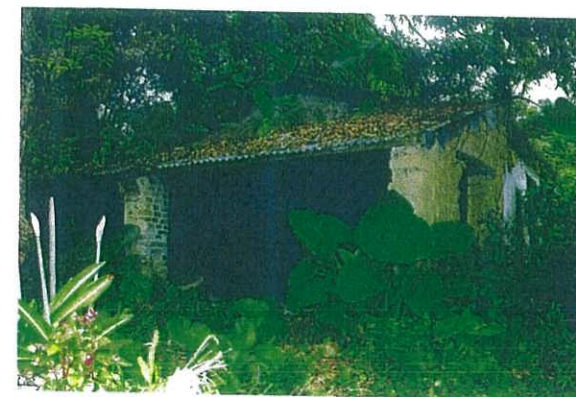
Location	Ng Uk Tsuen		
Ref	AAHB - 367	Construction Date	Unknown
Recorded on	23 10 02	Condition	Very poor
Updated on		Orientation	South west
Type	Detached structure	Map Ref.	N/A
Present Use	Abandoned	Past Uses	Residential
Historical Associations	None		
General Description: Green brick and mud brick walls. Tile and concrete roof.			
Decorative Features: None.			
Renovations: Metal roof and door. Two windows added on façade.			
Setting: At back of village.			
Additional Notes: None.

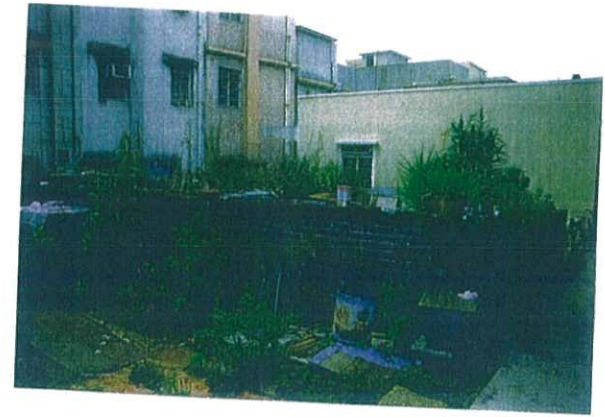
Location Ng Uk Tsuen			
Ref	AAHB - 370	Construction Date	Unknown
Recorded on	23 10 02	Condition	Run
Updated on		Orientation	N/A
Type	Terrace unit	Map Ref	N/A
General Description: Green brick walls, approx. 1.6 M with stone foundation. Part of side walls in mud brick render.			
Decorative Features: None			
Renovations: None			
Setting: Mid village			
Additional Notes: None

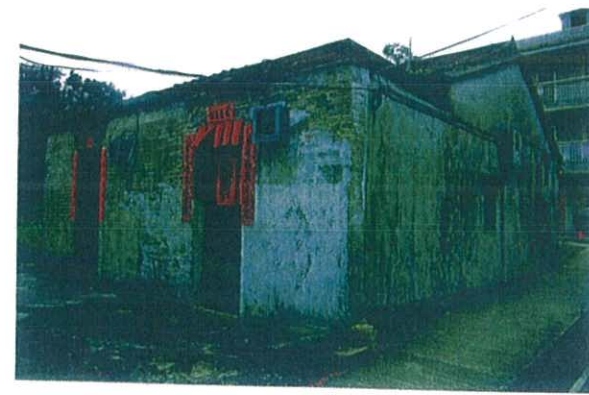
Location Ng Uk Tsuen			
Ref	AAHB - 371	Construction Date	c 100 years
Recorded on	23 10 02	Condition	Fair
Updated on		Orientation	South west
Type	Courtyard style terrace units (2-end)	Map Ref	#71
General Description: Grey brick walls. Grey bricks on façade are very eroded. Double panel wooden doors with stone thresholds. Rear wall of pounded earth with brick corners.			
Decorative Features: Canopies over each entrance and friezes in very poor condition.			
Renovations: Concrete covered side walls, pounded earth rear wall covered in concrete render. Electrical fittings added.			
Setting: At edge of village (middle)			
Additional Notes: None

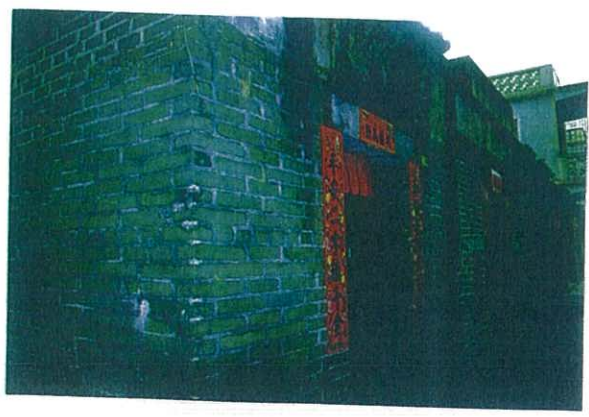
Location Ng Uk Tsuen			
Ref	AAHB - 373	Construction Date	c 100 years
Recorded on	23 10 02	Condition	Fair
Updated on		Orientation	South west
Type	Terrace units (2 end, 2 mid)	Map Ref	# 46 - 49
General Description: Green brick walls. Stone thresholds and lintels.			
Decorative Features: All except 2nd left hand unit have Canopies in fair condition. 2nd unit.			
Renovations: modern side windows in far left unit. One unit has concrete parapet.			
Setting: Mid village			
Additional Notes: None

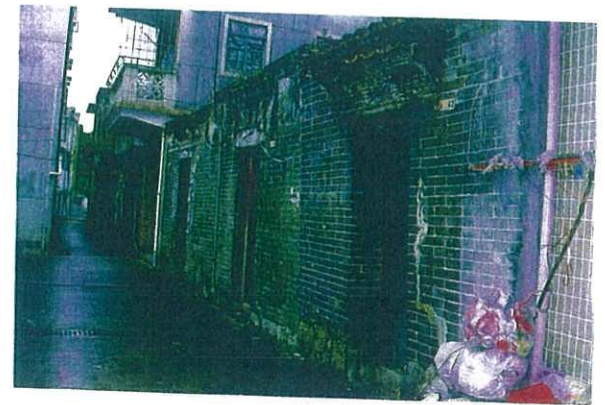
Location Ng Uk Tsuen			
Ref	AAHB - 374	Construction Date	c 100 years
Recorded on	23 10 02	Condition	Fair
Updated on		Orientation	South west
Type	Courtyard style terrace units (2 mid, 1 end)	Map Ref	#41, 42, 43 and 44
General Description: Green brick walls with stone thresholds, lintels and double panel wooden doors. Uncut stone foundation on one unit. Tile and cement roof.			
Decorative Features: Moulded and painted canopies, patterns obscured.			
Renovations: Concrete patching. Electrical fittings added. Metal door and concrete covering.			
Setting: Mid village			
Additional Notes: None

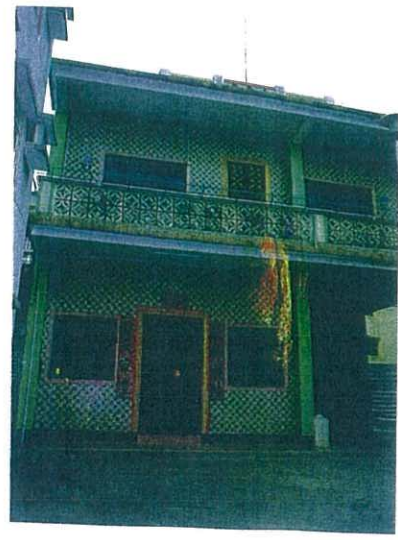
Location Ng Uk Tsuen			
Ref	AAHB - 375	Construction Date	Recent
Recorded on	23 10 02	Condition	Very good
Updated on		Orientation	South west
Type	Tsz tong	Map Ref	N/A
General Description: Large modern building, 2 storey, brown and cream tiles with green trim tile exterior balcony on 1st floor façade. Parapet and flag pole on roof. Windows with metal grilles.			
Decorative Features: Concrete parapet.			
Renovations: None			
Setting: At edge of village			
Additional Notes: None

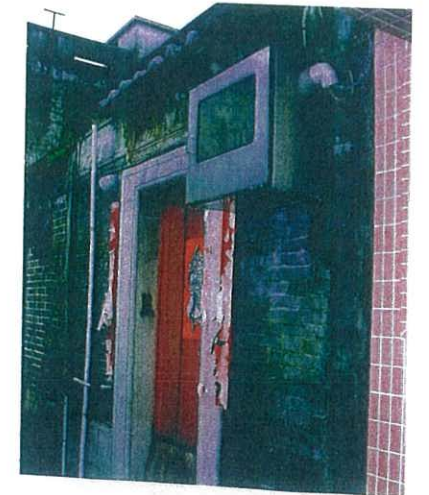
Location Ng Uk Tsuen			
Ref	AAHB - 376	Construction Date	c 100
Recorded on	23 10 02	Condition	Fair
Updated on		Orientation	South west
Type	Courtyard style terrace units (2-mid)	Map Ref	N/A
General Description: Green brick walls, stone thresholds. Tile and concrete roof.			
Decorative Features: Canopy over 1 unit entranceway, pattern indiscernible.			
Renovations: Roofs have been modified; right hand unit has modern concrete (pebble) frame and foundation. Concrete door frame.			
Setting: Mid village			
Additional Notes: None

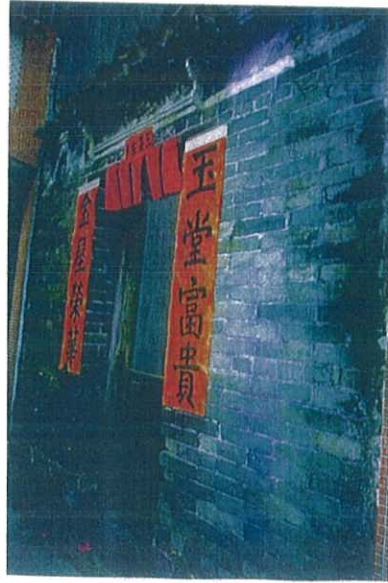
Location Ng Uk Tsuen			
Ref	AAHB - 378	Construction Date	c 100 years
Recorded on	23 10 02	Condition	Very poor
Updated on		Orientation	South west
Type	Courtyard style terraced unit (1-mid)	Map Ref	N/A
Present Use Abandoned			
Past Uses Residential			
Historical Associations None			
General Description: Green brick walls with stone foundation and doorstep. Tile and concrete roof at rear. front section has no roof.			
Decorative Features: Canopy above entrance, pattern indiscernible			
Renovations: Wooden door frame. Concrete patching			
Setting: Mid village			
Additional Notes: None

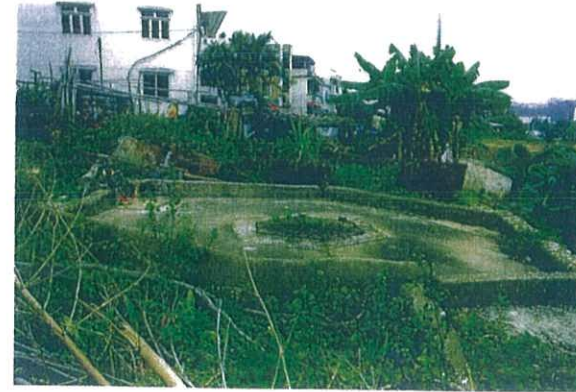
Location Ng Uk Tsuen			
Ref	AAHB - 379	Construction Date	Unknown
Recorded on	23 10 02	Condition	Good
Updated on		Orientation	N/A
Type	Wall	Map Ref	N/A
Present Use Unused			
Past Uses Well			
Historical Associations None			
General Description: Sides of well built up with granite worked blocks. 2 shrines + incense holders in front with orientation to South.			
Decorative Features: None			
Renovations: Concrete enclosure around well			
Setting: At front of village			
Additional Notes: None

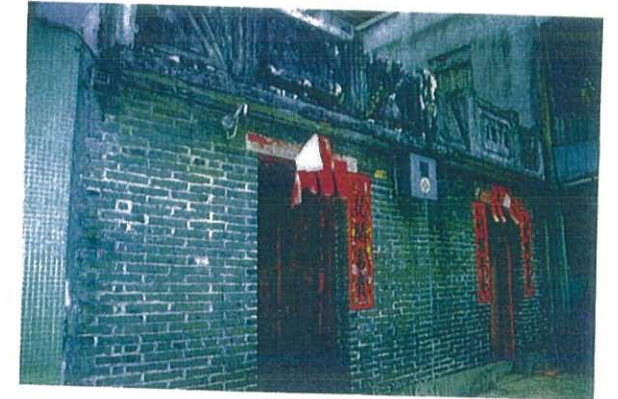
Location Ng Uk Tsuen			
Ref	AAHB - 380	Construction Date	c 100 years
Recorded on	23 10 02	Condition	Fair
Updated on		Orientation	South west
Type	Courtyard style terraced units (2-mid)	Map Ref	N/A
Present Use Vacant			
Past Uses Residential			
Historical Associations None			
General Description: Green brick walls. One double panel wooden door. Left hand unit has stone doorstep.			
Decorative Features: Concrete parapets with 1966 and 1972 dates			
Renovations: Left unit has concrete door frame, metal door and concrete render façade. right hand unit has concrete frame & doorstep, metal door and concrete render façade			
Setting: Near front of village			
Additional Notes: None

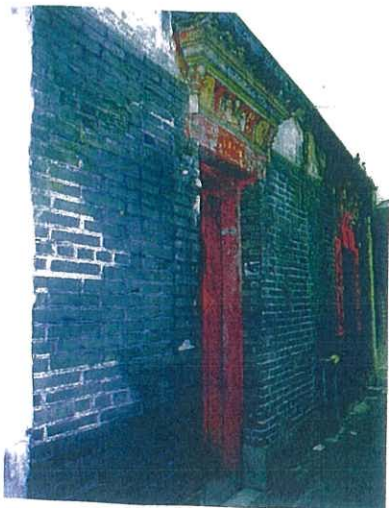
Location Ng Uk Tsuen			
Ref	AAHB - 381	Construction Date	c 100 years
Recorded on	23 10 02	Condition	Fair
Updated on		Orientation	South west
Type	Courtyard style terraced units (2-mid)	Map Ref	N/A
Present Use Storage			
Past Uses Residential			
Historical Associations None			
General Description: Green brick walls with lower walls of pounded earth earth. Stone thresholds.			
Decorative Features: Moulded canopies over doors, formerly painted bands under eaves of façade. Patterns indiscernible			
Renovations: Concrete and render patching. Wooden door frames and concrete threshold.			
Setting: Near front of village			
Additional Notes: None

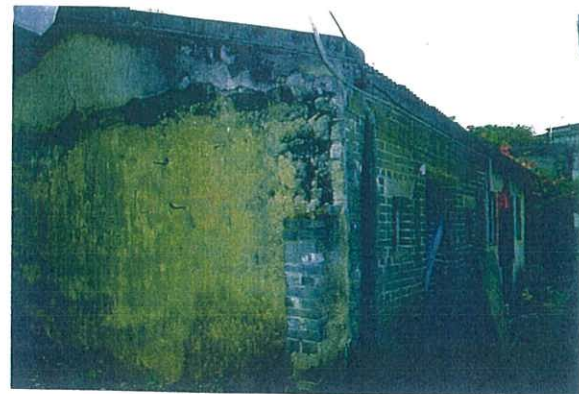
Location Ng Uk Tsuen			
Ref	AAHB - 382	Construction Date	c 100 years
Recorded on	23 10 02	Condition	Poor
Updated on		Orientation	South west
Type	Terrace units (7)	Map Ref	N/A
Present Use Abandoned			
Past Uses Residential			
Historical Associations None			
General Description: Single storey, single room units. Mixed building materials, bricks, pounded earth.			
Decorative Features: None			
Renovations: Windows, doors, concrete patching and render.			
Setting: Near front of village.			
Additional Notes: Local informants said the row was built during the Japanese Occupation.

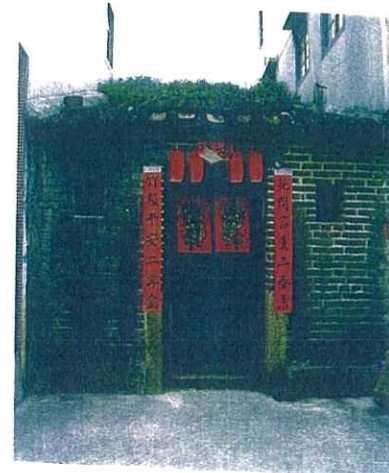
Location Ng Uk Tsuen			
Ref	AAHB - 383	Construction Date	c 60 to 70 years
Recorded on	23 10 02	Condition	Poor
Updated on		Orientation	South west
Type	Terrace unit	Map Ref	N/A
Present Use Storage			
Past Uses Residential			
Historical Associations None			
General Description: Green brick walls with stones for foundations. Cut granite 1/2 door frame. Tile and concrete roof. Double panel wooden door. Stone doorstep and brick lined eave. 2 small windows on façade.			
Decorative Features: None			
Renovations: Concrete lintel. Concrete around foundation.			
Setting: Near front of village			
Additional Notes: None

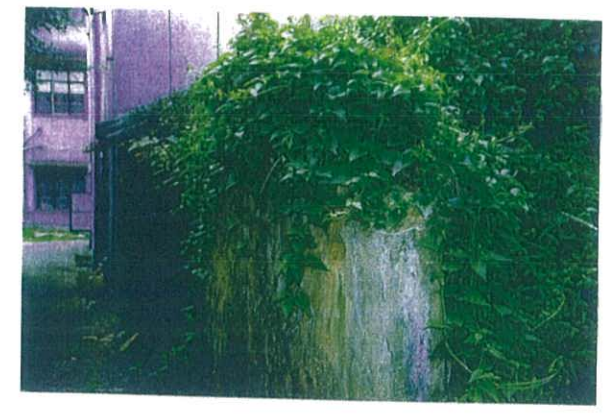
Location Ng Uk Tsuen			
Ref	AAHB - 386	Construction Date	Unknown
Recorded on	23 10 02	Condition	Ruin
Updated on		Orientation	N/A
Type	Terrace units	Map Ref	N/A
Present Use Abandoned			
Past Uses Residential?			
Historical Associations None			
General Description Mixed brick and pounded earth wall in portions. Portions of roof visible. Overgrown			
Decorative Features None			
Renovations None			
Setting Near front of village			
Additional Notes None

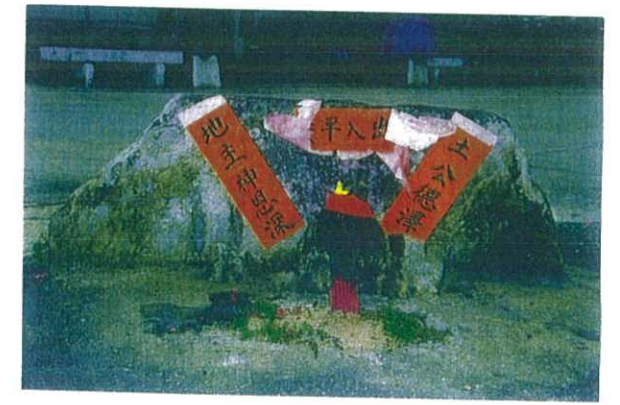
Location Ng Uk Tsuen			
Ref	AAHB - 388	Construction Date	Unknown
Recorded on	23 10 02	Condition	Fair
Updated on		Orientation	South west
Type	Earth God shrine	Map Ref	N/A
Present Use Shrine			
Past Uses Shrine			
Historical Associations None			
General Description Large rectangular stone at back with smaller stone (triangular in shape) in front. Small pot incense holder and sand in concrete in front of stones for incense			
Decorative Features None			
Renovations None			
Setting In road/ open and in front of rural committee building			
Additional Notes None

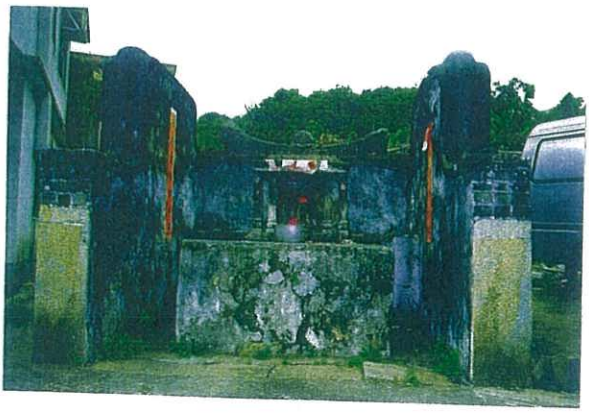
Location Ng Uk Tsuen			
Ref	AAHB - 389	Construction Date	Unknown
Recorded on	23 10 02	Condition	Fair
Updated on		Orientation	South west
Type	Pak Kung shrine	Map Ref	N/A
Present Use Shrine			
Past Uses Shrine			
Historical Associations None			
General Description Stone foundation and green brick enclosure on top, 'wok yee' style sides. Elaborate interior 'stone' in altar with enclosure. Stone inside enclosure, concrete covered stone platform. Cut blocks (stone) floor			
Decorative Features Concrete ridge decoration at top of rear wall			
Renovations Concrete patching			
Setting South east of village			
Additional Notes

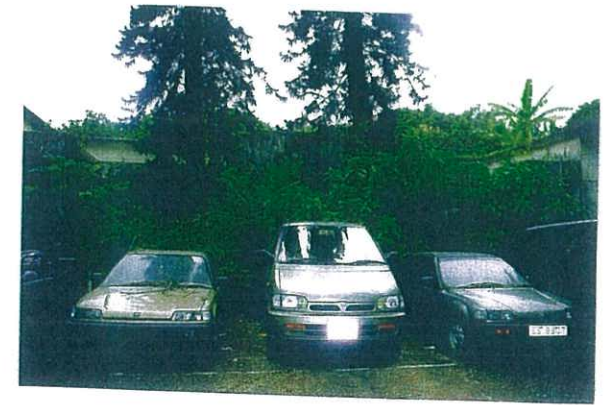
Location Ng Uk Tsuen			
Ref	AAHB - 390	Construction Date	c 1960
Recorded on	23 10 02	Condition	Fair
Updated on		Orientation	South east
Type	Kam Yan Public School 金仁公立學校	Map Ref	N/A
Present Use Abandoned			
Past Uses School			
Historical Associations None			
General Description Concrete platform, brick with concrete render in cream color. Large metal grill. 2 large pines in front of main entrance. Concrete foundation render			
Decorative Features None			
Renovations None			
Setting South east of village			
Additional Notes None

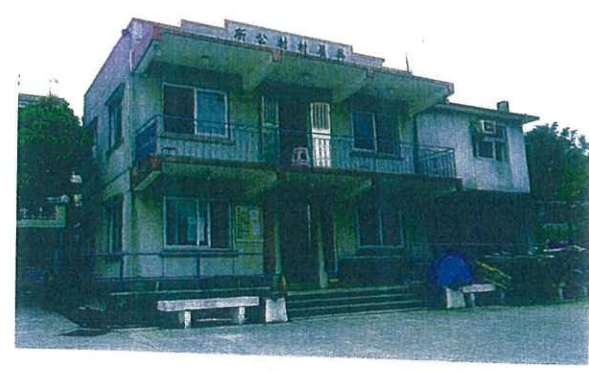
Location Ng Uk Tsuen			
Ref	AAHB - 391	Construction Date	Modern
Recorded on	23 10 02	Condition	Very good
Updated on		Orientation	South east
Type	Rural committee bldg 興區村公所	Map Ref	N/A
Present Use Rural committee building			
Past Uses Rural committee building			
Historical Associations None			
General Description Modern structure (1970) contains a shrine of General Tsang Kwok (鎮國將軍 (an ancestor)). Cannons set in concrete at entrance were salvaged from a shipwreck about 100 years ago			
Decorative Features Parapet with inscription on facade			
Renovations None			
Setting South east of village			
Additional Notes None

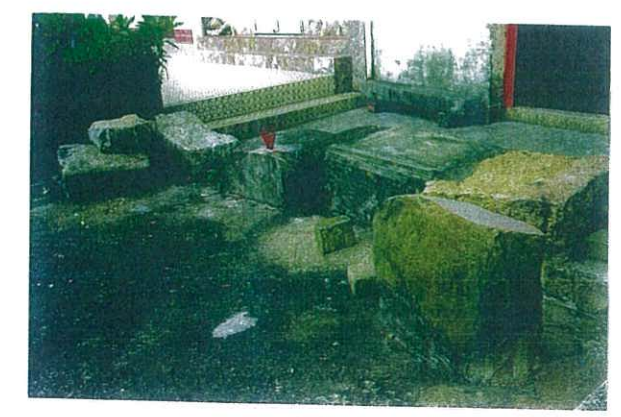
Location Ng Uk Tsuen			
Ref	AAHB - 392	Construction Date	Unknown
Recorded on	23 10 02	Condition	Fair
Updated on		Orientation	South west
Type	Shrine	Map Ref	N/A
Present Use Shrine			
Past Uses Shrine			
Historical Associations None			
General Description Concrete open area of former house site + sitting area with shrine. A group of building stone and moulded perforated block and block set in the concrete. Incense holder. Large whatstone set upright in concrete			
Decorative Features None			
Renovations None			
Setting Concrete covered open and sitting area in front of house			
Additional Notes None

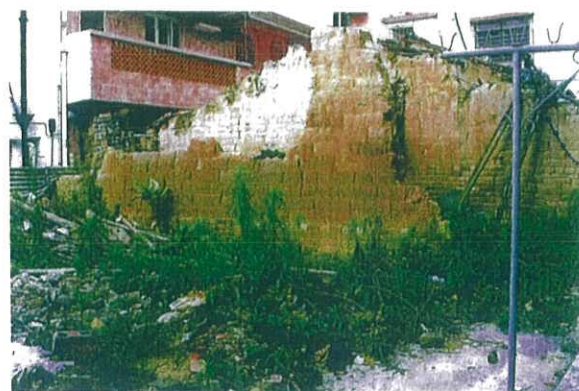
Location Fan Tin Tsuen, San Tin			
Ref AAHB 394	Construction Date c 100 years	Present Use Abandoned	
Recorded on 02 01 03	Condition Ruin	Past Uses Residential	
Updated on	Orientation N/A	Historical Associations None	
Type Village house	Map Ref N/A		
General Description Collapsed roof Portions of mud brick and green brick walls Overgrown			
Decorative Features None			
Renovations None			
Setting Mid village			
Additional Note None

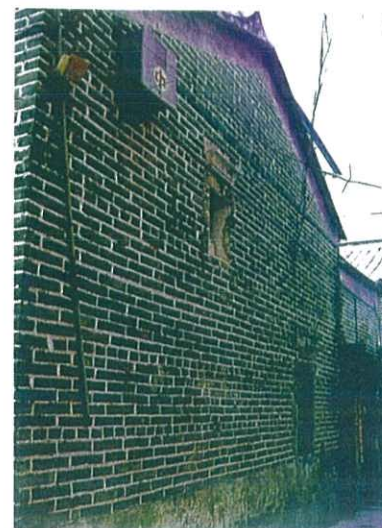
Location Fan Tin Tsuen, San Tin			
Ref AAHB - 395	Construction Date over 70 years	Present Use Residential	
Recorded on 02 01 03	Condition Fair	Past Uses Residential	
Updated on	Orientation North west	Historical Associations None	
Type Courtyard style terrace unit (end)	Map Ref #242B		
General Description Concrete and tile roof Green brick walls			
Decorative Features Plaster quoins on corners			
Renovations Metal door and windows in side wall Electrical fittings added			
Setting Mid village			
Additional Notes joined to another house by brick wall

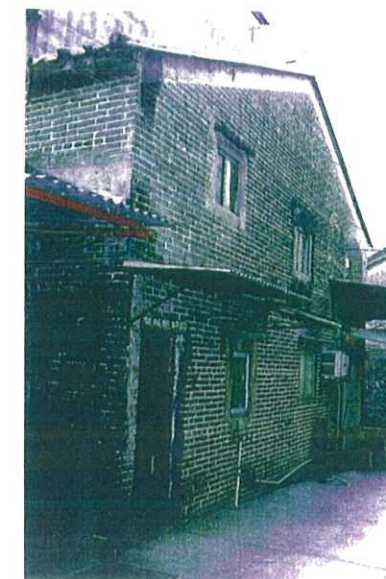
Location Fan Tin Tsuen, San Tin			
Ref AAHB 396	Construction Date c 70 years	Present Use Shop	
Recorded on 02 01 03	Condition Good	Past Uses Residential	
Updated on	Orientation North west	Historical Associations None	
Type Two storey house	Map Ref #242A		
General Description Tile and concrete roof Green brick walls			
Decorative Features None			
Renovations Metal door, windows and air con in side wall			
Setting Mid village			
Additional Notes None

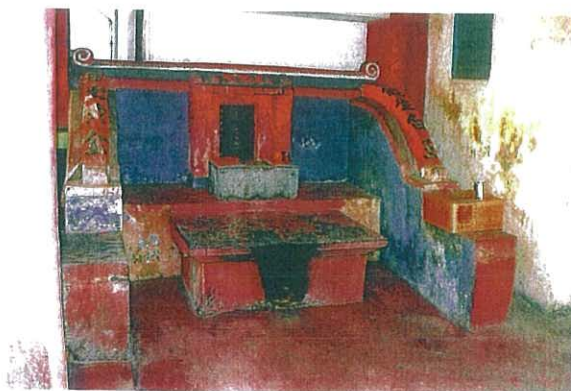
Location Fan Tin Tsuen, San Tin			
Ref AAHB - 398	Construction Date Modern	Present Use Shrine	
Recorded on 02 01 03	Condition Good	Past Uses Shrine	
Updated on	Orientation North west	Historical Associations None	
Type Village god shrine	Map Ref N/A		
General Description Concrete enclosure, painted grey with red trim Altar platform with burner in front			
Decorative Features Moulded scroll design on top rear			
Renovations None			
Setting Mid village			
Additional Notes inscription of shrine: 善田村總鄉土主善德之神

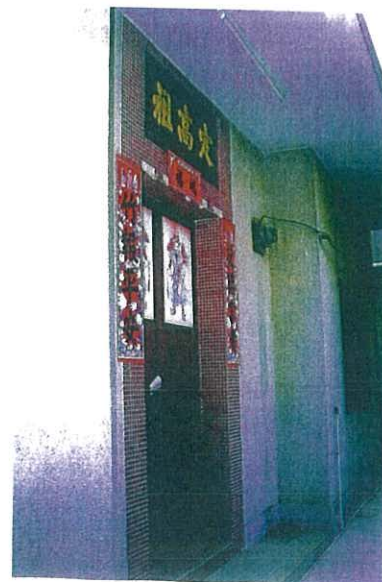
Location Fan Tin Tsuen, San Tin			
Ref AAHB - 399	Construction Date Modern	Present Use Tsz tong	
Recorded on 02 01 03	Condition Excellent	Past Uses Tsz tong	
Updated on	Orientation North west	Historical Associations None	
Type Tsz Tong (Man) 定高祖	Map Ref N/A		
General Description Modern tile and concrete building			
Decorative Features None			
Renovations Rebuilt structure			
Setting Mid village			
Additional Notes None

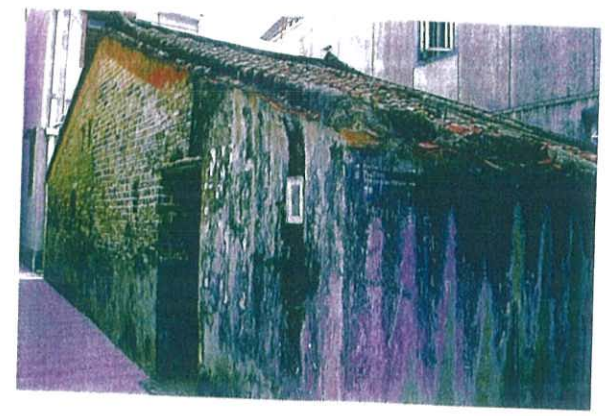
Location: Fan Tin Tsuen, San Tin		
Ref: AAHB - 401	Construction Date: c 100 years	Present Use: Abandoned
Recorded on: 02/01/03	Condition: Poor	Past Uses: Residential
Updated on:	Orientation: North west	Historical Associations: None
Type: Shed	Map Ref: #98	
General Description: Single storey, single room brick structure. Pitched roof, tile and concrete.		
Decorative Features: None		
Renovations: Concrete render on parts of walls		
Setting: Mid village		
Additional Notes: None

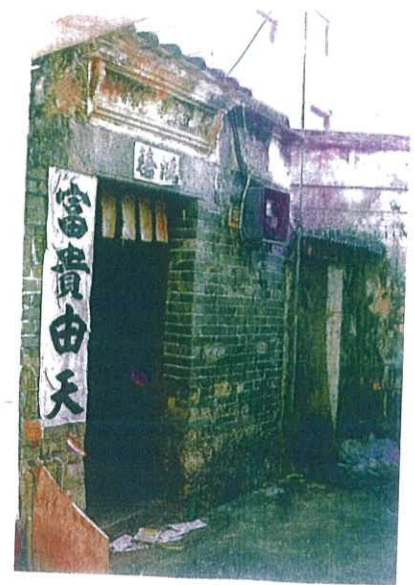
Location: Fan Tin Tsuen, San Tin		
Ref: AAHB - 402	Construction Date: c 100 years	Present Use: Storage/shrine
Recorded on: 02/01/03	Condition: Fair	Past Uses: Residential
Updated on:	Orientation: North west	Historical Associations: None
Type: Courtyard style terrace unit (mid)	Map Ref: #183	
General Description: Tile and concrete roof. Green brick walls. Granite lintel and threshold at entrance.		
Decorative Features: Canopy over entrance, pattern obscured.		
Renovations: Electrical fittings added.		
Setting: Mid village		
Additional Notes: None

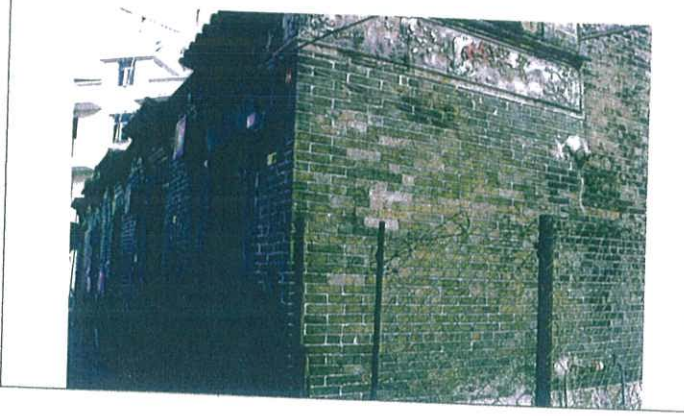
Location: Fan Tin Tsuen, San Tin		
Ref: AAHB - 403	Construction Date: c 100 years	Present Use: Residential
Recorded on: 02/01/03	Condition: Good	Past Uses: Residential
Updated on:	Orientation: North west	Historical Associations: None
Type: Courtyard style units (4 mid and 1 end)	Map Ref: # 217 - 221	
General Description: Tile and concrete roof. Green brick walls. Granite lintels and threshold stones.		
Decorative Features: Canopies over all entrances. Floral and landscape designs. Frieze panels on facade and side wall, landscape floral. All in very good condition. Plaster fish drain opening on side wall.		
Renovations: Concrete around foundation. Electrical outlets and lighting added.		
Setting: Mid village		
Additional Notes: A good example of complete row of traditional houses.

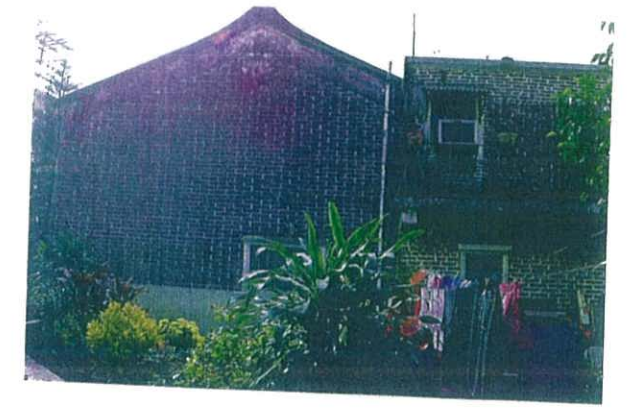
Location: Fan Tin Tsuen, San Tin		
Ref: AAHB - 404	Construction Date: Over 70 years	Present Use: Residential
Recorded on: 02/01/03	Condition: Good	Past Uses: Residential
Updated on:	Orientation: North west	Historical Associations: None
Type: Courtyard style terrace units (3 mid and 1 end)	Map Ref: #223	
General Description: Tile and concrete roof. Green brick walls with three courses of cut granite on lower wall, all around.		
Decorative Features: Ornate roof ridge. Canopies over all entrances. Gable oint moulding decoration and frieze panels.		
Renovations: Modern windows, doors and air cons added.		
Setting: Mid village		
Additional Notes: None

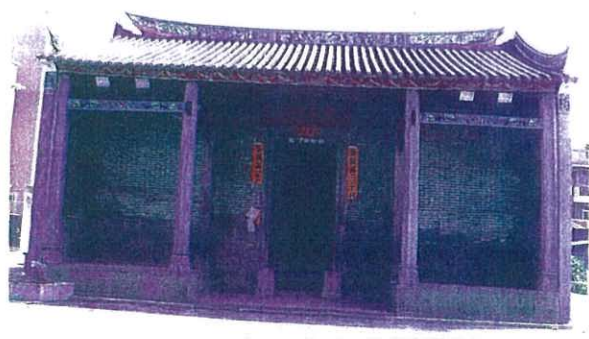
Location: Fan Tin Tsuen, San Tin		
Ref: AAHB - 405	Construction Date: mid 17th Century	Present Use: Tsz tong
Recorded on: 19/10/02	Condition: good	Past Uses: Tsz tong
Updated on:	Orientation: North west	Historical Associations: Man Family
Type: Man Lun Fung Tsz Tong	Map Ref:	
General Description: Traditional green brick Tsz Tong structure. Granite support columns. Cut granite courses along lower walls.		
Decorative Features: Ornate roof ridge, carved wooden panels, stone carving.		
Renovations: Restored structure.		
Setting: Front of village		
Additional Notes: None

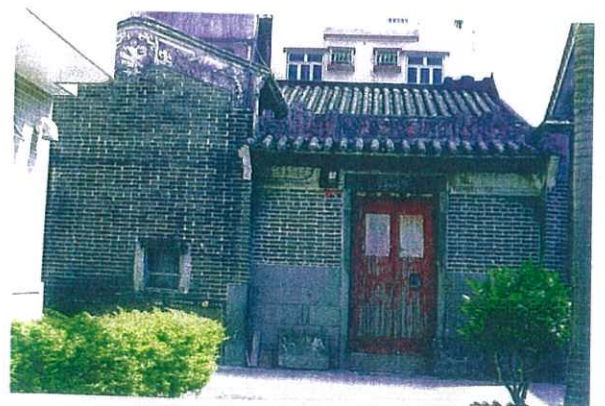
Location: Fan Tin Tsuen, San Tin		
Ref: AAHB - 405	Construction Date: c 150 years	Present Use: Unoccupied
Recorded on: 02/01/03	Condition: Good	Past Uses: Residential
Updated on:	Orientation: North west	Historical Associations: None
Type: Mansion	Map Ref: Beside Mig Yuen Tong	
General Description: L shaped green brick structure. Concrete and tile roof. Cut granite courses on lower walls. Granite door frame, carved lintel and threshold stones. Double panel wooden door.		
Decorative Features: Concrete parapet. Gable frieze and point decoration (geometric, floral and animals).		
Renovations: Electrical fittings.		
Setting: Mid village		
Additional Notes: A unique structure.

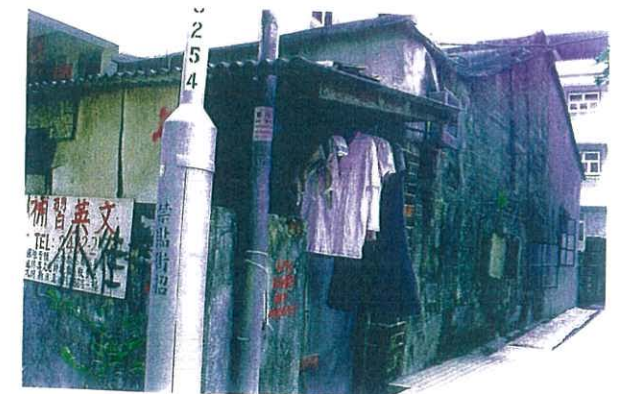
Location: Fan Tin Tsuen, San Tin		
Ref: AAHB - 408	Construction Date: c 100 years	Present Use: Residential
Recorded on: 19/10/02	Condition: Fair	Past Uses: Residential
Updated on:	Orientation: North west	Historical Associations: None
Type: Courtyard style terrace unit (1-end)	Map Ref: #201	
General Description: Tile and concrete roof. Grey and red brick walls.		
Decorative Features: None		
Renovations: Addition at front, windows, modern door.		
Setting: Mid village		
Additional Notes: None

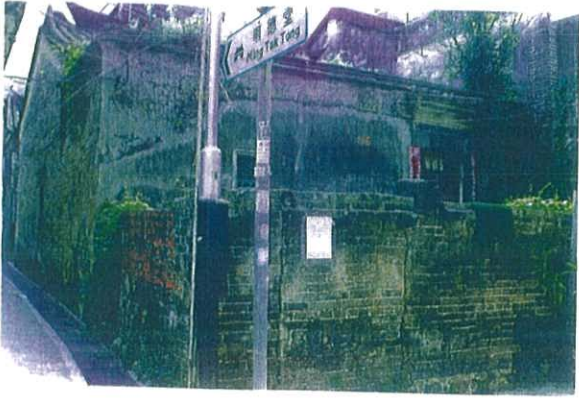
Location Fan Tin Tsuen, San Tin			
Ref AAHB 409	Construction Date c 100 years	Present Use Residential	
Recorded on 19/10/02	Condition Poor	Past Uses Residential	
Updated on	Orientation North west	Historical Associations None	
Type Courtyard style terrace unit (1-end)	Map Ref Across from #32		
General Description Tile and concrete roof. Green brick walls			
Decorative Features Green ceramic window grille on façade. Canopy over entrance, pattern obscured			
Renovations Concrete render on façade. Windows added			
Setting Mid village			
Additional Notes Originally two units, now joined together
