Drainage Services
Department

Agreement No.
CE 66/2001(EP)

EIA and TIA Studies for the
Stage 2 of PWP Item No.
215DS - Yuen Long and
Kam Tin Sewerage and
Sewage Disposal

Final Environmental Impact
Assessment

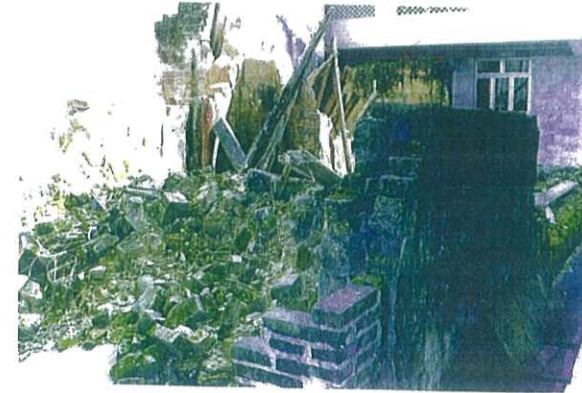
Location Fan Tin Tsuen, San Tin			
Ref AAHB 411	Construction Date Unknown	Present Use Abandoned	
Recorded on 19/10/02	Condition Ruin	Past Uses Residential	
Updated on	Orientation North west	Historical Associations None	
Type Village house	Map Ref Beside #208		
General Description portions of green brick and mud brick wall in a collapsed state			
Decorative Features None			
Renovations None			
Setting Mid village			
Additional Notes None

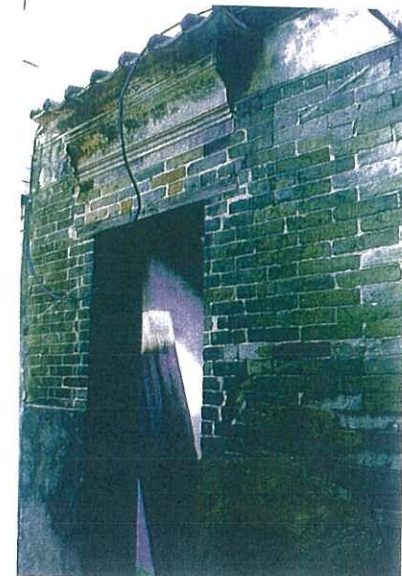
Location Fan Tin Tsuen, San Tin			
Ref AAHB 414	Construction Date c 100 years	Present Use Abandoned	
Recorded on 19/10/02	Condition Ruin	Past Uses Residential	
Updated on	Orientation North west	Historical Associations None	
Type Courtyard style terrace unit (mid)	Map Ref Beside #212		
General Description Tile and concrete roof. Green, grey brick walls. Double panel wooden door			
Decorative Features Canopy over entrance, pattern obscured. Gable frieze, geometric pattern			
Renovations Concrete patches on walls. Inner door sealed up. Window in rear wall			
Setting Mid village			
Additional Notes Whet stone set in concrete to right of entrance

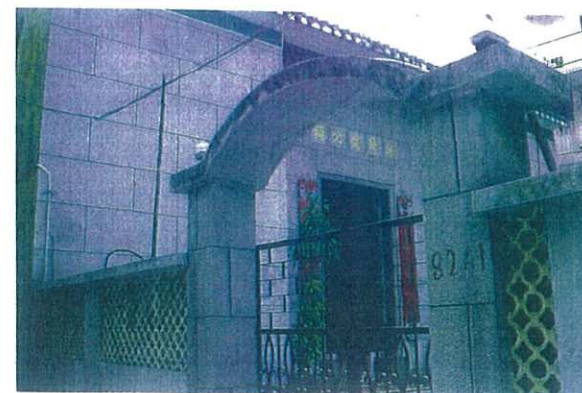
Location Fan Tin Tsuen			
Ref AAHB 415	Construction Date Modern	Present Use Ancestral hall	
Recorded on 19/10/02	Condition Excellent	Past Uses Ancestral hall	
Updated on	Orientation North west	Historical Associations None	
Type Ming Tak Tong (Wing Sau Man Ancestral Hall) 明德堂 (永秀文公祠)	Map Ref N/A		
General Description Modern reconstruction of Tsz Tong. Grey concrete			
Decorative Features Ceramic roof tiles. Ceramic frieze panels on facade			
Renovations Recent construction			
Setting Mid village			
Additional Notes None

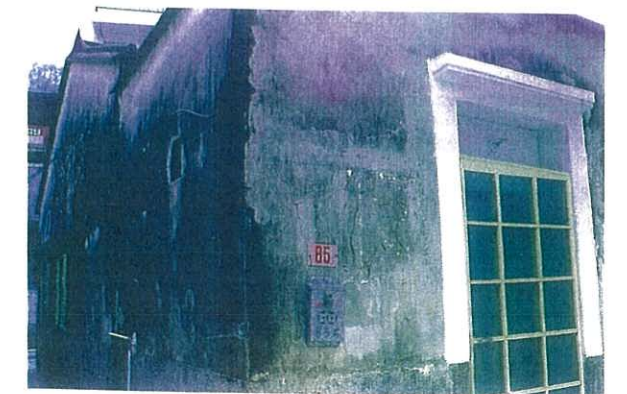
Location Fan Tin Tsuen			
Ref AAHB 416	Construction Date Over 50 years	Present Use Residential	
Recorded on 19/10/02	Condition Fair	Past Uses Residential	
Updated on	Orientation North west	Historical Associations None	
Type Courtyard style terrace unit and house	Map Ref # 85, 85A		
General Description Terrace unit has tile and concrete roof, granite courses on lower wall. Other unit is single storey red brick			
Decorative Features None			
Renovations Modern doors and windows. Electrical fittings			
Setting Mid village			
Additional Notes Graniteaving in courtyard

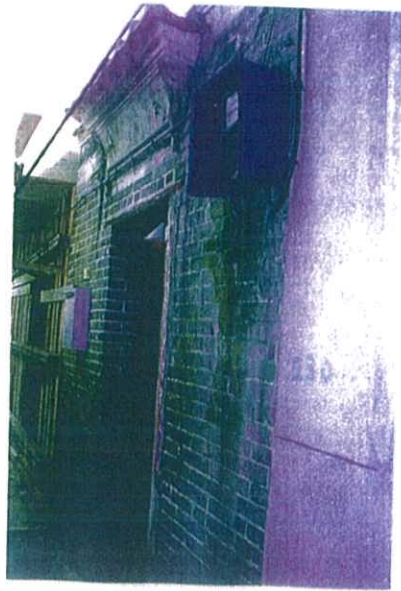
Location Fan Tin Tsuen			
Ref	AAHB - 417		
Recorded on	19 10 02	Construction Date	c 100 years
Updated on		Condition	Good
Type	Courtyard style terrace unit (1-mid)	Orientation	North west
		Map Ref	#225
Present Use Residential			
Past Uses Residential			
Historical Associations None			
General Description: Tile and concrete roof. Green brick walls.			
Decorative Features: Canopy pattern obscured.			
Renovations: Modern door. Electrical fittings.			
Setting: Mid village.			
Additional Notes: None.

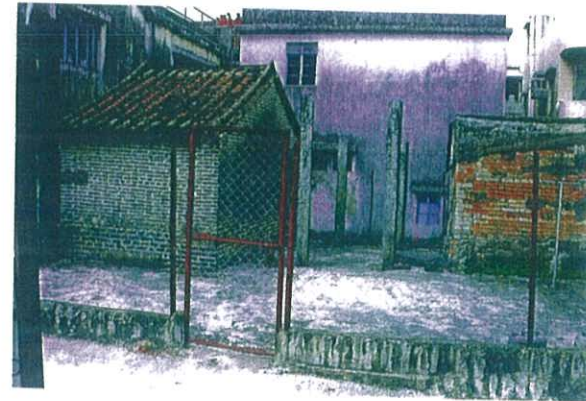
Location Fan Tin Tsuen			
Ref	AAHB - 418		
Recorded on	19 10 02	Construction Date	Unknown
Updated on		Condition	Good
Type	Pillars	Orientation	N/A
		Map Ref	Beide Ming Tak Tong
Present Use None			
Past Uses Structural			
Historical Associations None			
General Description: Cut granite pillars set in concrete platform with two brick sheds to either side.			
Decorative Features: None.			
Renovations: None.			
Setting: Mid village.			
Additional Notes: None.

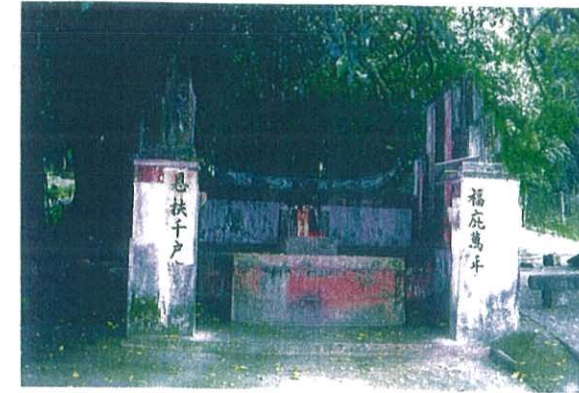
Location Fan Tin Tsuen			
Ref	AAHB - 419		
Recorded on	19 10 02	Construction Date	rebuilt 1962
Updated on		Condition	good
Type	Village god shrine	Orientation	North west
	運鄉社 (土地之神)	Map Ref	N/A
Present Use Shrine			
Past Uses Shrine			
Historical Associations None			
General Description: Large concrete shrine. Grey and red in colour with 'painted' bricks on interior.			
Decorative Features: Roof ridge style decoration at rear.			
Renovations: 1962.			
Setting: At edge of village path at base of San Tin Park.			
Additional Notes: 乾隆四十七年歲次壬寅九月初九癸亥日吉重修

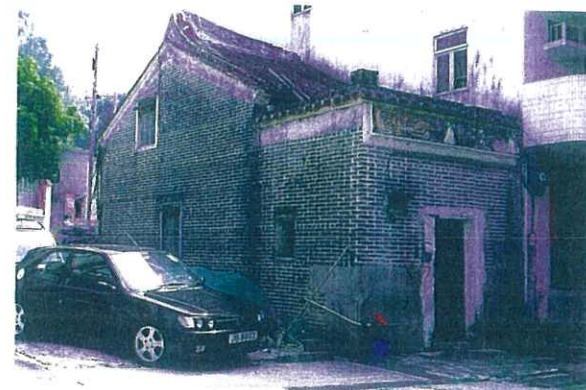
Location Fan Tin Tsuen			
Ref	AAHB - 422		
Recorded on	19 10 02	Construction Date	c 100 years
Updated on		Condition	Good
Type	Courtyard style terrace unit (1-end)	Orientation	North west
		Map Ref	# 77
Present Use Residential			
Past Uses Residential			
Historical Associations None			
General Description: Tile and concrete roof. Green brick walls with three courses of cut granite at front corners. Granite threshold.			
Decorative Features: Roof ridge. Frieze panel on façade, geometric and floral.			
Renovations: Windows and modern door.			
Setting: Rear of village.			
Additional Notes: None.

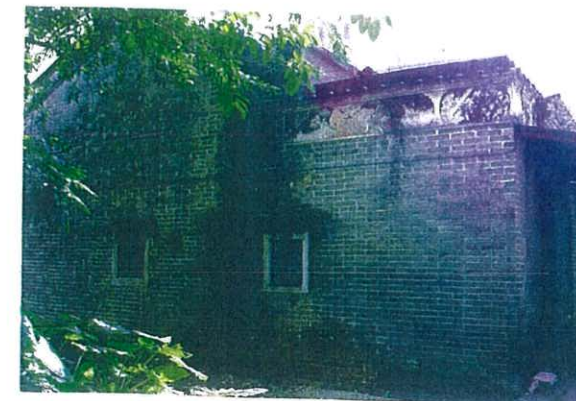
Location Fan Tin Tsuen			
Ref	AAHB - 423		
Recorded on	19 10 02	Construction Date	19 10 02
Updated on		Condition	Fair
Type	Courtyard style terrace unit (1-end)	Orientation	North west
		Map Ref	#81
Present Use Residential			
Past Uses Residential			
Historical Associations None			
General Description: Tile and concrete roof. Green brick walls. Granite lintel.			
Decorative Features: Moulded canopy and frieze panels, façade and side, floral and landscape patterns.			
Renovations: Modern windows and door.			
Setting: rear of village.			
Additional Notes: None.

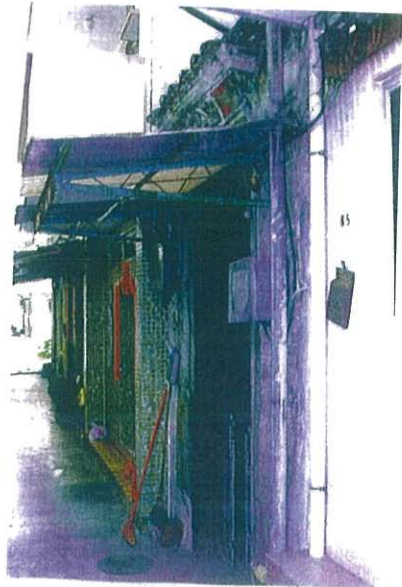
Location	Fan Tin Tsuen		
Ref	AAHB 425	Construction Date	c 100 years
Recorded on	19 10 02	Condition	Fair
Updated on		Orientation	North west
Type	Courtyard style terrace unit (1-mid)	Map Ref	# 84A
Present Use	Residential	Past Uses	Residential
Historical Associations: None			
General Description: Tile and concrete roof. Pale grey brick walls. Granite lintel and door frame.			
Decorative Features: Canopy over entrance, floral pattern.			
Renovations: Concrete patching on walls. Electrical fittings added.			
Setting: Mid village.			
Additional Notes: None.

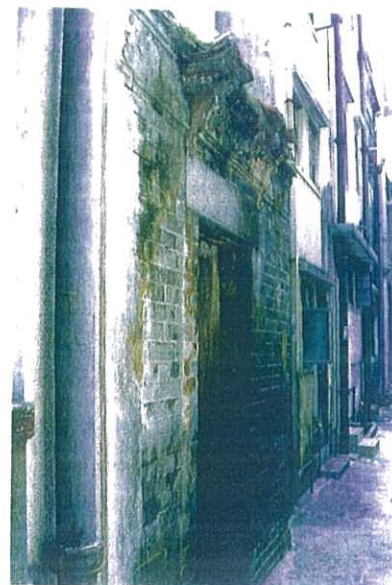
Location On Lung Tsuen, San Tin			
Ref AAHB - 456	Construction Date	Over 70 years	Present Use Abandoned
Recorded on 02/01/03	Condition	Very poor	Past Uses Residential
Updated on	Orientation	North	Historical Associations None
Type Courtyard style terrace unit (1-mid)	Map Ref	beside # 13	
General Description Tile and concrete roof with green brick walls. Granite lintel. Double panel wooden door.			
Decorative Features Canopy over entrance, floral and geometric pattern. Plain frieze.			
Renovations Wooden door frame. Concrete patches on walls in places.			
Setting Mid village.			
Additional Notes None.

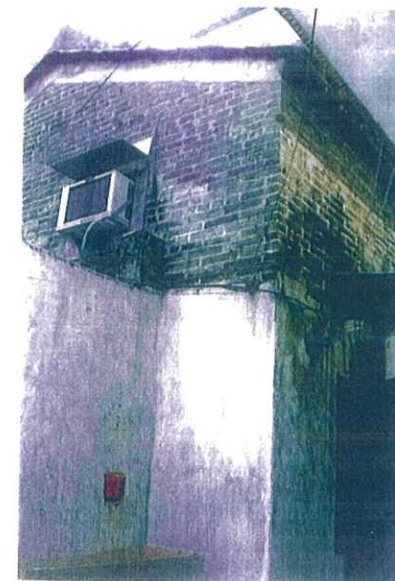
Location On Lung Tsuen, San Tin			
Ref AAHB - 457	Construction Date	Over 70 years	Present Use Residential
Recorded on 02/01/03	Condition	Good	Past Uses Residential
Updated on	Orientation	North	Historical Associations None
Type Courtyard style terrace units (2-mid)	Map Ref	N/A	
General Description Tile and concrete roof. Green brick walls.			
Decorative Features One canopy, inscription pattern.			
Renovations Windows, aircon, modern doors added.			
Setting Mid village.			
Additional Notes None.

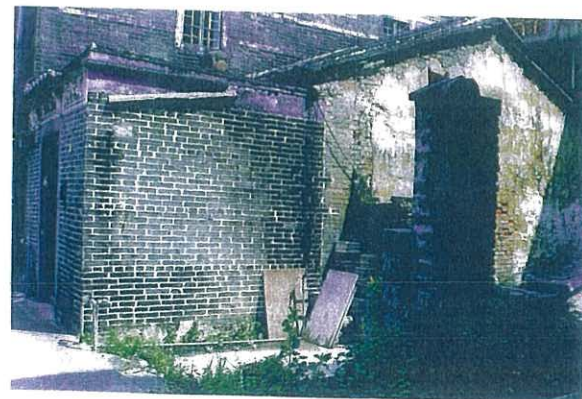
Location On Lung Tsuen			
Ref AAHB - 459	Construction Date	Over 70 years	Present Use Residential
Recorded on 02/01/03	Condition	Good	Past Uses Residential
Updated on	Orientation	North	Historical Associations None
Type Courtyard style terrace unit (1-end)	Map Ref	N/A	
General Description Tile and concrete roof. Green brick walls. Granite door frame.			
Decorative Features Canopy over entrance, floral pattern. Frieze panel on façade, floral pattern.			
Renovations Front of unit has been built up. Concrete patches.			
Setting Mid village.			
Additional Notes None.

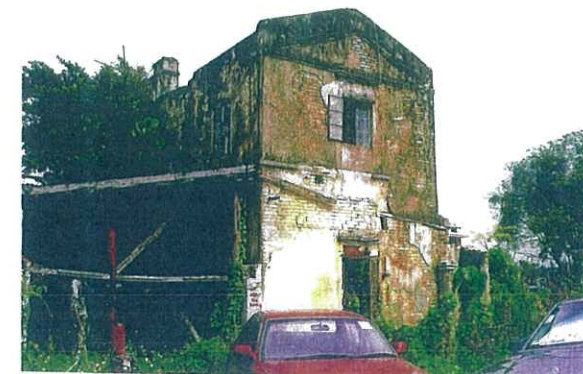
Location Wing Ping Tsuen			
Ref AAHB - 461	Construction Date	c 1930's	Present Use Abandoned
Recorded on 02/01/03	Condition	Very poor	Past Uses Residential
Updated on	Orientation	South	Historical Associations None
Type 2 story house and compound	Map Ref	Across from Tai Fu Tai	
General Description Green brick walls with concrete render. Windows with metal grilles. Number of smaller brick structures in compound.			
Decorative Features Moulding on gable.			
Renovations None.			
Setting In overgrown area at edge of village.			
Additional Notes None.

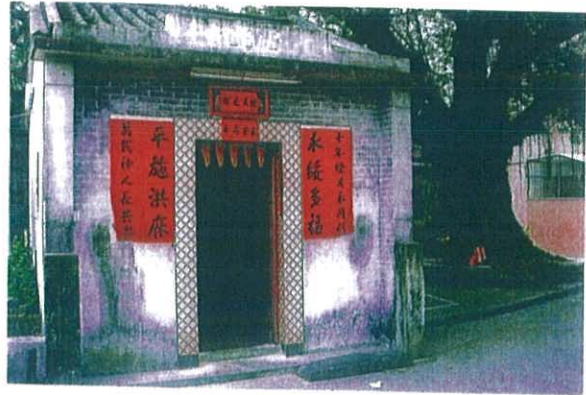
Location Wing Ping Tsuen, San Tin			
Ref	AAHB - 462	Construction Date	Unknown
Recorded on	02 01 03	Condition	Fair
Updated on		Orientation	East
Type	Gods hall + tree shrine	Map Ref	In front of Tai Fu Tai
Present Use		Gods hall / tree shrine	
Past Uses		Shrine / gods hall	
Historical Associations		None	
General Description: Single room hall with painted brick exterior. Piers on either end of façade and concrete roof.			
Decorative Features: Modern tile door frame.			
Renovations: Recent.			
Setting: Open area near large Banyan tree.			
Additional Notes: None.

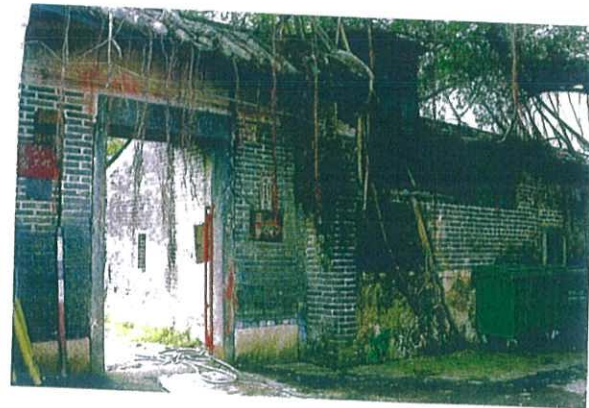
Location Wing Ping Tsuen, San Tin			
Ref	AAHB - 463	Construction Date	Unknown
Recorded on	02 01 03	Condition	Fair
Updated on		Orientation	North
Type	Gate of Tai Fu Tai	Map Ref	N/A
Present Use		Gate	
Past Uses		Gate	
Historical Associations		None	
General Description: Green brick gate with attached structure. Granite lintel.			
Decorative Features: Moulding under eaves.			
Renovations: None.			
Setting: Near gods hall.			
Additional Notes: None.

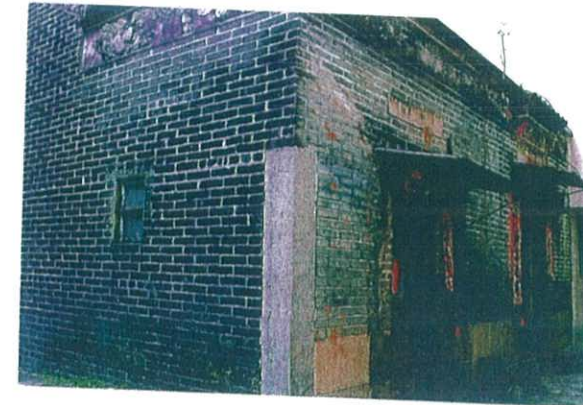
Location Wing Ping Tsuen, San Tin			
Ref	AAHB - 464	Construction Date	c 100 years
Recorded on	02 01 03	Condition	Fair
Updated on		Orientation	South
Type	Courtyard style terrace units (1 mid and 1 end)	Map Ref	
Present Use		Residential	
Past Uses		Residential	
Historical Associations		None	
General Description: Tile and concrete roof. Green brick walls with granite courses on lower façade walls. Large granite corner stone. Granite lintel and door frame.			
Decorative Features: One canopy with scholar pattern. Decorative frieze on façade and front side with landscape pattern.			
Renovations: Metal awnings over entrances. Electrical fittings.			
Setting: Mid village.			
Additional Notes: None.

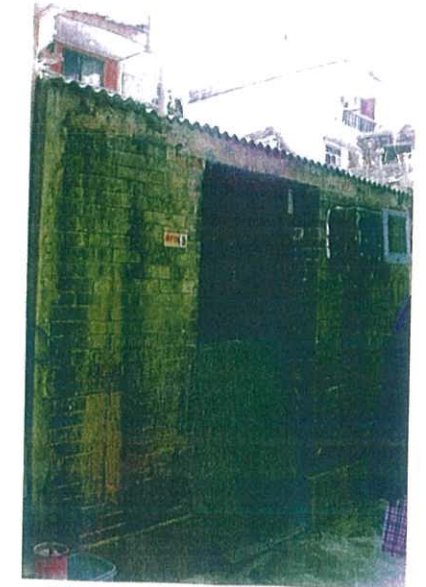
Location Wing Ping Tsuen, San Tin			
Ref	AAHB - 465	Construction Date	Pre 1950
Recorded on	02 01 03	Condition	Poor
Updated on		Orientation	South
Type	Courtyard style unit (mid)	Map Ref	# 48
Present Use		Residential	
Past Uses		Residential	
Historical Associations		None	
General Description: Grey brick walls.			
Decorative Features: None.			
Renovations: Modern roof. Modern door. Electrical fittings.			
Setting: Mid village.			
Additional Notes: None.

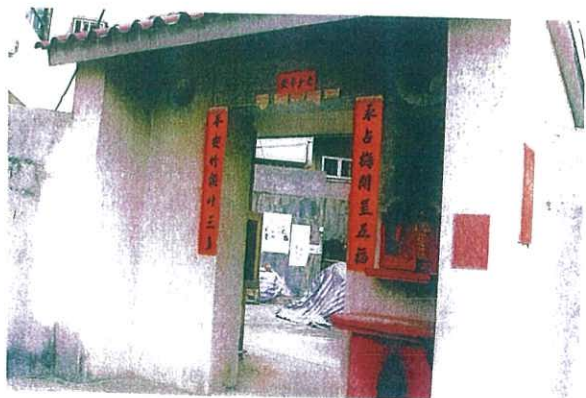
Location Wing Ping Tsuen, San Tin			
Ref	AAHB - 466	Construction Date	Modern
Recorded on	02 01 03	Condition	Excellent
Updated on		Orientation	South east
Type	Village gate	Map Ref	beside # 65
Present Use		Gate	
Past Uses		Gate	
Historical Associations		None	
General Description: Modern concrete gate with two circular openings at either side of top.			
Decorative Features: Small alcove for incense holder.			
Renovations: Recently built.			
Setting: At edge of village.			
Additional Notes: None.

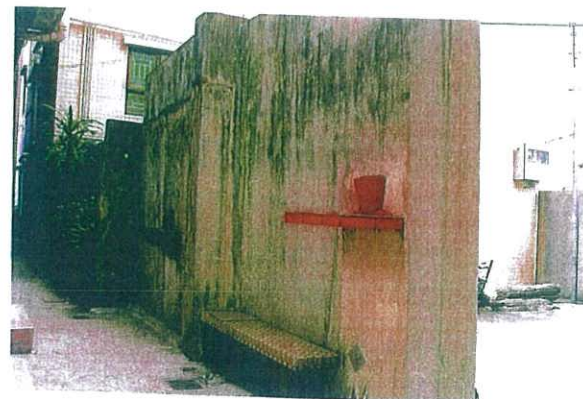
Location Wing Ping Tsuen, San Tin			
Ref	AAHB - 467	Construction Date	Modern
Recorded on	02 01 03	Condition	Good
Updated on		Orientation	Running north/south in front of # 53 - 55
Type	Fung shui wall	Map Ref	
Present Use		Fung shui wall	
Past Uses		Fung shui wall	
Historical Associations		None	
General Description: Concrete wall approx. 2 metres tall with ledge for incense holder.			
Decorative Features: None.			
Renovations: Recent concrete covering.			
Setting: Mid village.			
Additional Notes: None.

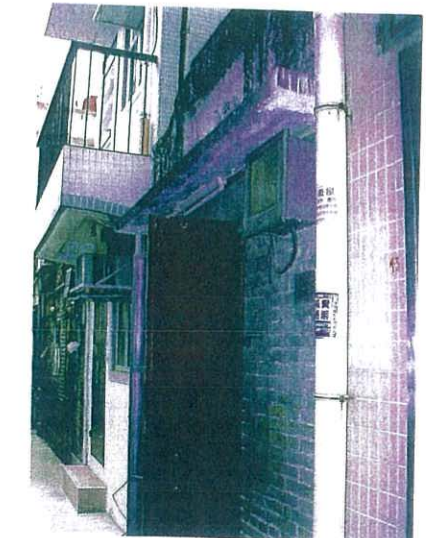
Location Wing Ping Tsuen, San Tin			
Ref	AAHB - 469	Construction Date	c. 70 - 80 years
Recorded on	02 01 03	Condition	Fair
Updated on		Orientation	South
Type	1 terrace unit (mid)	Map Ref	# 42
Present Use		Residential	
Past Uses		Residential	
Historical Associations		None	
General Description: Tile and concrete roof. Grey brick walls.			
Decorative Features: None.			
Renovations: Concrete parapet added on façade. Modern metal door at entrance.			
Setting: Mid village.			
Additional Notes: None.

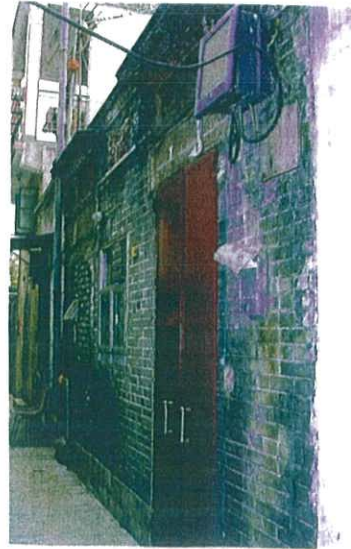
Location Wing Ping Tsuen, San Tin			
Ref AAHB - 470	Construction Date c 70 - 80 years	Present Use Vacant	
Recorded on 02 01 03	Condition poor	Past Uses Residential	
Updated on	Orientation South	Historical Associations None	
Type 2 terrace units	Map Ref # 40		
General Description Tile and concrete roof. Gray brick walls. Granite lintels.			
Decorative Features Two canopies, domestic, floral and bat motif. Frieze on façade with floral motif.			
Renovations One door removed and replaced with modern window.			
Setting Mid village.			
Additional Notes None.

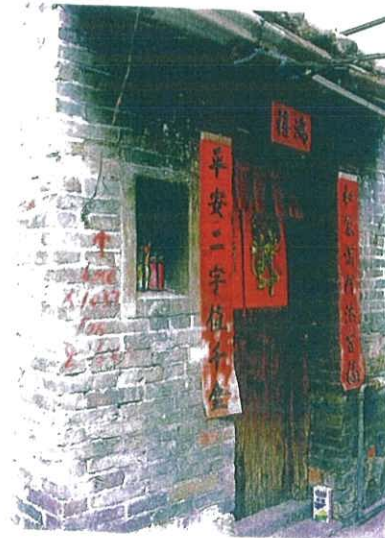
Location Wing Ping Tsuen, San Tin			
Ref AAHB - 472	Construction Date c 70 years	Present Use Storage	
Recorded on 02 01 03	Condition Poor	Past Uses Residential	
Updated on	Orientation South	Historical Associations None	
Type Terrace house (end)	Map Ref beside # 55		
General Description Cut stone foundation. Gray brick walls, single pitched roof. Double panel wooden door.			
Decorative Features Moulding under eaves on façade.			
Renovations Window on façade wall.			
Setting Mid village.			
Additional Notes None.

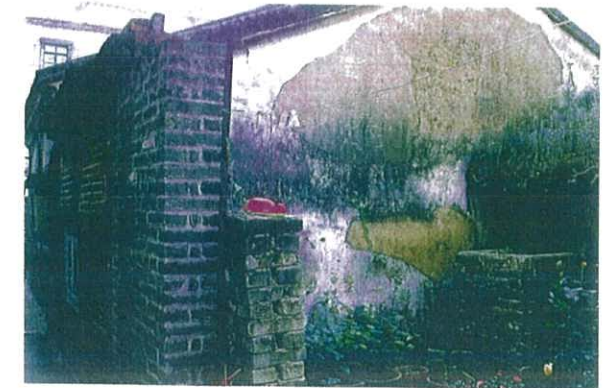
Location Wing Ping Tsuen, San Tin			
Ref AAHB - 473	Construction Date c 70 - 80 years	Present Use Storage	
Recorded on 02 01 03	Condition Poor	Past Usage Residential	
Updated on	Orientation South	Historical Associations None	
Type Courtyard style terrace units (3 mid)	Map Ref # 37, 37A		
General Description Tile and concrete roof. Gray brick walls.			
Decorative Features Canopies, three, domestic, geometric, floral and landscape patterns.			
Renovations Windows, air cons and doors added.			
Setting Mid village.			
Additional Notes None.

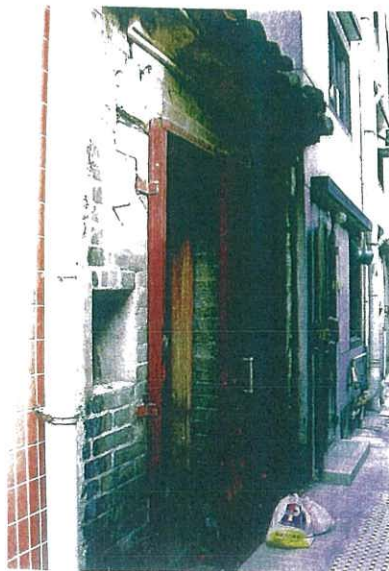
Location Wing Ping Tsuen, San Tin			
Ref AAHB - 474	Construction Date over 100 years	Present Use Abandoned	
Recorded on 02 01 03	Condition ruin	Past Uses Residential	
Updated on	Orientation South	Historical Associations None	
Type Courtyard style terrace unit	Map Ref beside # 55		
General Description Tile and concrete roof. Gray brick walls.			
Decorative Features Moulding under eaves on façade.			
Renovations Modern door and window.			
Setting Mid village.			
Additional Notes None.

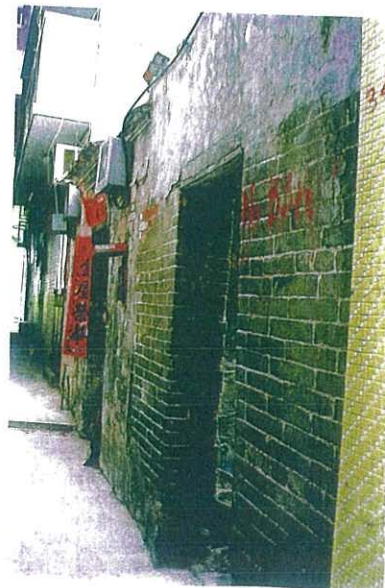
Location Wing Ping Tsuen, San Tin			
Ref AAHB - 475	Construction Date c 70 - 80 years	Present Use Storage	
Recorded on 02 01 03	Condition Ruin	Past Uses Residential	
Updated on	Orientation South	Historical Associations None	
Type Courtyard style terrace units (2 mid)	Map Ref in front of 32A		
General Description Tile and concrete roof. Green brick walls.			
Decorative Features One canopy with obscured pattern.			
Renovations None.			
Setting Mid village.			
Additional Notes None.

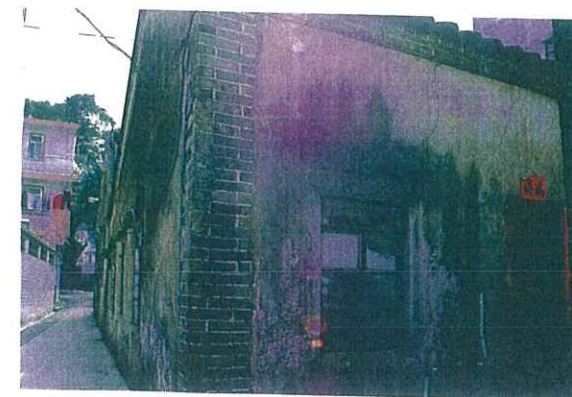
Location Wing Ping Tsuen, San Tin			
Ref AAHB - 476	Construction Date Pre 1950	Present Use Residential	
Recorded on 02 01 03	Condition Fair	Past Uses Residential	
Updated on	Orientation South	Historical Associations None	
Type Village house	Map Ref # 16B		
General Description Large brick and concrete structure. Metal framed and gridded windows. Tile and concrete roof.			
Decorative Features Moulding under eaves.			
Renovations Concrete patching on walls.			
Setting Near front of village.			
Additional Notes None.

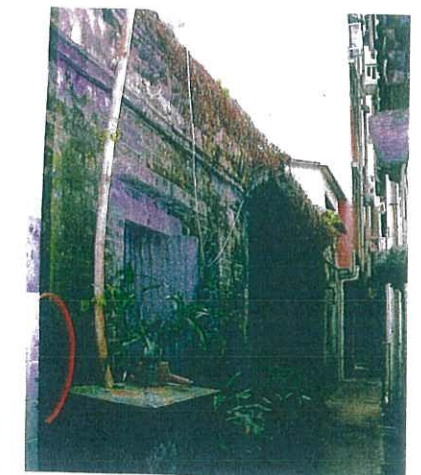
Location Wing Ping Tsuen, San Tin			
Ref AAHB - 477	Construction Date c 70 - 80 years	Present Use Abandoned	
Recorded on 02 01 03	Condition Fair	Past Uses Residential	
Updated on	Orientation South	Historical Associations None	
Type Village house	Map Ref Behind 16B		
General Description Green brick house with courtyard.			
Decorative Features Moulding under eaves.			
Renovations Concrete patches on walls.			
Setting Near edge of village.			
Additional Notes None.

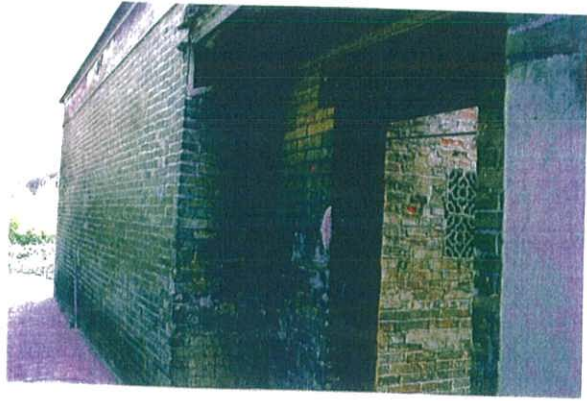
Location: Wing Ping Tsuen, San Tin			
Ref: AAHB - 476	Construction Date: c 100 years	Present Use: Abandoned	
Recorded on: 02 01 03	Condition: Ruin	Past Uses: Residential	
Updated on:	Orientation: South east	Historical Associations: None	
Type: Village house	Map Ref: beside # 29		
General Description: Large green brick house and compound			
Decorative Features: Ceramic window grilles			
Renovations: None			
Setting: Near edge of village			
Additional Notes: None

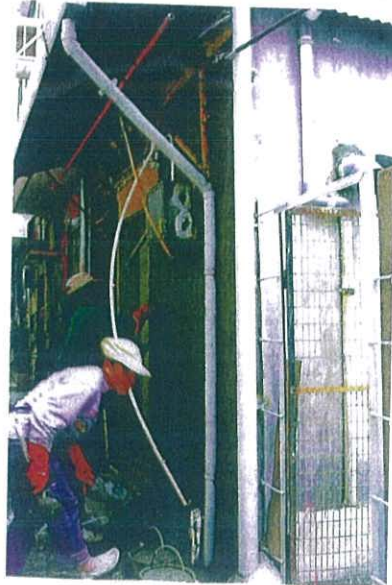
Location: Wing Ping Tsuen, San Tin			
Ref: AAHB - 479	Construction Date: unknown	Present Use: Residential	
Recorded on: 02 01 03	Condition: completely renovated	Past Uses: Residential	
Updated on:	Orientation: South	Historical Associations: None	
Type: village house	Map Ref: # 8		
General Description: Completely renovated structure only old feature is canopy over door			
Decorative Features: Canopy over door. Painted yellow			
Renovations: Ongoing			
Setting: Mid village			
Additional Notes: None

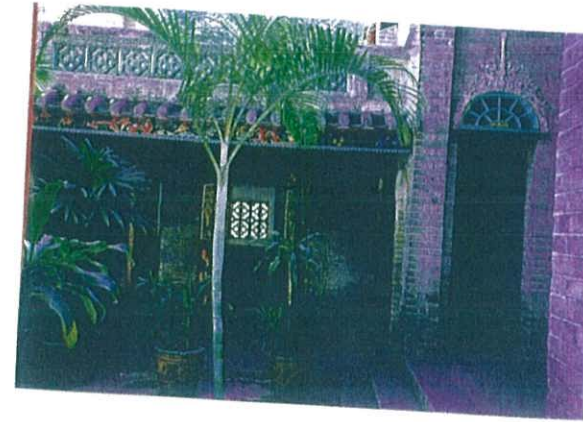
Location: Wing Ping Tsuen, San Tin			
Ref: AAHB - 490	Construction Date: 19th century	Present Use: Declared Monument	
Recorded on: 02 01 03	Condition: Very good	Past Uses: Residential	
Updated on:	Orientation: South	Historical Associations: None	
Type: Tai Fu Tai 大夫第	Map Ref: N/A		
General Description: Large mansion, green brick			
Decorative Features: Ceramic roof decorations, roof ridge, carved stone and wooden boards			
Renovations: Professionally renovated			
Setting: In compound near edge of historical village			
Additional Notes: Declared Monument

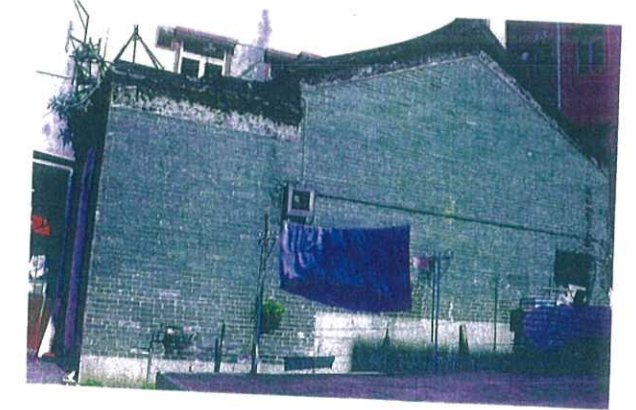
Location: San Lung Tsuen			
Ref: AAHB - 481	Construction Date: c 70 to 80 years	Present Use: Residential	
Recorded on: 19 10 02	Condition: Good	Past Uses: Residential	
Updated on:	Orientation: North west	Historical Associations: None	
Type: Courtyard style terrace unit (1-end)	Map Ref: # 12		
General Description: Tile and concrete roof. Green brick walls. Cut granite courses along lower part of wall. Granite lintels			
Decorative Features: Canopy over entrance, floral, geometric pattern and poem. Moulding under eaves on rear wall			
Renovations:			
Setting: Mid village			
Additional Notes: None

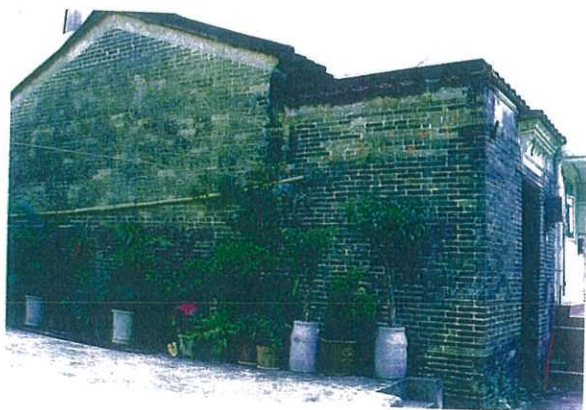
Location: San Lung Tsuen, San Tin			
Ref: AAHB - 482	Construction Date: c 70 to 80 years	Present Use: Abandoned	
Recorded on: 19 10 02	Condition: Good	Past Uses: Residential	
Updated on:	Orientation: North west	Historical Associations: None	
Type: Courtyard style terrace unit (1-end)	Map Ref: # 11		
General Description: Tile and concrete roof. Green brick walls			
Decorative Features: Canopy over entrance, inscription and mythical creatures. Plain frieze panels			
Renovations: None			
Setting: Mid village			
Additional Notes: None

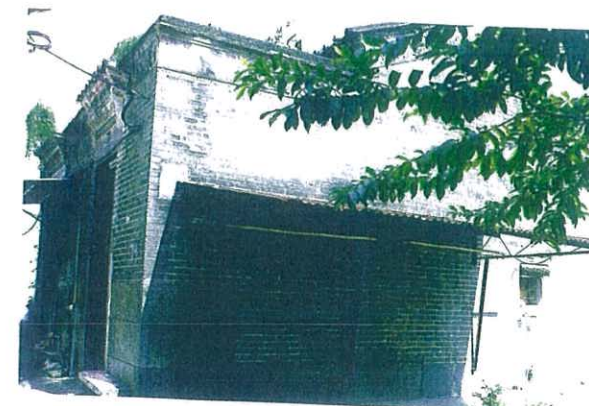
Location: San Lung Tsuen, San Tin			
Ref: AAHB - 485	Construction Date: c 70 to 80 years	Present Use: Residential	
Recorded on: 19 10 02	Condition: Fair	Past Uses: Residential	
Updated on:	Orientation: North west	Historical Associations: None	
Type: Courtyard style terrace units (1-mid and 1-end)	Map Ref: # 73, 74		
General Description: Green brick walls. Tile and concrete roof. 3 courses of cut granite on façade. Cut granite course along side. Granite door frame and threshold			
Decorative Features: Canopy over entrance, floral, landscape and geometric pattern			
Renovations: Windows added. Metal awnings on front and side			
Setting: Mid village			
Additional Notes: None

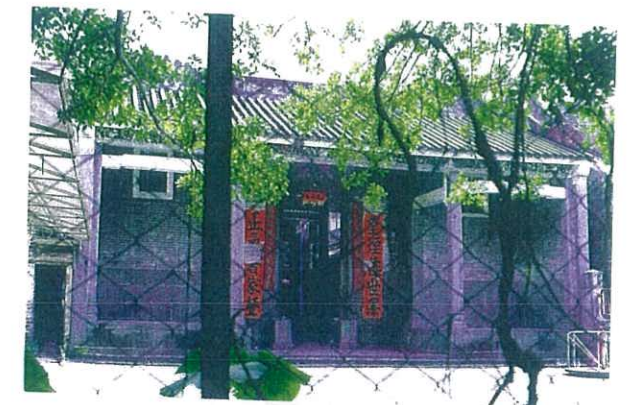
Location: San Lung Tsuen, San Tin			
Ref: AAHB - 486	Construction Date: Unknown	Present Use: Tsz tong	
Recorded on: 19 10 02	Condition: Good	Past Uses: Tsz tong	
Updated on:	Orientation: North west	Historical Associations: None	
Type: Man's Ancestral Hall (Shun Yue Tong)	Map Ref: N/A		
General Description: Traditional style Tsz Tong. Green brick with tile and concrete roof. Cut granite courses on lower walls			
Decorative Features: Carved columns, roof ridge			
Renovations: Traditional style kept			
Setting: Mid village			
Additional Notes: 文氏宗祠 (禔裕堂)

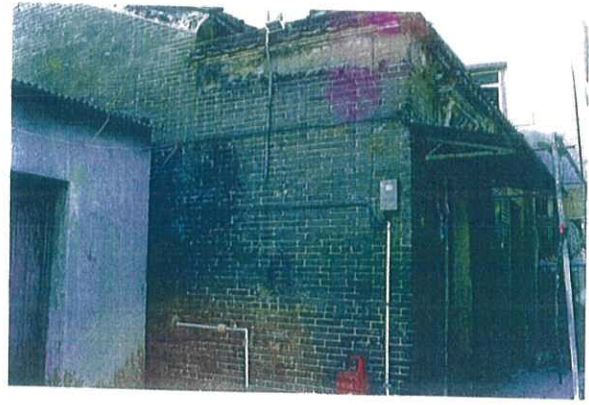
Location: San Lung Tsuen, San Tin			
Ref: AAHB - 489	Construction Date: c 70 to 80 years	Present Use: Residential	
Recorded on: 19 10 02	Condition: Fair	Past Uses: Residential	
Updated on:	Orientation: North west	Historical Associations: None	
Type: Courtyard style terrace unit (1-mid)	Map Ref: # 9		
General Description: Tile and concrete roof, Grey brick walls, Granite lintel			
Decorative Features: Canopy over entrance, pattern obscured			
Renovations: Modern door			
Setting: Mid village			
Additional Notes: None

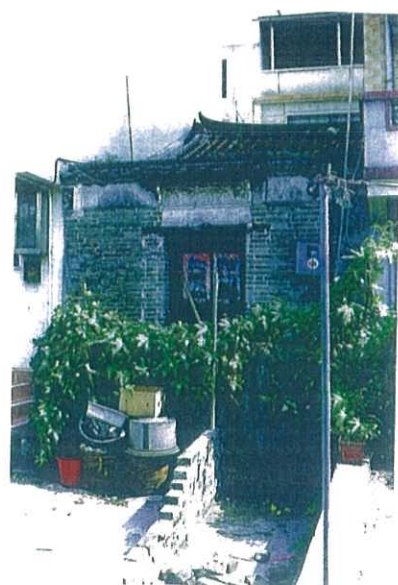
Location: San Lung Tsuen, San Tin			
Ref: AAHB - 490	Construction Date: 2000 rebuilt	Present Use: Study hall	
Recorded on: 19 10 02	Condition: Very good	Past Uses: Study hall	
Updated on:	Orientation: North west	Historical Associations: Belongs to the 5th generation	
Type: Tak Tai Study Hall 德泰書室	Map Ref: # 8		
General Description: Modern tile and concrete structure			
Decorative Features: None			
Renovations: Recent			
Setting: Mid village			
Additional Notes: None

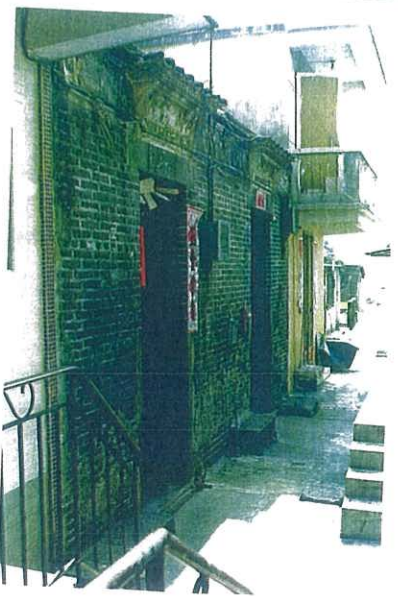
Location: San Lung Tsuen, San Tin			
Ref: AAHB - 492	Construction Date: c 70 to 80 years	Present Use: Residential	
Recorded on: 19 10 02	Condition: Fair	Past Uses: Residential	
Updated on:	Orientation: North west	Historical Associations: None	
Type: Courtyard style terrace unit (end)	Map Ref: #28		
General Description: Tile and concrete roof, Green brick walls			
Decorative Features: plain frieze			
Renovations: Concrete parapet at front, Electrical fittings added, Concrete around foundation			
Setting: Mid village			
Additional Notes: None

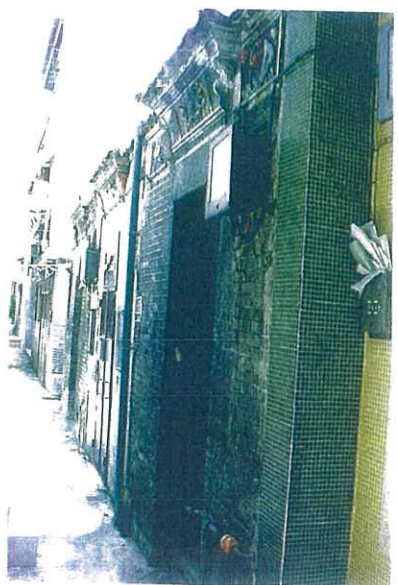
Location: San Lung Tsuen, San Tin			
Ref: AAHB - 494	Construction Date: c 70 to 80 years	Present Use: Abandoned	
Recorded on: 19 10 02	Condition: Poor	Past Uses: Residential	
Updated on:	Orientation: North west	Historical Associations: None	
Type: Courtyard style terrace unit (1-mid)	Map Ref: left of #23		
General Description: Tile and concrete roof, Green brick walls, granite lintel and half door frame			
Decorative Features: Canopy over entrance, floral and geometric design			
Renovations: Modern door			
Setting: Mid village			
Additional Notes: None

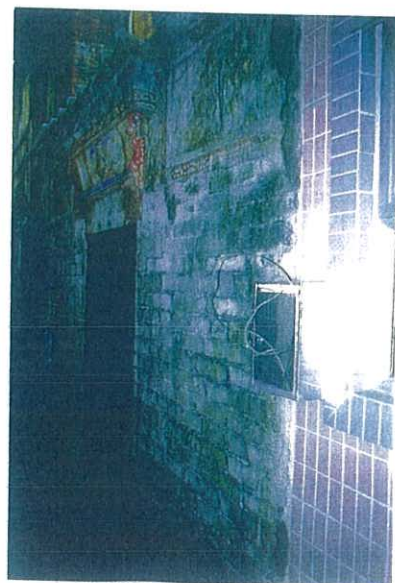
Location Ref	Tung Chan Wai, San Tin AAHB - 509	Construction Date	Unknown	Present Use	Residential
Recorded on	19 10 02	Condition	Poor	Past Uses	Residential
Updated on		Orientation	South east	Historical Associations	None
Type	Courtyard style terrace unit	Map Ref	#5		
General Description: Flat roof. Grey brick walls.					
Decorative Features: None.					
Renovations: 1961. Concrete parapet. Second storey added. Electrical fittings added.					
Setting: Mid village.					
Additional Notes: None.

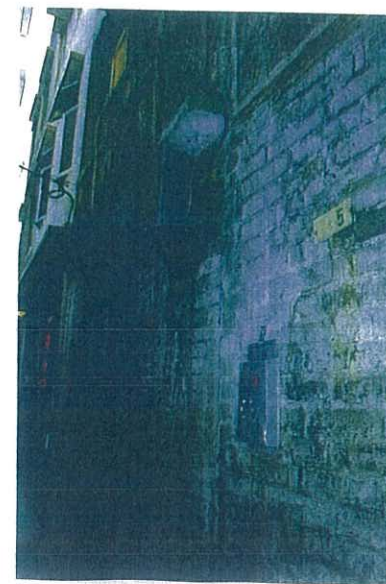
Location Ref	Tung Chan Wai, San Tin AAHB - 510	Construction Date	c. 70 to 80 years	Present Use	Residential
Recorded on	19 10 02	Condition	Fair	Past Uses	Residential
Updated on		Orientation	South east	Historical Associations	None
Type	Courtyard style terrace unit (1-mid)	Map Ref			
General Description: Tile and concrete roof. Grey brick walls. Granite lintel.					
Decorative Features: Canopy above door and frieze panel on façade. Landscape pattern.					
Renovations:					
Setting: Mid village.					
Additional Notes: None.

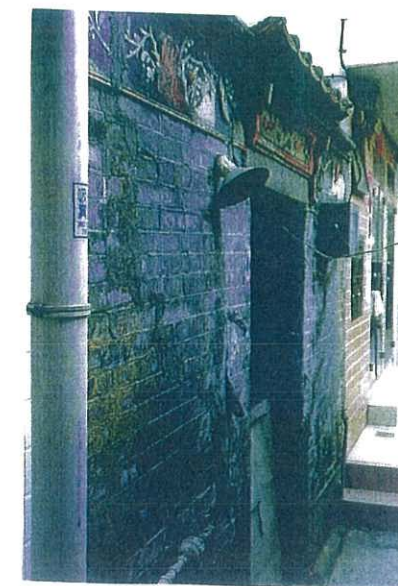
Location Tung Chan Wai, San Tin			
Ref	AAHB - 511	Construction Date	c 70 to 80 years
Recorded on	19 10 02	Condition	Fair
Updated on		Orientation	South east
Type	Courtyard style terrace unit (mid)	Map Ref	#13
Present Use Residential			
Past Uses Residential			
Historical Associations None			
General Description: Tile and concrete roof Green brick walls Stone lintel			
Decorative Features: Canopy over entrance, moulded floral pattern Frieze pattern on façade in poor condition			
Renovations: Wooden door and frame Electrical fittings			
Setting: Mid village			
Additional Notes: None

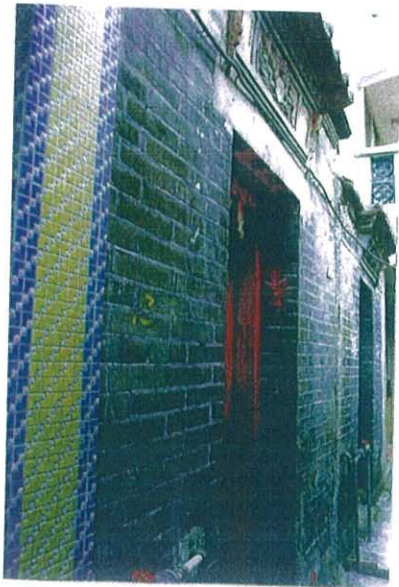
Location Tung Chan Wai, San Tin			
Ref	AAHB - 512	Construction Date	c 70 to 80 years ago
Recorded on	19 10 02	Condition	Fair
Updated on		Orientation	South east
Type	Courtyard style terrace units (mid)	Map Ref	#12
Present Use Residential			
Past Uses Residential			
Historical Associations None			
General Description: Tile and concrete roof Grey brick walls			
Decorative Features: Canopy over entrance Moulded floral and landscape pattern			
Renovations: Lintel removed and wooden slat inserted Modern wooden door			
Setting: Mid village			
Additional Notes: None

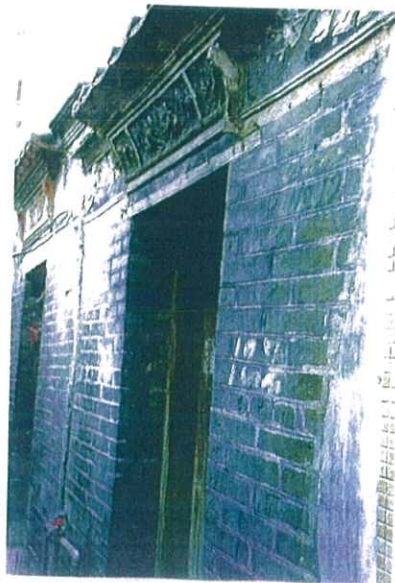
Location Tung Chan Wai, San Tin			
Ref	AAHB - 513	Construction Date	Pra 1950
Recorded on	19 10 02	Condition	Fair
Updated on		Orientation	South east
Type	Terrace unit (and)	Map Ref	#21B
Present Use Residential			
Past Uses Residential			
Historical Associations None			
General Description: Tile and concrete pitched roof Grey brick walls			
Decorative Features: None			
Renovations: Modern door and gate Windows Electrical fittings			
Setting: Mid village			
Additional Notes: None

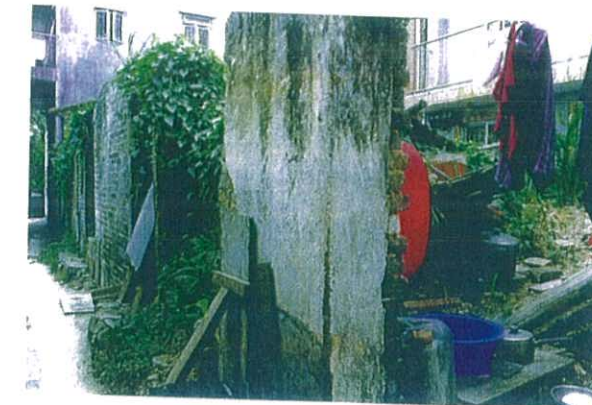
Location Tung Chan Wai, San Tin			
Ref	AAHB - 515	Construction Date	Unknown
Recorded on	19 10 02	Condition	Ruin
Updated on		Orientation	South east
Type	Village house	Map Ref	N/A
Present Use Abandoned			
Past Uses Residential			
Historical Associations None			
General Description: Portions of green brick facade wall Interior overgrown			
Decorative Features: None			
Renovations: None			
Setting: Mid village			
Additional Notes: None

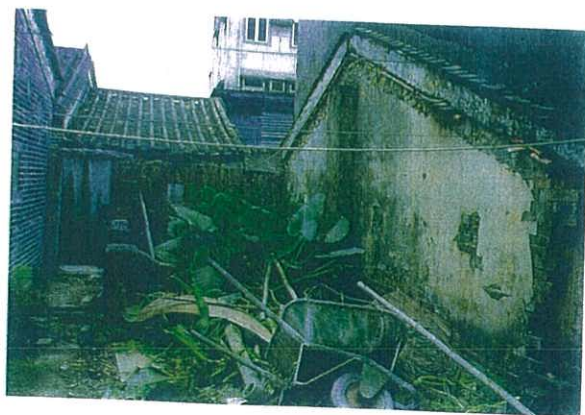
Location Tung Chan Wai, San Tin			
Ref	AAHB - 516	Construction Date	c 70 to 80 years
Recorded on	19 10 02	Condition	Good
Updated on		Orientation	South east
Type	Terrace unit	Map Ref	N/A
Present Use Residential			
Past Uses Residential			
Historical Associations None			
General Description: Pitched tile and concrete roof Green brick walls			
Decorative Features: Gable frieze, white in colour with moulded floral pattern			
Renovations: Windows, door			
Setting: Mid village			
Additional Notes: None

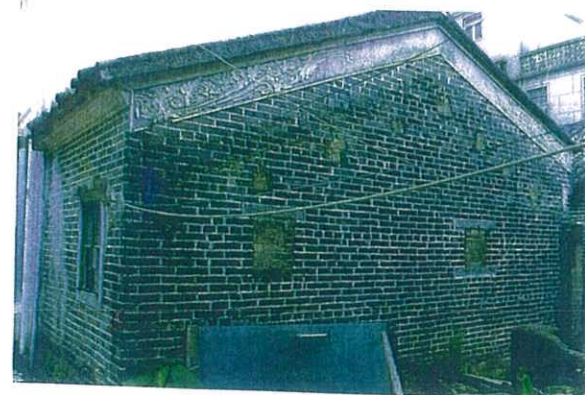
Location Tung Chan Wai, San Tin			
Ref	AAHB - 517	Construction Date	c 70 years
Recorded on	19 10 02	Condition	Fair
Updated on		Orientation	South east
Type	Terrace units (3 mid)	Map Ref	#8, 9 and 10
Present Use Residential			
Past Uses Residential			
Historical Associations None			
General Description: Tile and concrete roof Grey brick walls Granite lintels and thresholds			
Decorative Features: Moulding under eaves on façade			
Renovations: Modern doors and windows Electrical fittings			
Setting: Near edge of village			
Additional Notes: None

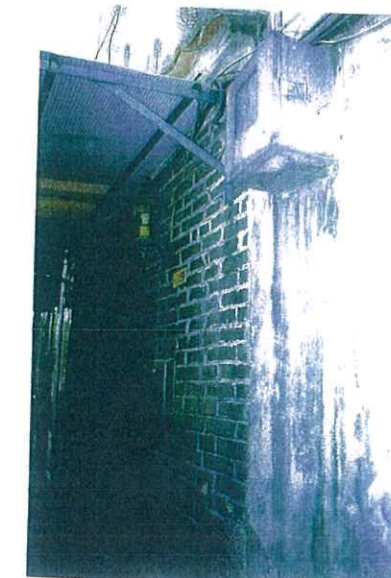
Location Tung Chan Wai, San Tin			
Ref	AAHB 518	Construction Date	c 70 to 80 years
Recorded on	19 10 02	Condition	Fair
Updated on		Orientation	South east
Type	Terrace unit	Map Ref	#50
Present Use Residential			
Past Uses Residential			
Historical Associations None			
General Description: Tile and concrete roof Grey brick walls Granite corner stones			
Decorative Features: None			
Renovations: Modern door, plastic awning on façade Electrical fittings			
Setting: Mid village			
Additional notes: None

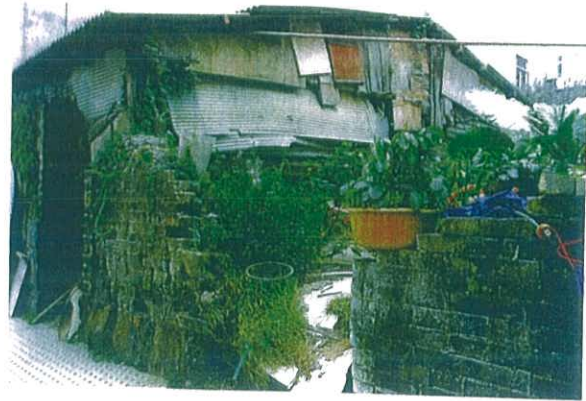
Location Tung Chan Wai, San Tin			
Ref AAHB - 519	Construction Date c. 70 to 80 years	Present Use Abandoned	
Recorded on 19 10 02	Condition Run	Past Uses Residential	
Updated on	Orientation South east	Historical Associations None	
Type Village house	Map Ref N/A		
General Description Portions of grey brick walls Interior overgrown			
Decorative Features None			
Renovations None			
Setting Mid village			
Additional Notes None

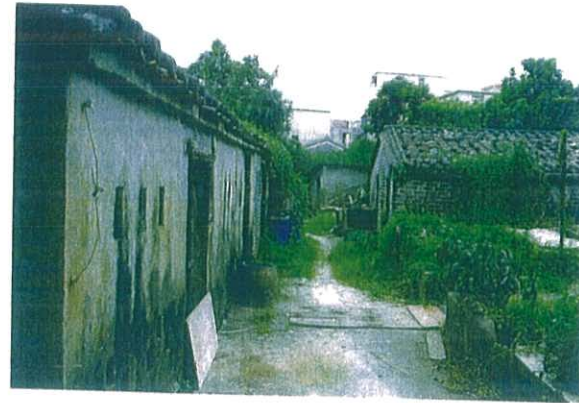
Location Tung Chan Wai, San Tin			
Ref AAHB - 520	Construction Date Unknown	Present Use Abandoned	
Recorded on 19 10 02	Condition Poor	Past Uses Pig pens	
Updated on	Orientation South east	Historical Associations None	
Type Pig pens	Map Ref N/A		
General Description Grey brick structure L-shaped Wooden support beams Small windows and open doorway			
Decorative Features None			
Renovations Concrete render on some walls			
Setting Near back of village			
Additional Notes None

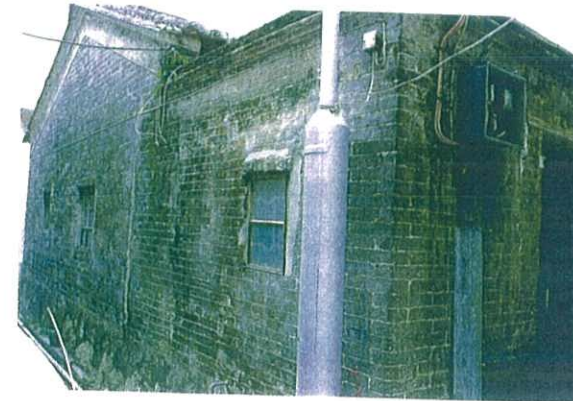
Location Tung Chan Wai, San Tin			
Ref AAHB - 521	Construction Date Pre 1950	Present Use Residential	
Recorded on 19 10 02	Condition Fair	Past Uses Residential	
Updated on	Orientation South east	Historical Associations None	
Type Courtyard style terrace unit (1-and)	Map Ref N/A		
General Description Tile and concrete roof Grey brick walls Uncut stone foundation			
Decorative Features Moulding under eaves on rear wall Plain gable frieze			
Renovations Concrete patching Modern door Wooden lintel Windows in side wall Electrical fittings			
Setting Mid village			
Additional Notes None

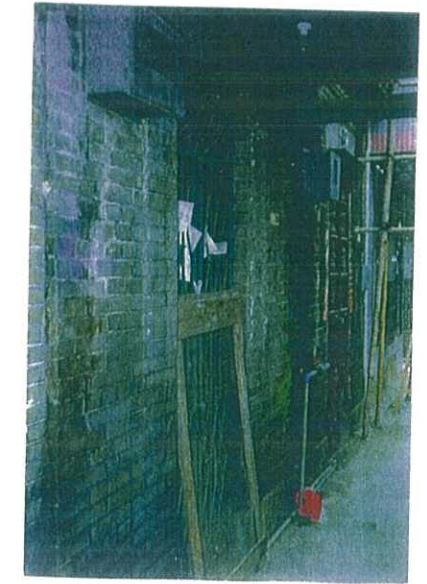
Location Tung Chan Wai, San Tin			
Ref AAHB - 522	Construction Date c. 70 to 80 years	Present Use Residential	
Recorded on 19 10 02	Condition Fair	Past Uses Residential	
Updated on	Orientation South east	Historical Associations None	
Type Terrace units (2 mid)	Map Ref #75		
General Description Tile and concrete roof Grey brick walls			
Decorative Features Moulding under eaves at rear			
Renovations Modern door and gate at entrance Awning over front Electrical fittings added			
Setting Mid village			
Additional Notes None

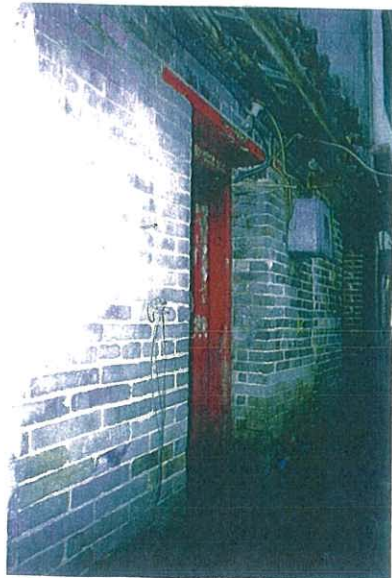
Location Tung Chan Wai, San Tin			
Ref AAHB - 523	Construction Date over 100 years	Present Use Residential	
Recorded on 19 10 02	Condition Fair	Past Uses Residential	
Updated on	Orientation South east	Historical Associations None	
Type Terrace units	Map Ref N/A		
General Description Tile and concrete roof Grey brick walls Double panel wooden doors Granite lintels and thresholds			
Decorative Features None			
Renovations Electrical fittings			
Setting Mid village			
Additional Notes None

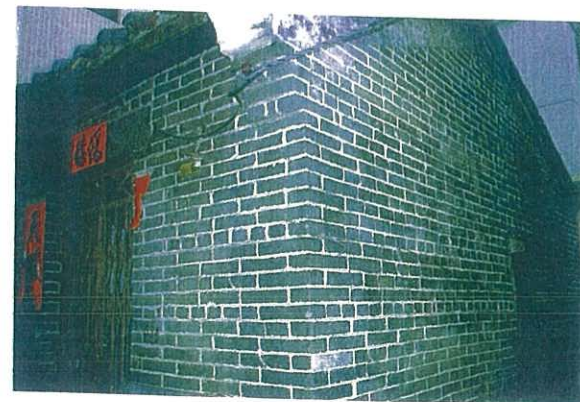
Location Tung Chan Wai, San Tin			
Ref AAHB - 524	Construction Date Pre 1950	Present Use Residential	
Recorded on 19 10 02	Condition Good	Past Uses Residential	
Updated on	Orientation South east	Historical Associations None	
Type Terrace unit	Map Ref #86		
General Description: Tile and concrete roof Grey brick walls Granite lintel			
Decorative Features Moulded gable end			
Renovations Modern door and gate			
Setting Mid village			
Additional Notes None

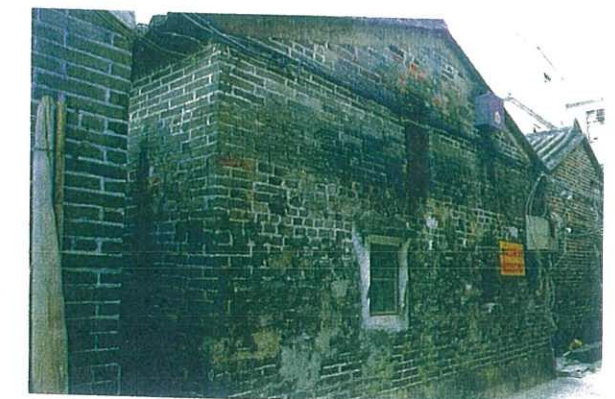
Location Tung Chan Wai, San Tin			
Ref AAHB - 526	Construction Date c. 70 to 80 years	Present Use Residential	
Recorded on 19 10 02	Condition Fair	Past Uses Residential	
Updated on	Orientation 19 10 02	Historical Associations None	
Type terrace unit	Map Ref N/A		
General Description Large grey and green brick structures connected together with outer walls Inner courtyards Tile and concrete roofs			
Decorative Features Plain frieze panels under gables			
Renovations Concrete patching in many places Windows and doors			
Setting Mid village			
Additional Notes None

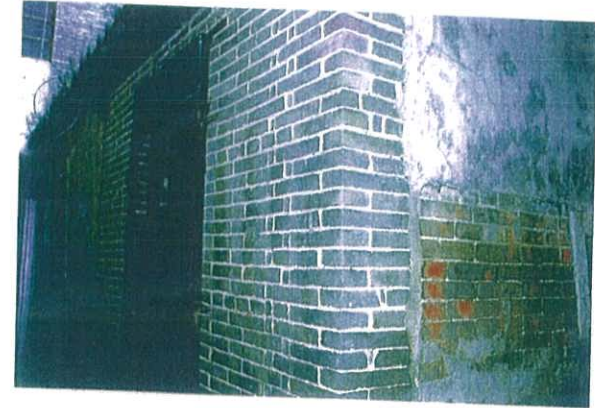
Location Tung Chan Wai, San Tin			
Ref: AAHB - 527	Construction Date: c. 70 to 80 years	Present Use: Residential	
Recorded on: 19 10 02	Condition: Fair	Past Uses: Residential	
Updated on:	Orientation: 19 10 02	Historical Associations: None	
Type: Terrace units (2)	Map Ref: N/A		
General Description: Tile and concrete roof. Grey and red brick walls. Stone foundation.			
Decorative Features: None			
Renovations: Metal gate and wooden door. Electrical fittings.			
Setting: Mid village			
Additional Notes: None

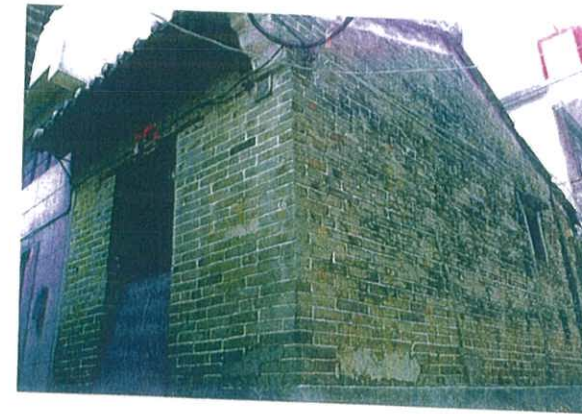
Location Tung Chan Wai, San Tin			
Ref: AAHB - 529	Construction Date: c. 70 to 80 years	Present Use: Abandoned	
Recorded on: 19 10 02	Condition: Poor	Past Uses: Residential	
Updated on:	Orientation: 19 10 02	Historical Associations: None	
Type: Terrace unit (end)	Map Ref:		
General Description: Tile and concrete roof. Round beam under eaves on façade. Grey brick walls.			
Decorative Features: Moulding on gable end.			
Renovations: Front door removed. Concrete around foundation. Concrete patches. Electrical fittings.			
Setting: Mid village			
Additional Notes:

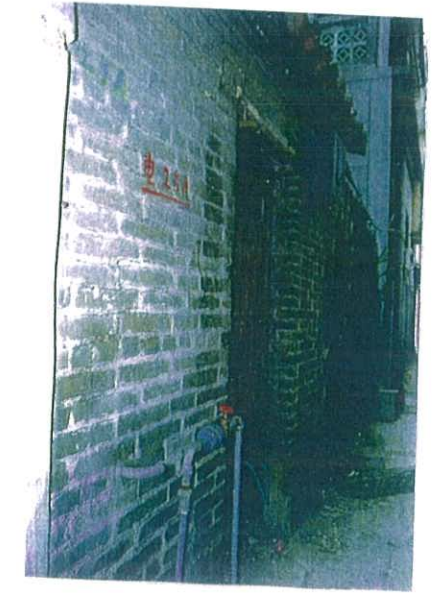
Location Tung Chan Wai, San Tin			
Ref: AAHB - 530	Construction Date: c. 70 to 80 years	Present Use: Abandoned	
Recorded on: 19 10 02	Condition: Ruin	Past Uses: Residential	
Updated on:	Orientation: 19 10 02	Historical Associations: None	
Type: Terrace unit	Map Ref: #25A		
General Description: Tile and concrete roof. Grey brick walls. Interiors collapsed.			
Decorative Features: None			
Renovations: Metal gates on entrances.			
Setting: Mid village			
Additional Notes: None
