Drainage Services
Department

Agreement No.
CE 66/2001(EP)

EIA and TIA Studies for the
Stage 2 of PWP Item No.
215DS - Yuen Long and
Kam Tin Sewerage and
Sewage Disposal

Final Environmental Impact
Assessment

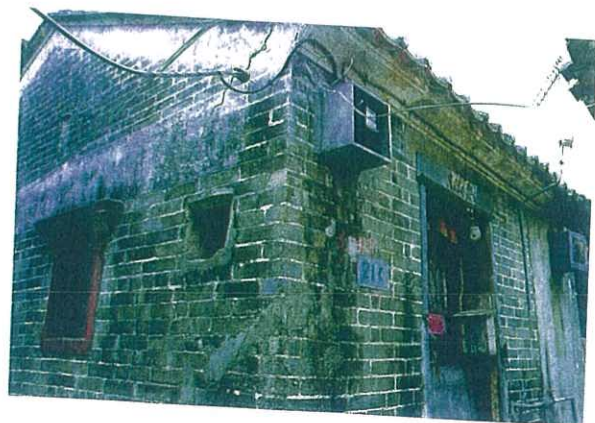
Location Tung Chan Wai, San Tin			
Ref: AAHB - 531	Construction Date: c. 70 to 80 years	Present Use: Residential	
Recorded on: 19 10 02	Condition: Poor	Past Uses: Residential	
Updated on:	Orientation: 19 10 02	Historical Associations: None	
Type: 2 terrace units (1 end and 1 mid)	Map Ref: #21C		
General Description: Tile and concrete roof. Grey brick walls.			
Decorative Features: Moulding under eaves.			
Renovations: Windows added on side. Electrical fittings.			
Setting: Mid village			
Additional Notes: None

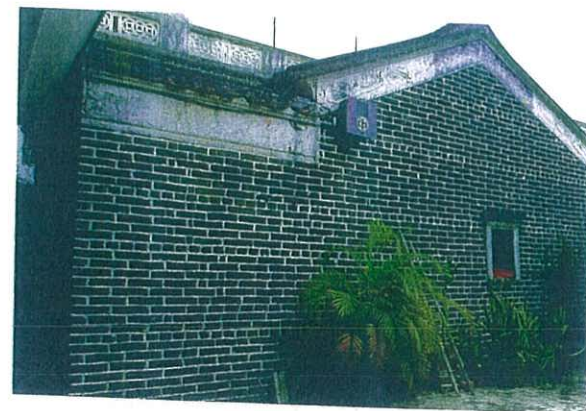
Location Tung Chan Wai, San Tin			
Ref: AAHB - 532	Construction Date: c. 60-70 years	Present Use: Residential	
Recorded on: 19 10 02	Condition: Good	Past Uses: Residential	
Updated on:	Orientation: 19 10 02	Historical Associations: None	
Type: Courtyard style terrace unit (1-end)	Map Ref: N/A		
General Description: Tile and concrete roof. Green brick walls.			
Decorative Features: Canopy over entrance with floral pattern. Gable frieze, white panel with moulded floral pattern.			
Renovations: Balustrade on roof. Window on side.			
Setting: Mid village			
Additional Notes: None

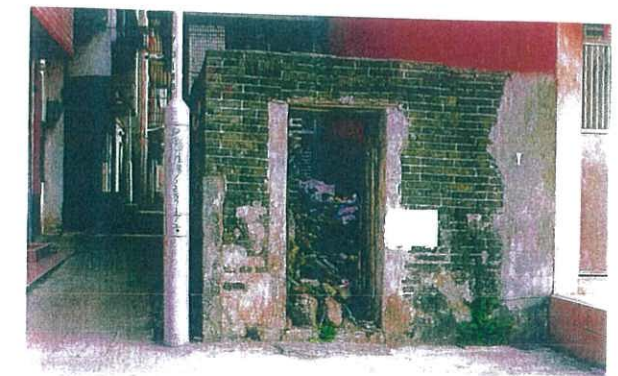
Location Yan Shau Wai, San Tin			
Ref: AAHB - 534	Construction Date: c. 100 years	Present Use: Abandoned	
Recorded on: 19 10 02	Condition: poor	Past Uses: Residential	
Updated on:	Orientation: South east	Historical Associations: None	
Type: Single storey terrace unit	Map Ref: N/A		
General Description: Green brick walls, no roof. Interior strewn with rubble.			
Decorative Features: None			
Renovations: None			
Setting: Mid village			
Additional Notes: None

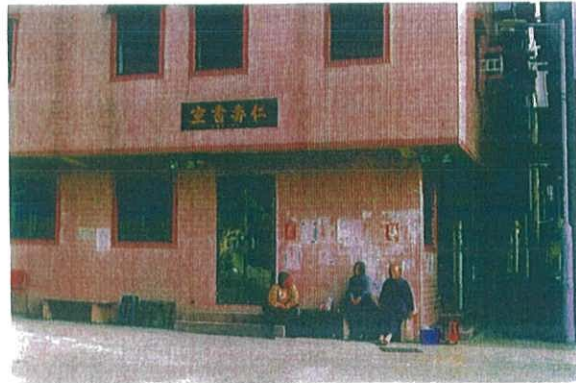
Location	Yan Shau Wai, San Tin		
Ref	AAHB - 535	Construction Date	1958
Recorded on	19 10 02	Condition	Very good
Updated on		Orientation	South east
Type	Yan Shau Study Hall	Map Ref	N/A
Present Use	Study hall	Past Uses	Study Hall
Historical Associations	None		
General Description: Modern pink tile building			
Decorative Features: None			
Renovations: Newly constructed			
Setting: Mid village			
Additional Notes: None

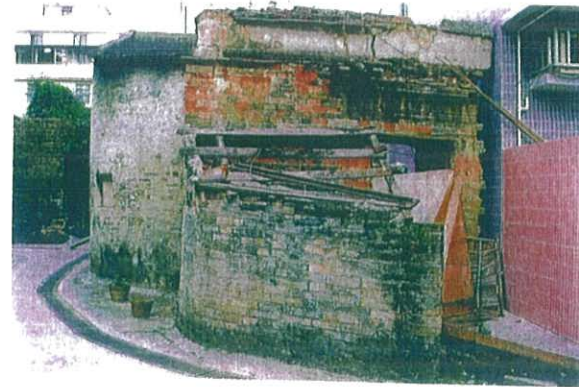
Location	Yan Shau Wai, San Tin		
Ref	AAHB - 536	Construction Date	c. 100 years
Recorded on	19 10 02	Condition	Run
Updated on		Orientation	South east
Type	Terrace unit (end)	Map Ref	N/A
Present Use	Abandoned	Past Uses	Residential
Historical Associations	None		
General Description: Grey and orange brick walls. Tile and concrete roof			
Decorative Features: Plain canopy over entrance			
Renovations: None			
Setting: Mid village			
Additional Notes: None

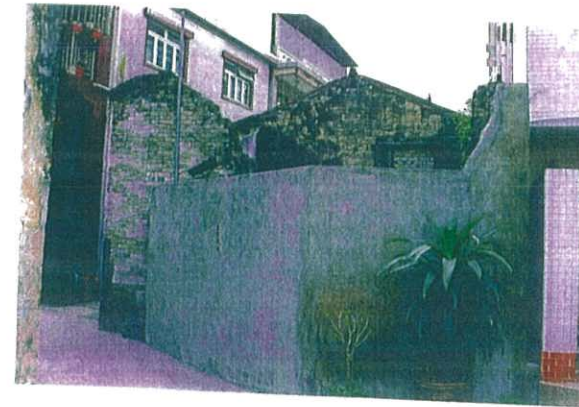
Location	Yan Shau Wai, San Tin		
Ref	AAHB - 537	Construction Date	c. 100 years
Recorded on	19 10 02	Condition	Very poor
Updated on		Orientation	South east
Type	Village house	Map Ref	N/A
Present Use	Storage	Past Uses	Residential
Historical Associations	None		
General Description: Grey brick and mud brick walls. Tile and concrete roof			
Decorative Features: None			
Renovations: Concrete wall built around one side			
Setting: Mid village			
Additional Notes: None

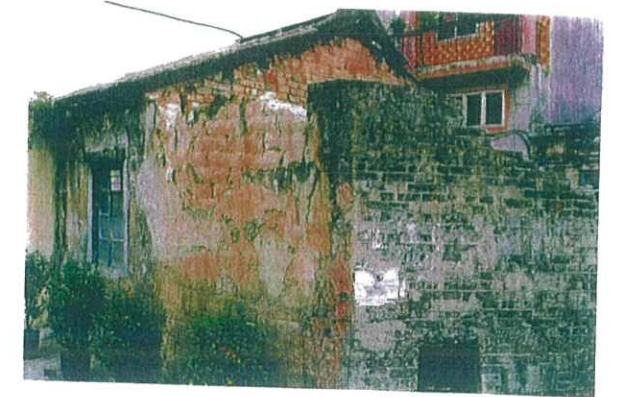
Location	Yan Shau Wai, San Tin		
Ref	AAHB - 538	Construction Date	c. 100 years
Recorded on	19 10 02	Condition	Run
Updated on		Orientation	South east
Type	Terrace unit (end)	Map Ref	N/A
Present Use	Abandoned	Past Uses	Residential
Historical Associations	None		
General Description: Mud brick and grey/red brick walls partially standing			
Decorative Features: None			
Renovations: Window			
Setting: Mid village			
Additional Notes: None

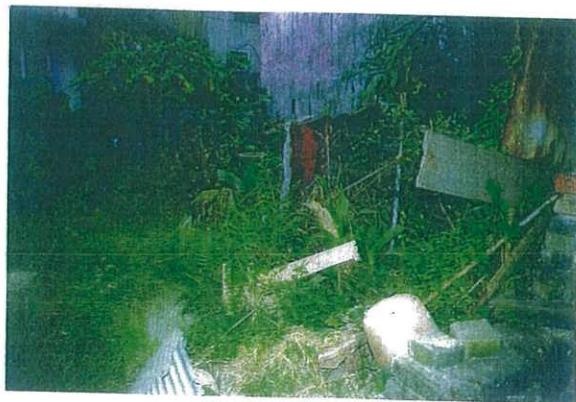
Location	Yan Shau Wai, San Tin		
Ref	AAHB - 539	Construction Date	Unknown
Recorded on	19 10 02	Condition	Run
Updated on		Orientation	South east
Type	Structure	Map Ref	N/A
Present Use	Abandoned	Past Uses	Residential
Historical Associations	None		
General Description: Portions of green brick wall standing			
Decorative Features: None			
Renovations: None			
Setting: Mid village			
Additional Notes: None

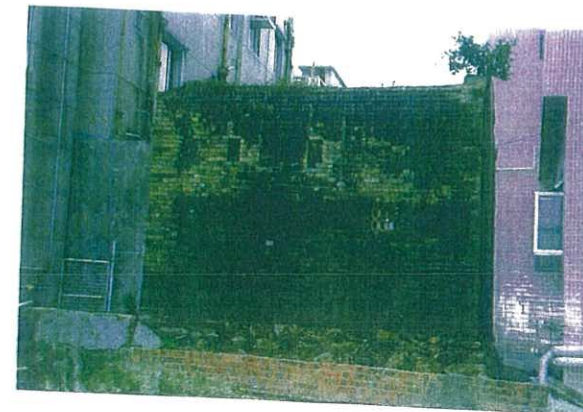
Location	Yan Shau Wai, San Tin		
Ref	AAHB - 541	Construction Date	c. 100 years
Recorded on	19 10 02	Condition	Run
Updated on		Orientation	South east
Type	Tower	Map Ref	N/A
Present Use	Abandoned	Past Uses	Tower
Historical Associations	None		
General Description: High green and grey brick wall. Uncut stone foundation. No roof			
Decorative Features: Unglazed window grille			
Renovations: None			
Setting: At front of village			
Additional Notes: None

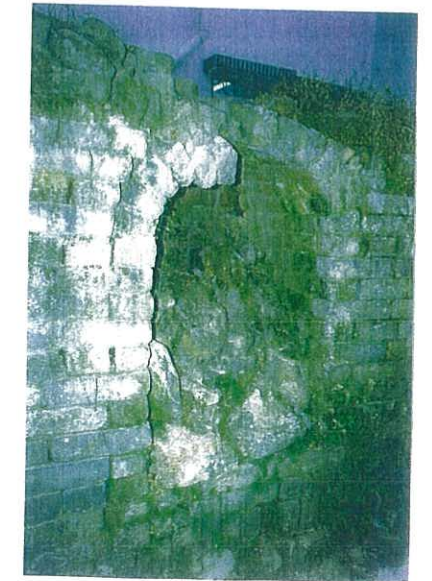
Location	Yan Shau Wai, San Tin		
Ref	AAHB - 543	Construction Date	Few hundred years
Recorded on	19 10 02	Condition	Poor
Updated on		Orientation	South east
Type	Village wall	Map Ref	N/A
Present Use	Village wall	Past Uses	Village wall
Historical Associations	None		
General Description: Green and grey brick wall, collapsed in places			
Decorative Features: None			
Renovations: None			
Setting: Perimeter of village			
Additional Notes: Arched openings in wall are gun emplacements according to locals

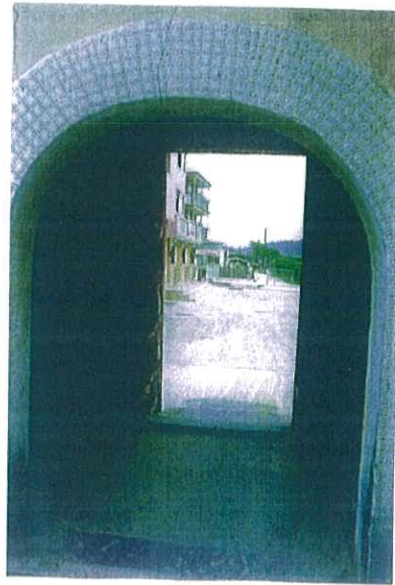
Location: Yan Shau Wai, San Tin			
Ref	Construction Date	Condition	Present Use
AAHB - 544	Modern	Good	Gate
Recorded on: 19/10/02			Past Uses: Gate
Updated on:	Orientation: South east		Historical Associations: None
Type: Village gate	Map Ref: N/A		
General Description: Tile and concrete gate. Outer door, rectangular and red sandstone blocks visible. Stepped leading to door. Inner archway entrance completely modern.			
Decorative Features: red sandstone features			
Renovations: Yes			
Setting: Entrance to village			
Additional Notes: Combination of old architectural elements used in modern reconstruction.

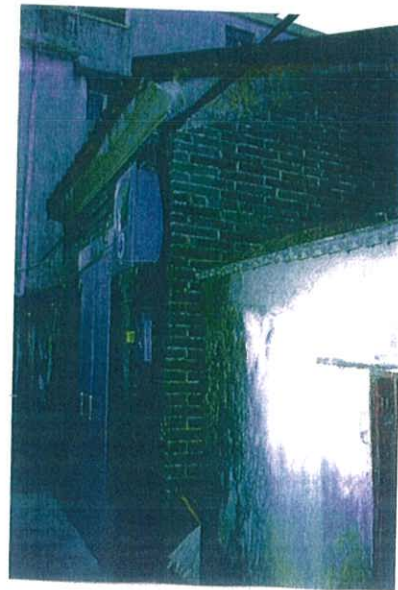
Location: Yan Shau Wai, San Tin			
Ref	Construction Date	Condition	Present Use
AAHB - 545	c. 70 to 80 years ago	poor	Residential
Recorded on: 19/10/02			Past Uses: Residential
Updated on:	Orientation: South east		Historical Associations: None
Type: Terrace unit (mid)	Map Ref:		
General Description: Tile and concrete roof. Green grey brick walls.			
Decorative Features: Moulding under eaves			
Renovations: Completely altered door, modern gate and wooden door. Electrical fittings.			
Setting:			
Additional Notes:

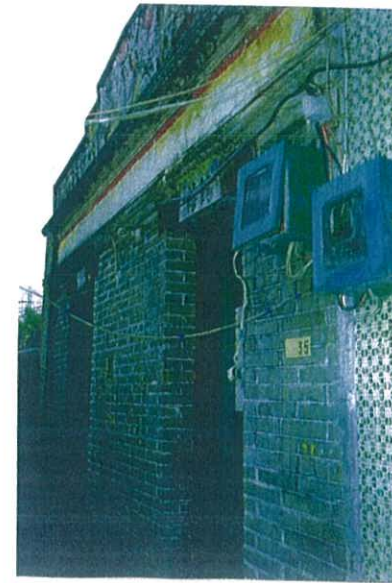
Location: Yan Shau Wai, San Tin			
Ref	Construction Date	Condition	Present Use
AAHB - 546	c. 70 to 80 years	Fair	Residential
Recorded on: 19/10/02			Past Uses: Residential
Updated on:	Orientation: South east		Historical Associations: None
Type: Courtyard style terrace units (1 and 1 mid)	Map Ref: #34 and 35		
General Description: Tile and concrete roof. Grey brick walls.			
Decorative Features: None			
Renovations: Concrete parapet and plain frieze panel underneath. Modern doors. Electrical fittings.			
Setting: Near edge of village			
Additional Notes: None

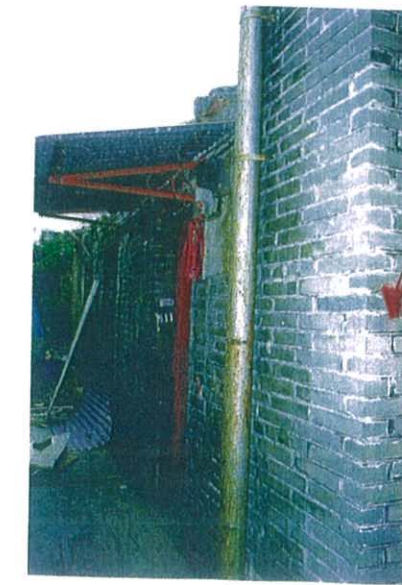
Location: Yan Shau Wai, San Tin			
Ref	Construction Date	Condition	Present Use
AAHB - 547	c. 70 to 80 years	Poor	Terrace
Recorded on: 19/10/02			Past Uses: Terrace
Updated on:	Orientation: South east		Historical Associations: None
Type: Single storey terrace units (5)	Map Ref:		
General Description: Row of grey brick units.			
Decorative Features: None			
Renovations: Metal awning on front above door. Electrical fittings.			
Setting: Near rear of village			
Additional Notes: None

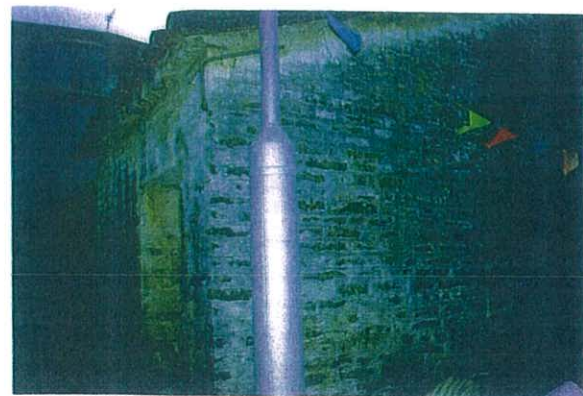
Location: Yan Shau Wai, San Tin			
Ref	Construction Date	Condition	Present Use
AAHB - 548	c. 70 to 80 years	Fair	Abandoned
Recorded on: 19/10/02			Past Uses: Residential
Updated on:	Orientation: South east		Historical Associations: None
Type: Shed	Map Ref:		
General Description: Green brick structure. Double panel wooden door. Tile and concrete roof.			
Decorative Features: None			
Renovations: Electrical fittings.			
Setting: Mid village			
Additional Notes: None

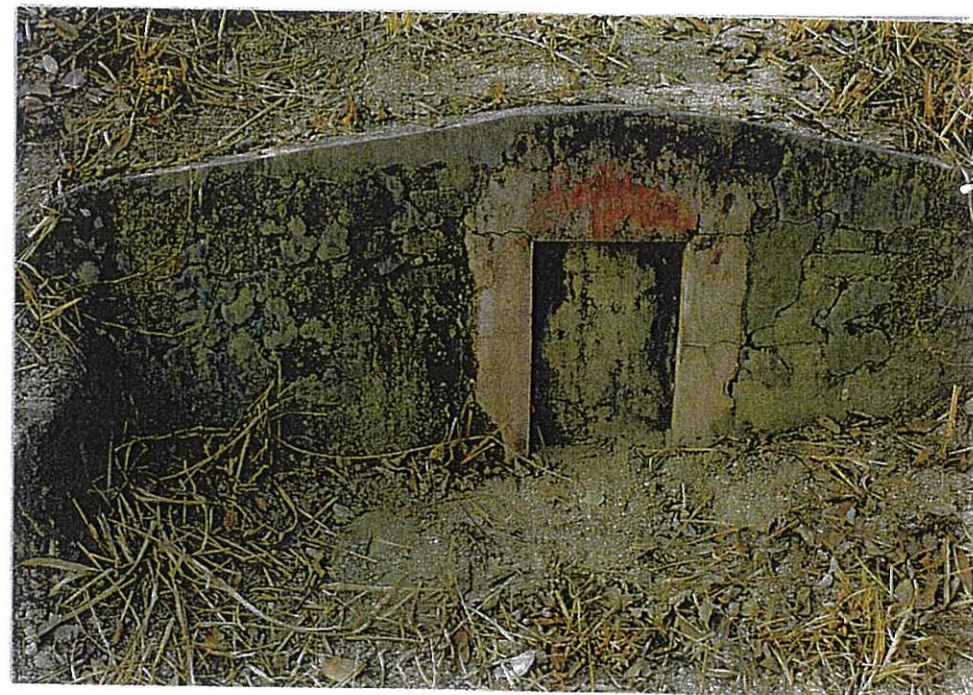
Ref #: <i>G01</i>	Project: <i>YLKT DRAINS</i>	Location: <i>Mong Tseng Tsuen</i>
Family:	Generation:	Renovation:
Dimensions (cms): Height: <i>60</i> Width: <i>250</i> Depth: <i>180</i>	Inscription: <i>墓</i>	
Description: <i>very poor condition Brick enclosure with concrete. Stone plaque.</i>

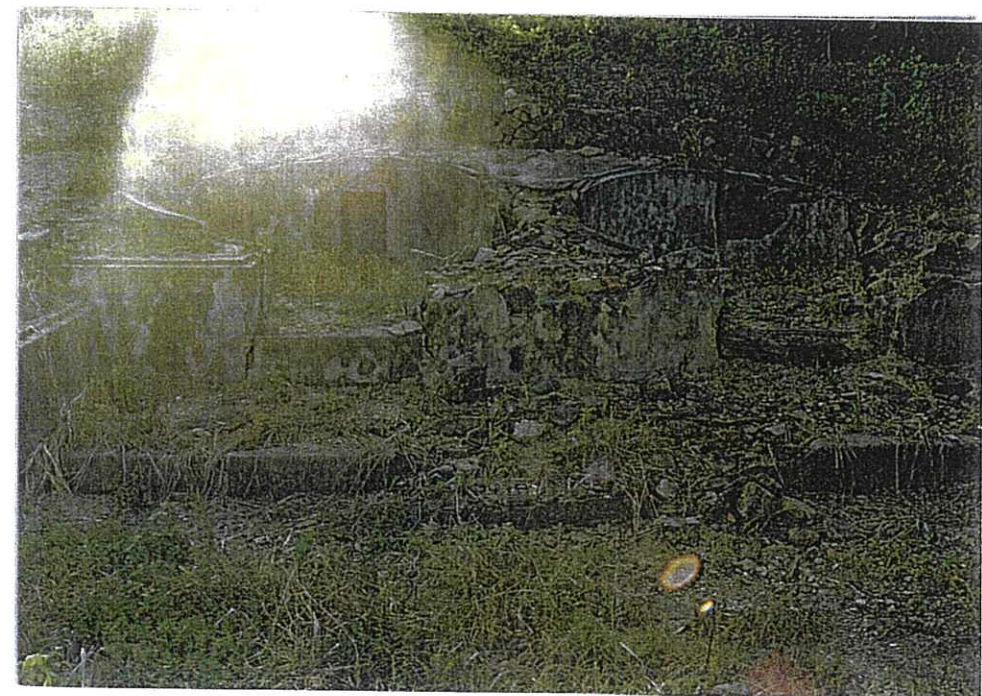
Ref #: <i>G02</i>	Project: <i>YLKT DRAINS</i>	Location: <i>Mong Tseng Tsuen</i>
Family: <i>Cheung</i>	Generation: <i>—</i>	Renovation: <i>Qing 同治元年 (1862)</i>
Dimensions (cms): Height: <i>70</i> Width: <i>450</i> Depth: <i>280</i>	Inscription: <i>Cannot read Plaque.</i>	
Description: <i>very dilapidated grave enclosure. Brick and uncut stone with concrete covering. Two graves</i>

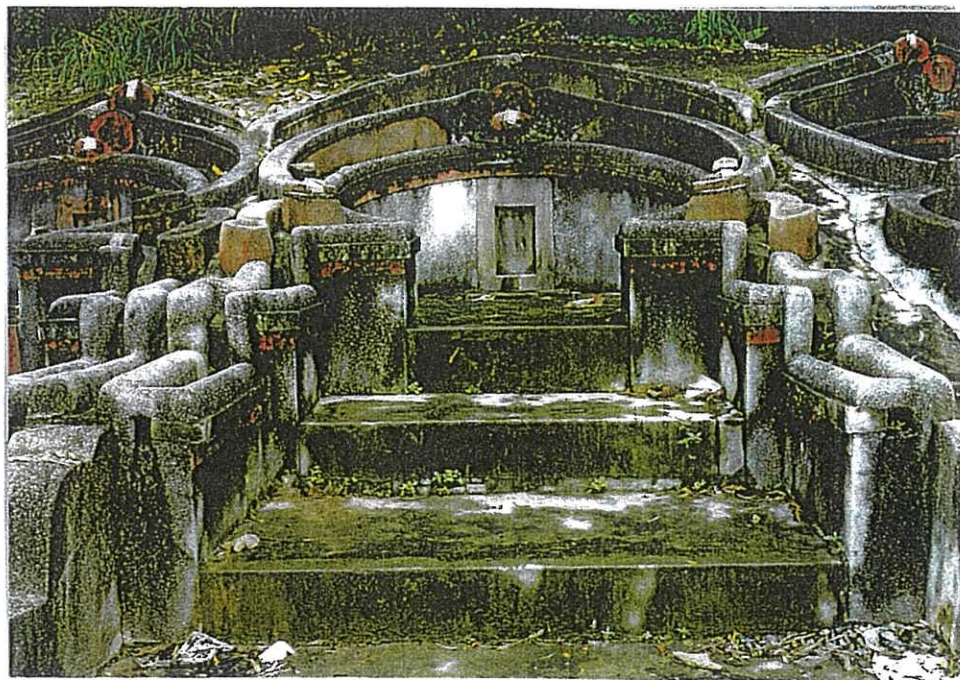
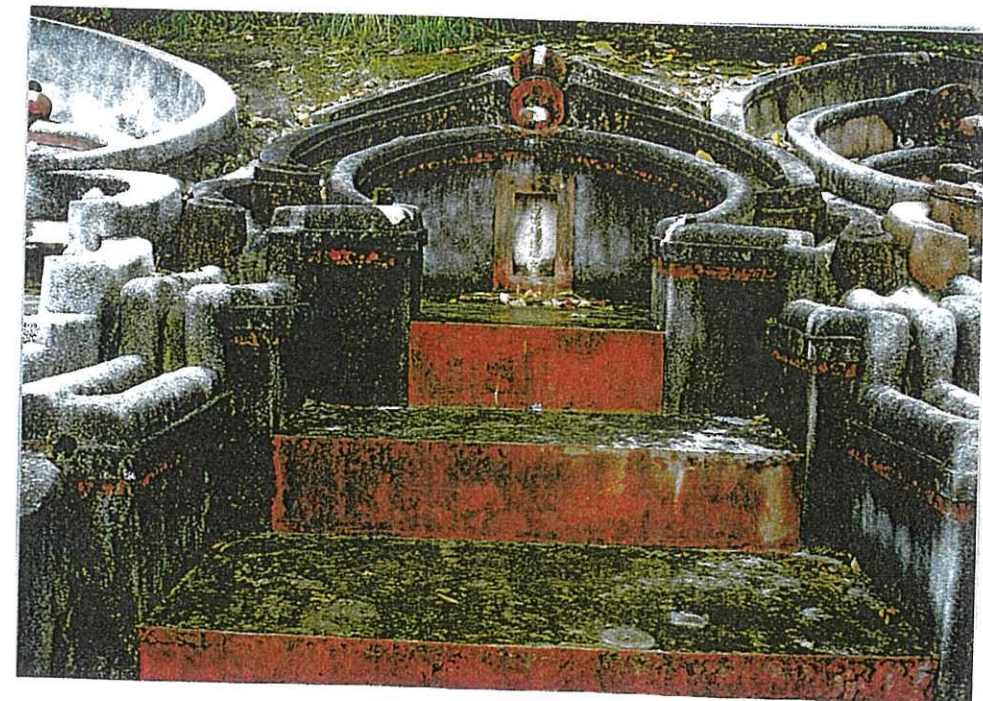
Ref #: G11	Project: YLKT DRAINS	Location: Kah Lung Rd San Tin
Family: Man	Generation: 14th.	Renovation: Not Noted
Dimensions (cms): Height: 280 Width: 300 Depth: 440	Inscription: 十四世祖 翹 挺 文 公	
Description: Concrete pebble style enclosure with red coloured trim. steps leading up to plaque. All modern materials.

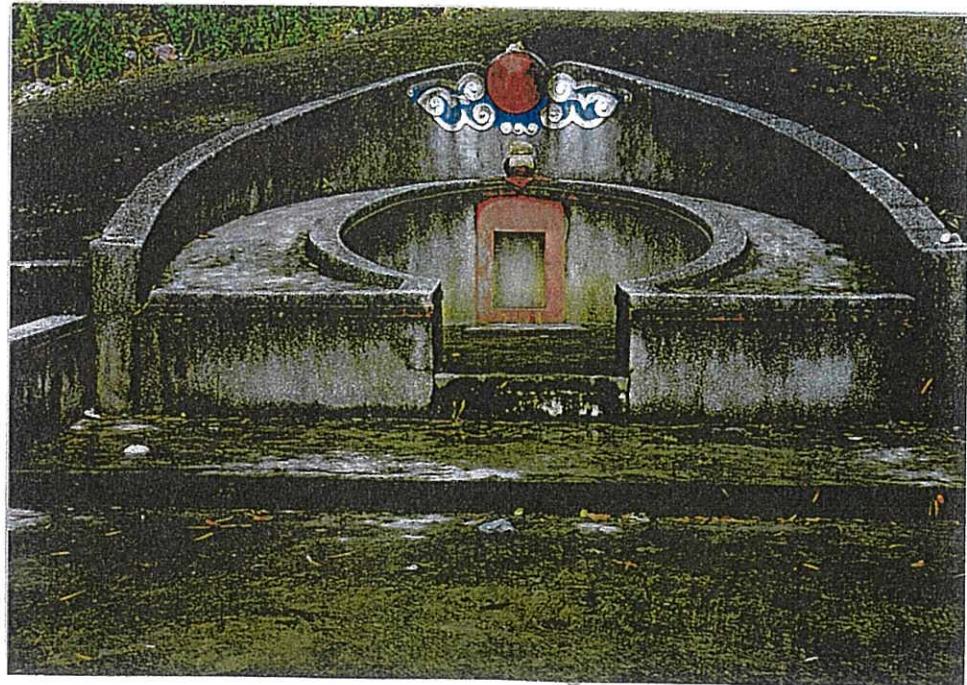
Ref #: G13	Project: YUKT DRAIN	Location: Kah Lung Rd San Tin
Family: Man	Generation: 16th	Renovation: 1954
Dimensions (cms): Height: 210 Width: 780 Depth: 495		Inscription: <p>請十六世祖 諱 中元甲午年仲冬吉旦重修 奉祀兩木廟子孫等合修</p> <p>公諱自中乃朝鄉公之子也配鄧氏生子此男葬上左邊穴左公卜葬于此生申向庚口外西之原立碑永垂不朽 家先先傳漢定針</p>
Description: Pebble Concrete enclosure with Plaque. Red and blue Colour trim all modern materials.

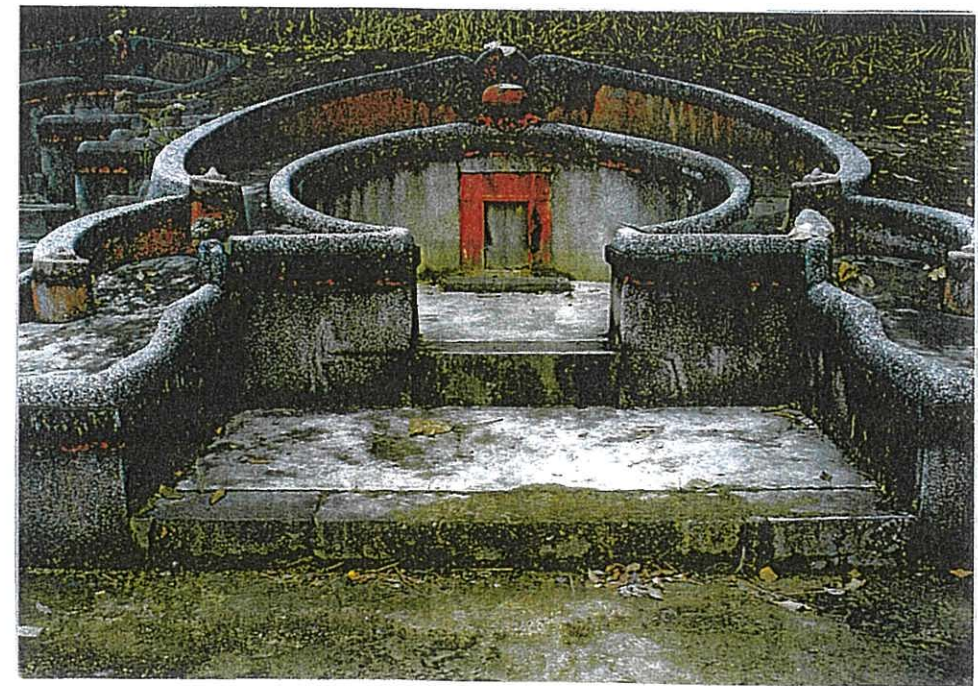
Ref #: G14	Project: YUKT DRAINS	Location: Kah Lung Rd San Tin
Family: Man	Generation: Qing 1774 9th (ren)	Renovation: Not Noted
Dimensions (cms): Height: 230 Width: 430 Depth: 525		Inscription: <p>九世祖 考處士 拙儒 文公 昔年 奉祀 舊 孫 之 今 人 在 大清 乾隆 三十九 年 歲 次 甲 午 十 月 吉 旦 重 修</p> <p>公字本和號拙儒作通麟峯公之五子也世居新田鄉娶鄧氏人岩氏名淑耕公之墓于本鄉后山土名松子凹... 公比子土名翁公權之子淑耕公... 淑公教攢規模猶公粉飾公新... 期年其生向分金... 金之...永垂不朽</p>
Description: Pebble Concrete enclosure. red Colour trim with plaque. all modern materials.		
Man Lung Fung's 5th Son.

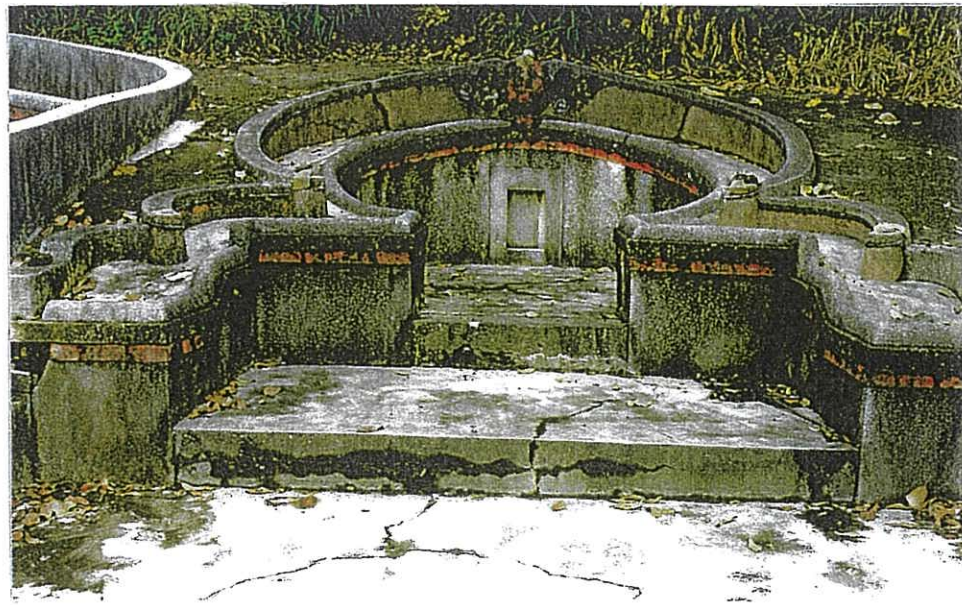
Ref #: 615	Project: YLKT DRAINS	Location: Kah Lung Rd Santin
Family: Man	Generation: ORI. Mtng Qing 1776 (ren)	Renovation: Not Noted
Dimensions (cms): Height: 210 Width: 440 Depth: 470	Inscription: <p>公諱深俊字永香廼淡耕公長子也配孀人林氏 生于諱〇字性還配孀人曾氏生三子長述還 以簡延三乾日林比孀人與曾比孀人俱墓于 土名瓦兜銀二石合墓于土名松子凹寅申 向庚寅庚申申金之原今卜吉故攢勒石 重修永垂不朽焉</p> <p>明太商祖考永香府君 高祖考性還府君 女公合墓之墓作</p> <p>乾隆三十一年歲次丙戌十月十二日 翁孫 景聰 宏圖 翰臣 尚恩 迅國 祥臣 殿侶 步元 廷元 仲侶 可程 俊侶 〇侶 等重修全</p>	
Description: Pebble concrete enclosure with red trim. all modern materials		
Man wing San + Son - grand-son + great grandson of 614.

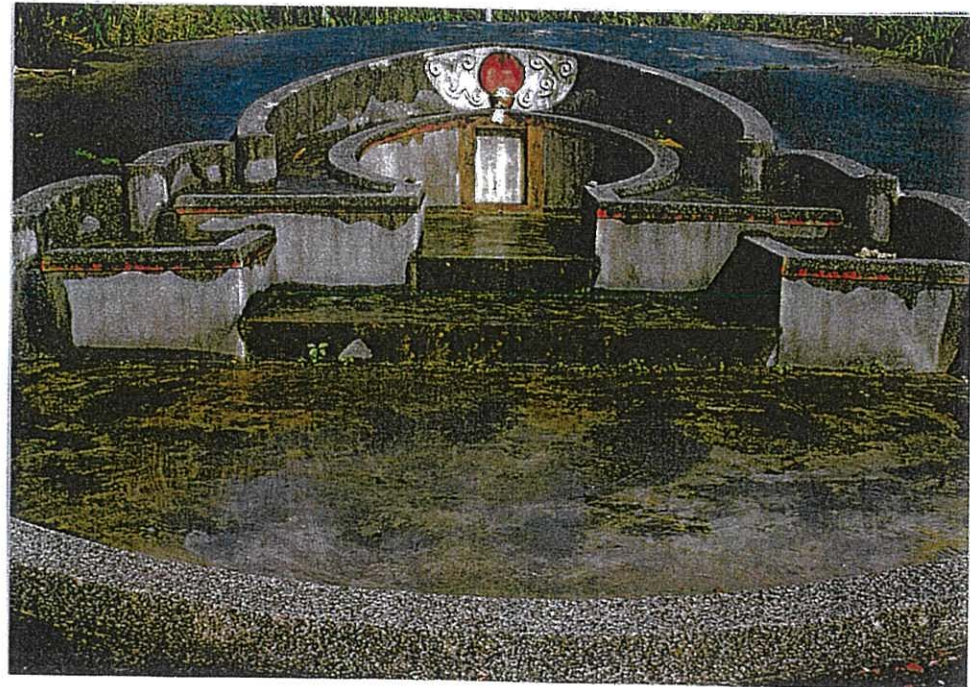
Ref #: 517	Project: YUKY BRAIN	Location: Kah Lung Rd. Santin
Family: Man	Generation:	Renovation: 1946
Dimensions (cms): Height: 190 Width: 560 Depth: 470	Inscription: 廿二世祖 考士保文公 之墓 此孀人張氏 之墓 奉祀孫 茂喜 曾孫 火泰 燦明 送池 日葵 錦明 錦南 景恒	
Description: Pebble Concrete enclosure, red colour trim with plaque.	<p>民國廿五年丙戌八月吉旦重修 * material is more recent than 1946. latest ren. not noted.</p>

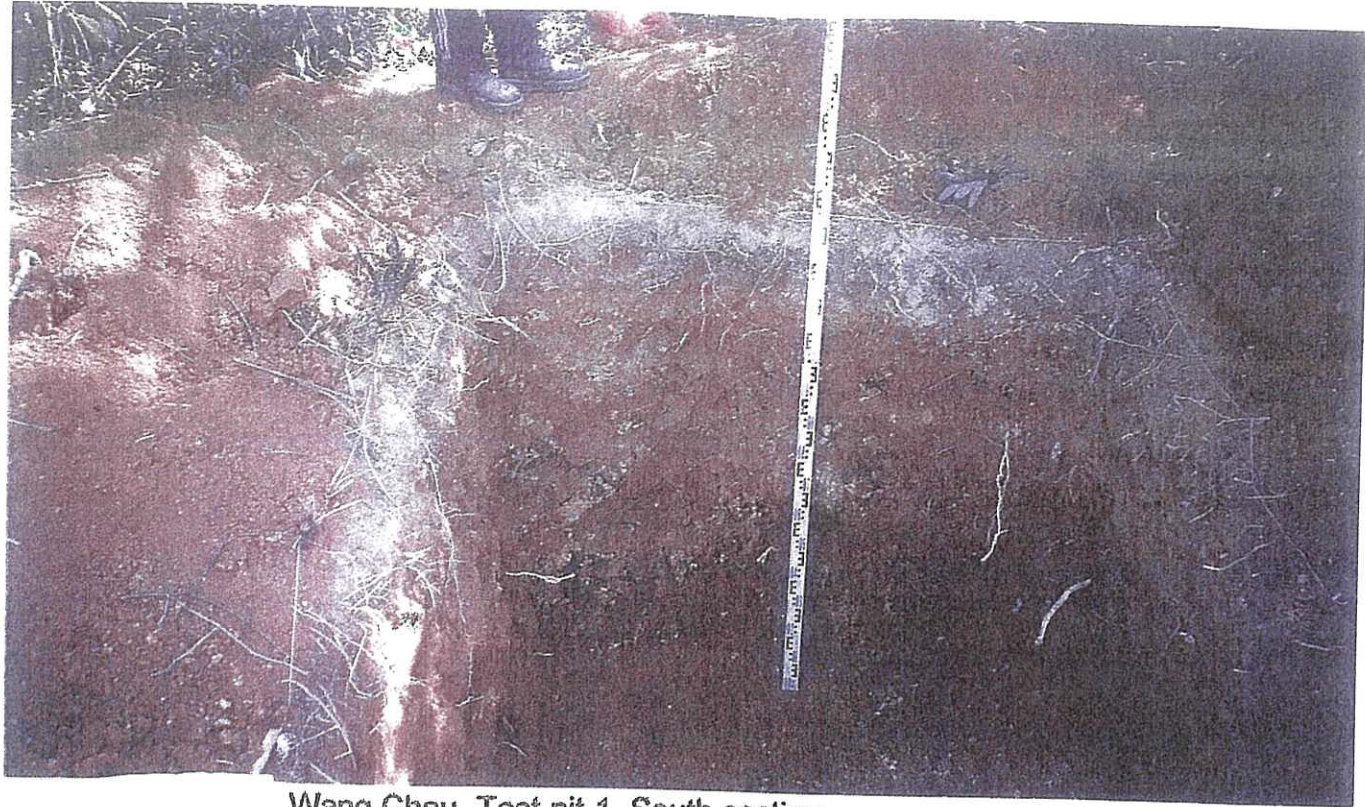
Wang Chau. Test pit 1. South section

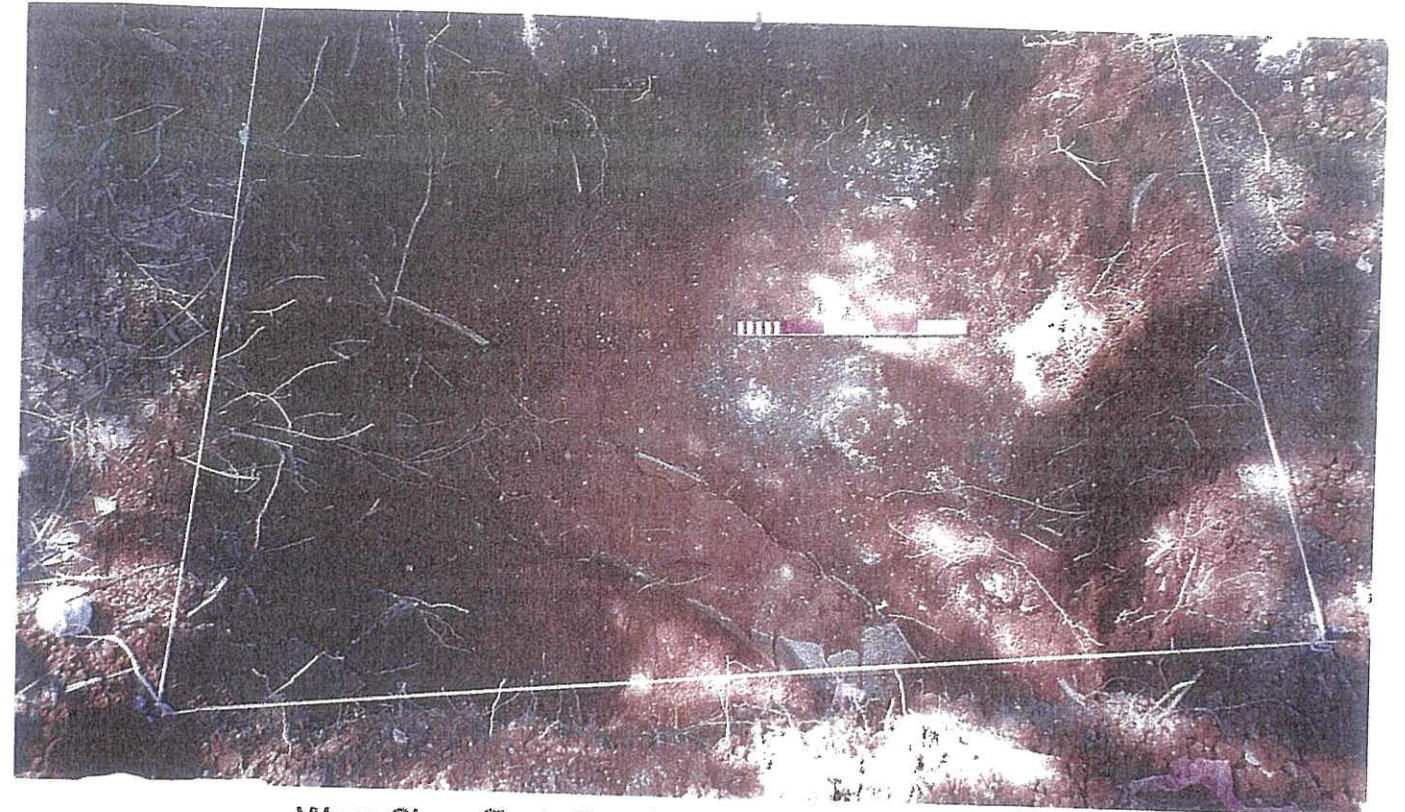
Wang Chau. Test pit 2. Grave structure and area of lime.

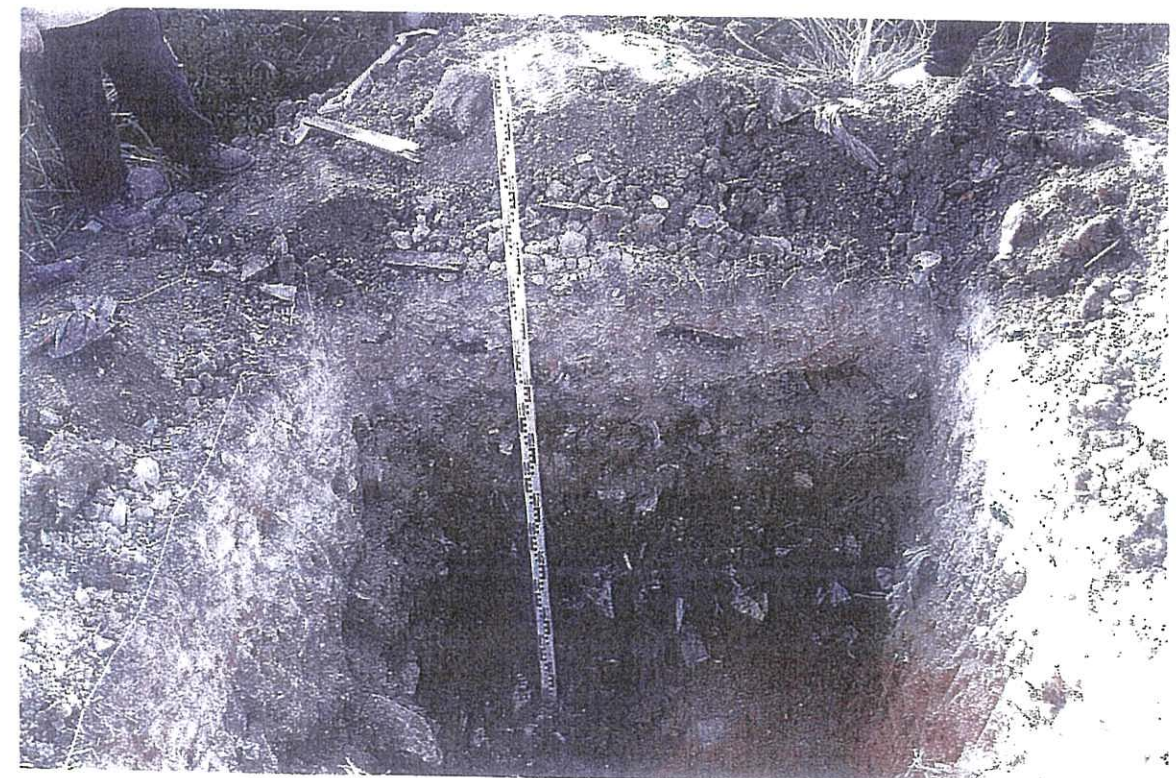
Ching San Tsuen. Test pit 1. West section
