Geotechnical Planning Review Report for Installation of Proposed Public Utility Installation and Associated Filling and Excavation of Land (OHL Pole & Stay Erection)

Geotechnical Planning Review | Government Land in D.D. 96, San Tin, Yuen Long

B190011.051.01 | 8 August 2022

CLP Power Hong Kong Limited

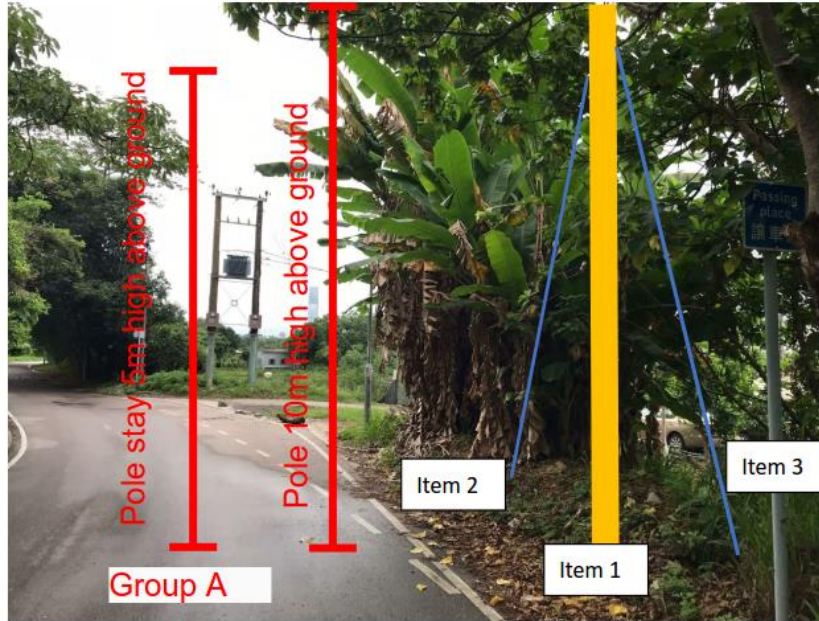
Location refers to figure 2

P1: General View 1 of the Site with Approximate Location of a Pole & Pole Stays (looking Southwest)

For the proposed public utility installation, 5 OHL poles with approximate height of 10m will be installed in the specified areas along a local road. General views along with the photo plan of the application site are shown in the Plates below. The road gradients is quite gentle and all poles are located at +6.0 mPD to +8.0 mPD approximately.

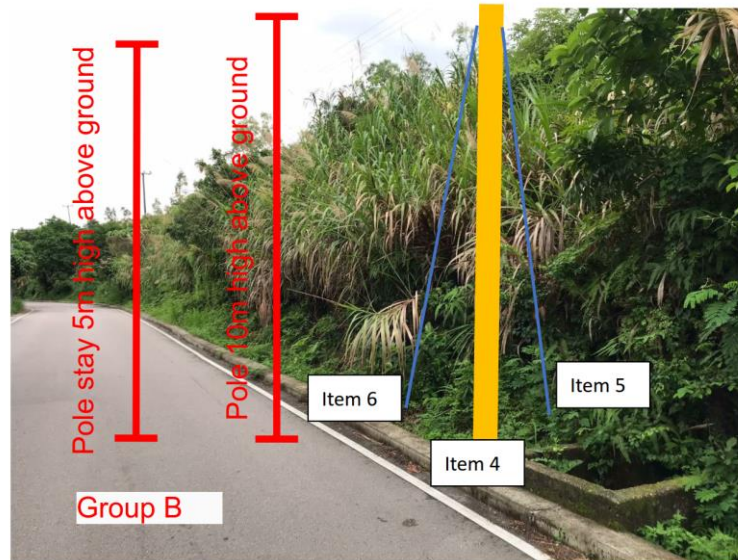
Location refers to figure 2

P2: General View 2 of the Site with Approximate Location of a Pole & Pole Stays (looking Northeast)

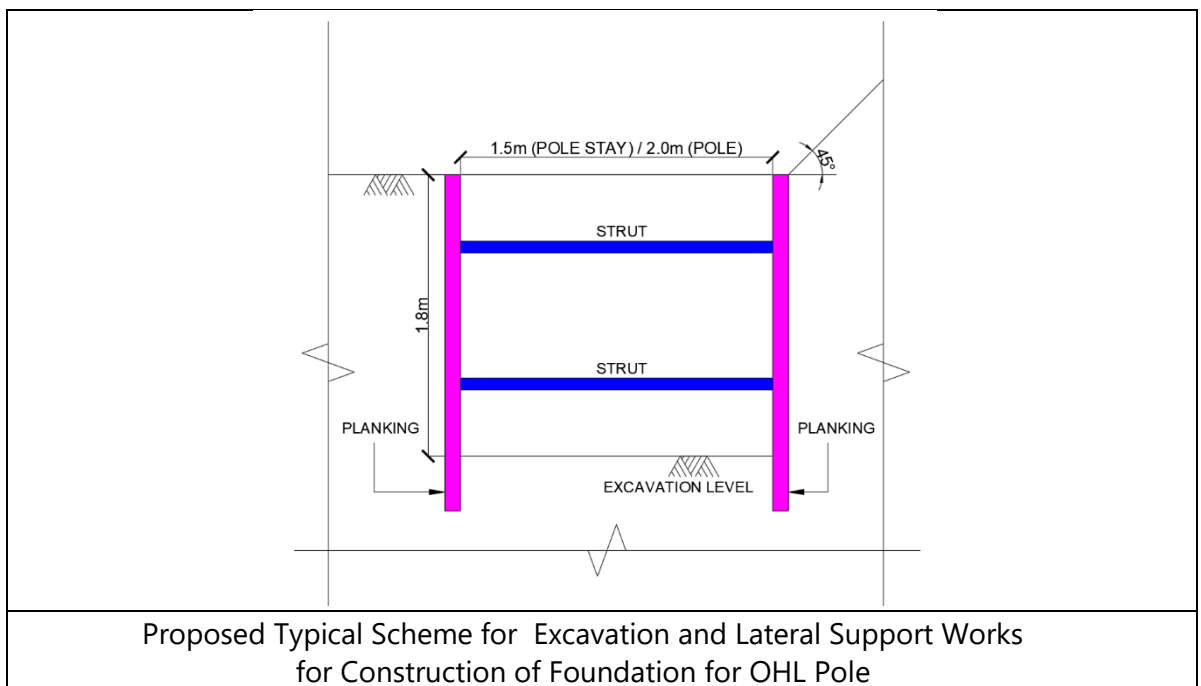
The foundation of the proposed OHL poles and pole stays will be constructed by pit excavation method. The pit will be 1.5m to 2m wide and 1.8m deep approximately. It is proposed that the pit will be supported by planking and struts as shown in the figure below.

In the design of excavation and lateral support works, attention should be paid to the excavation and strutting sequence and to the standard workmanship in order to limit loss of ground due to the inward movement of the temporary planking. Earth load, water load and surcharge should be taken into consideration. It was recorded that the water level of the site is approximately 1.2m below the existing ground, sufficient water pumps shall be provided to ensure that the pits are not submerged during the construction of foundation.

Since the pit excavation works involves excavation of depth 1.8m only, excavation effects on the adjacent slopes and change of ground profile should be minimal.

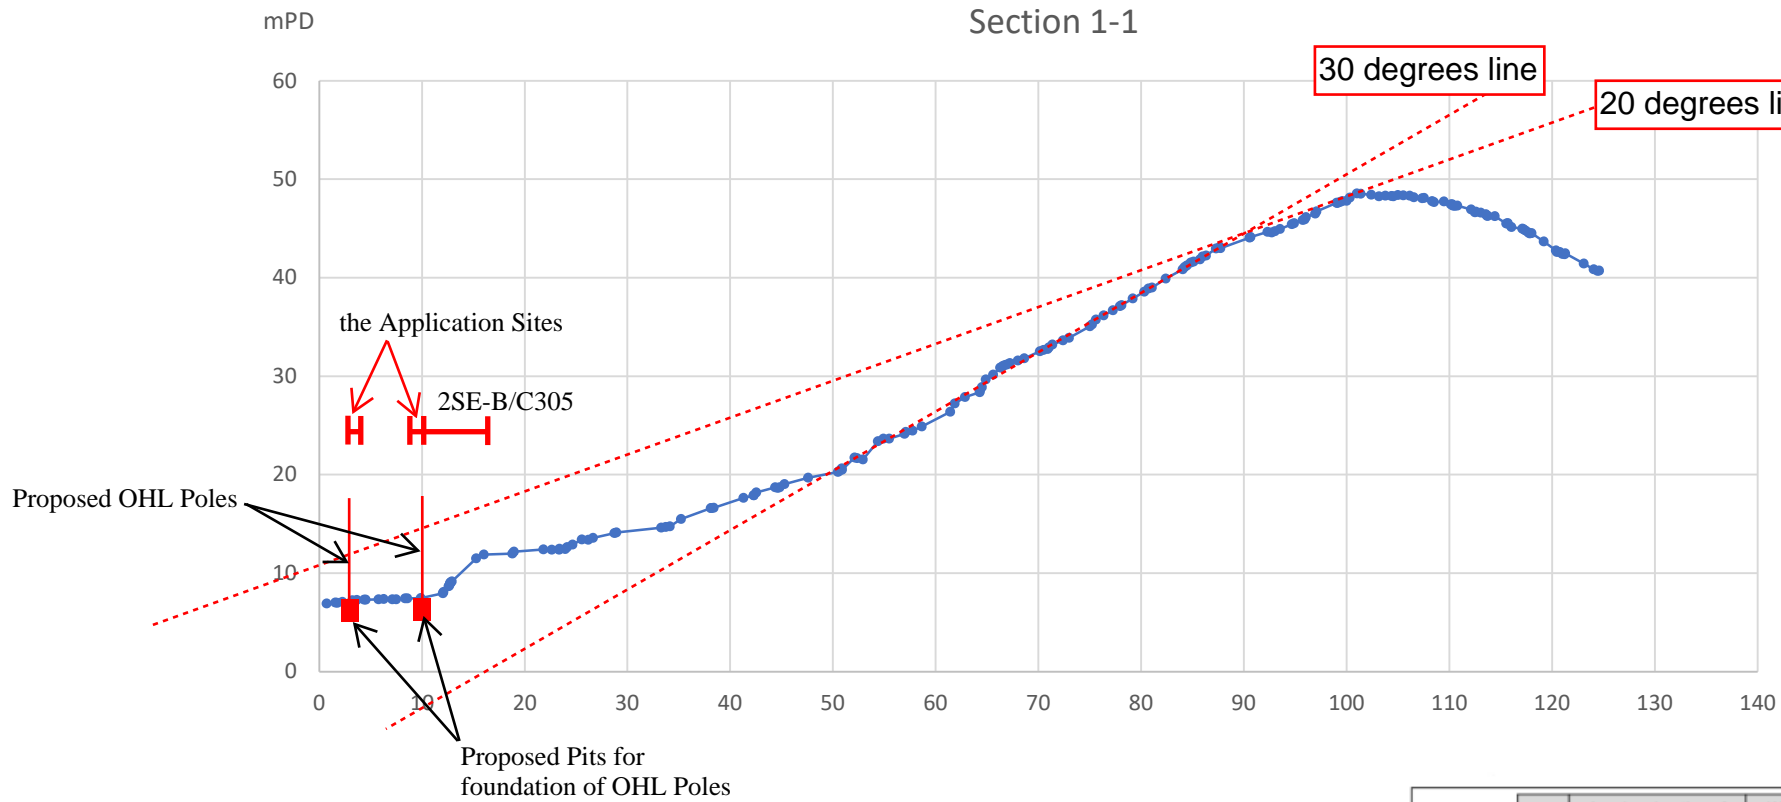
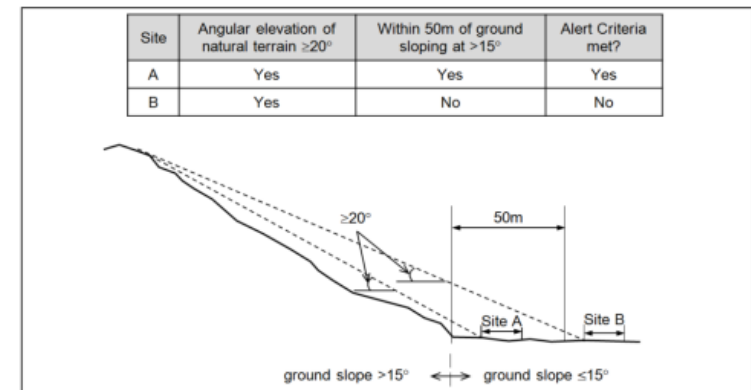
Figure 2.5 Application of Alert Criteria

Comparing Figure 2.5 and Section 1, the site for proposed OHL Pole meets alert criteria of natural terrain hazard.

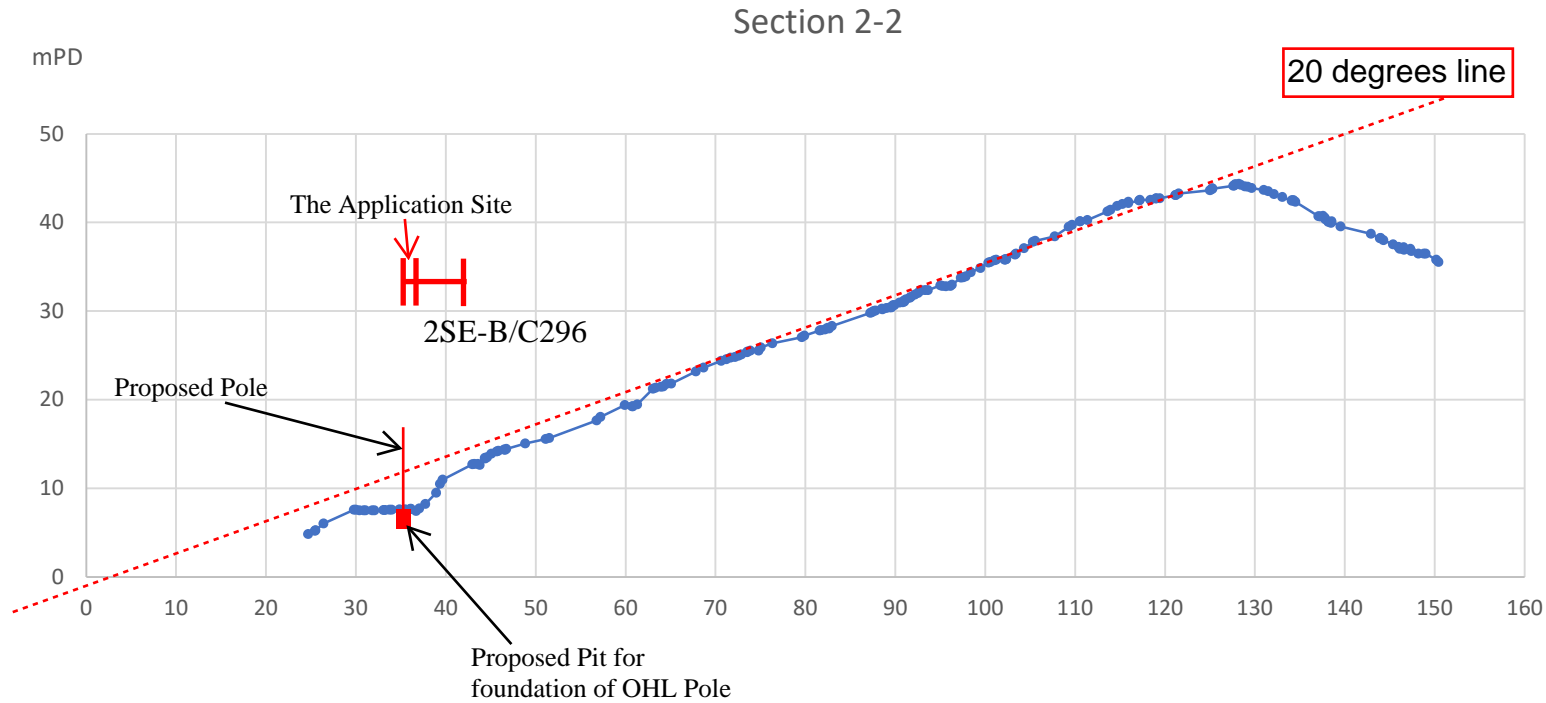
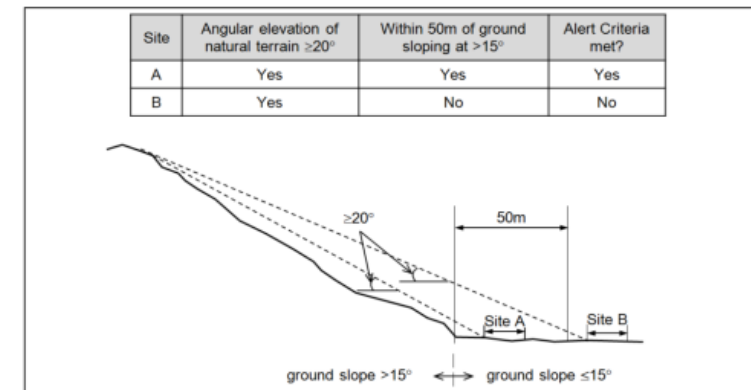
Figure 2.5 Application of Alert Criteria

Comparing Figure 2.5 and Section 2, the site for proposed OHL Pole meets alert criteria of natural terrain hazard.

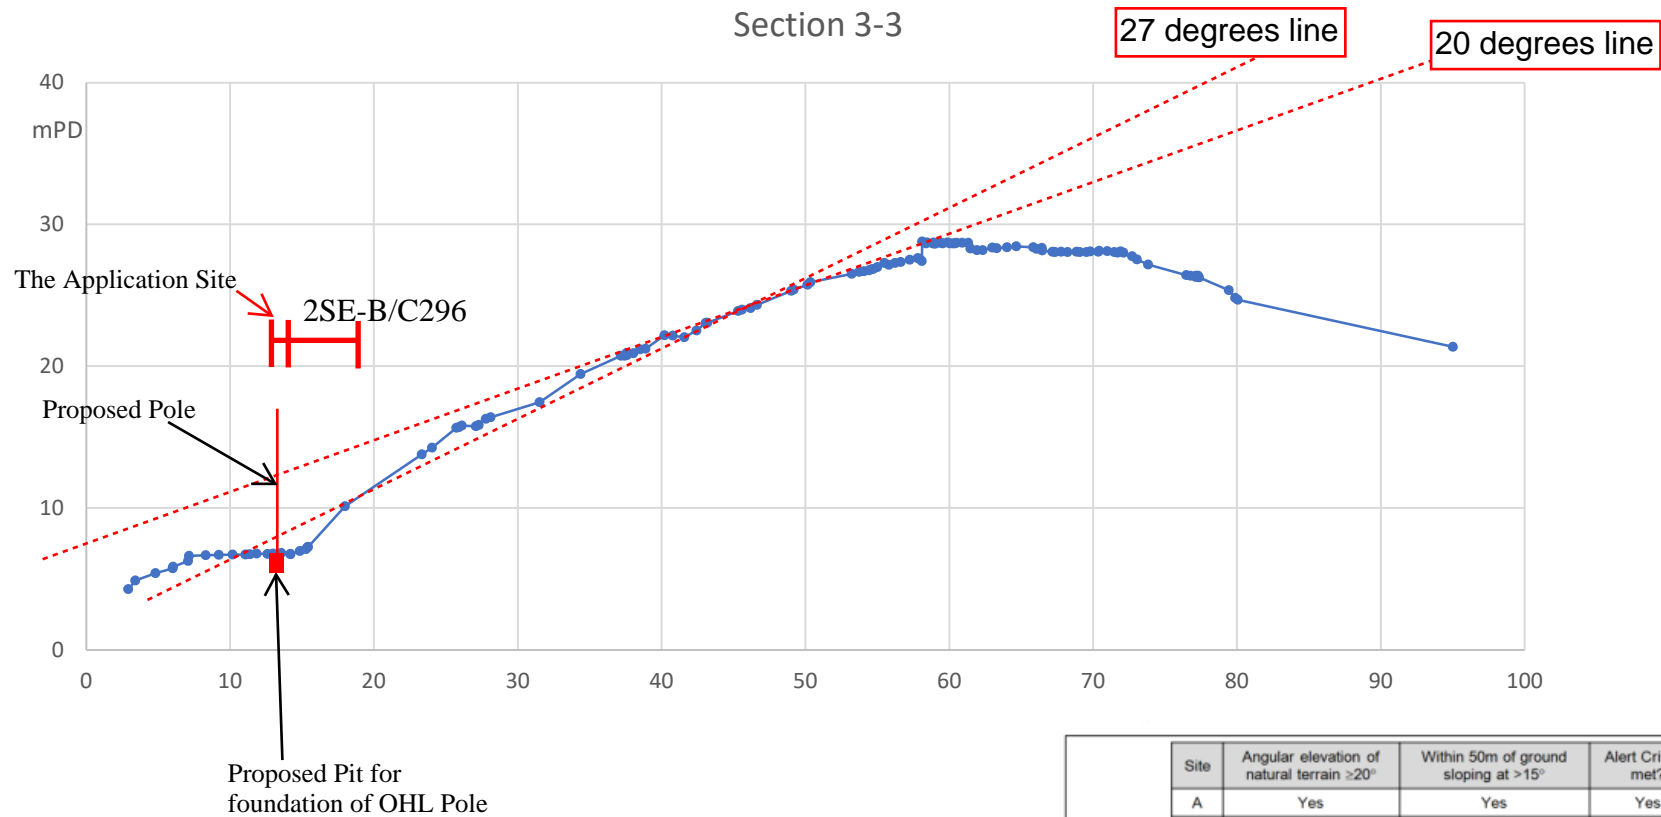
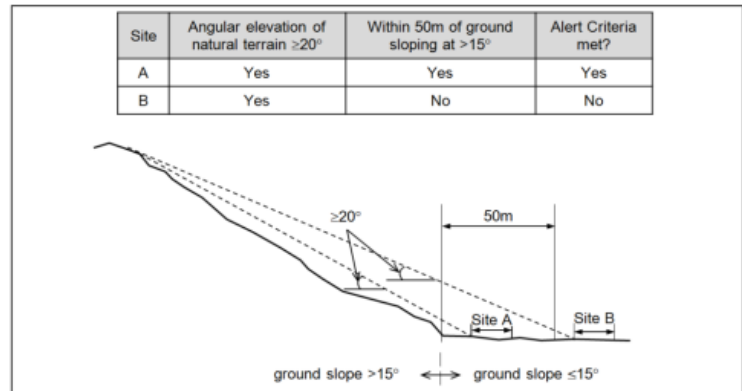
Figure 2.5 Application of Alert Criteria

Comparing Figure 2.5 and Section 3, the site for proposed OHL Pole meets alert criteria of natural terrain hazard.

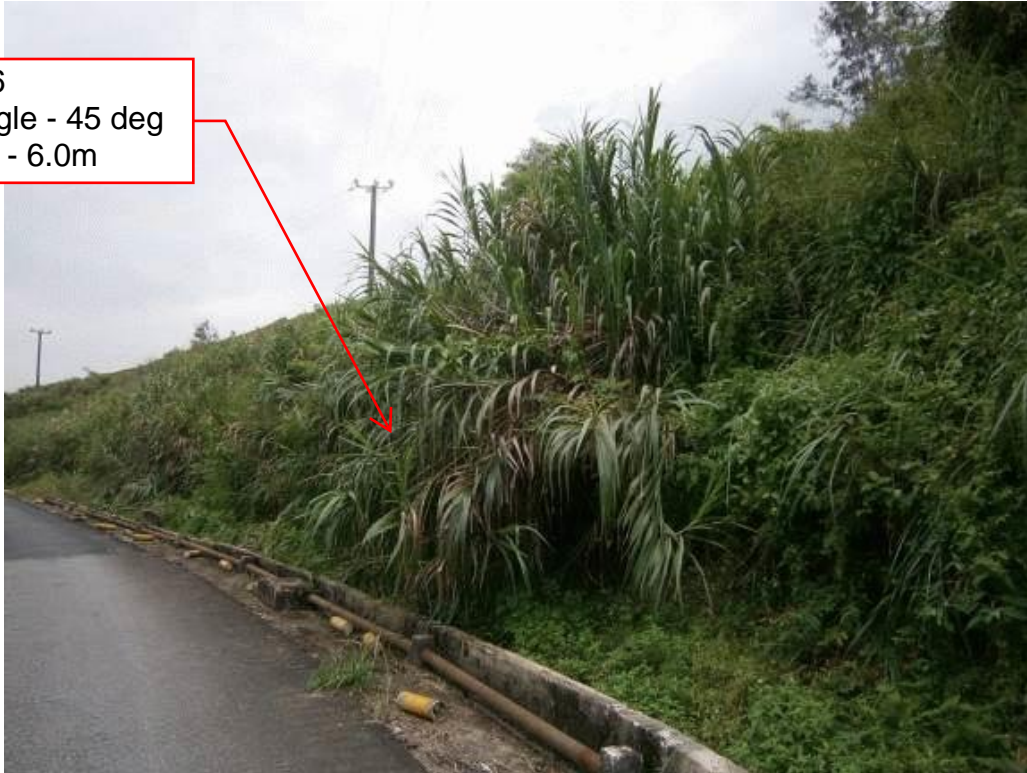
Photo 1: General View of 2SE-B/C296

2SE-B/C296
Average Angle - 45 deg
Max. Height - 6.0m

These 2 registered man-made slopes are cut slopes with 6m in height at 45° slope angle. In view of failure of the man-made slopes would affect the OHL poles at the slope toe, stability analysis is proposed to be carried out.

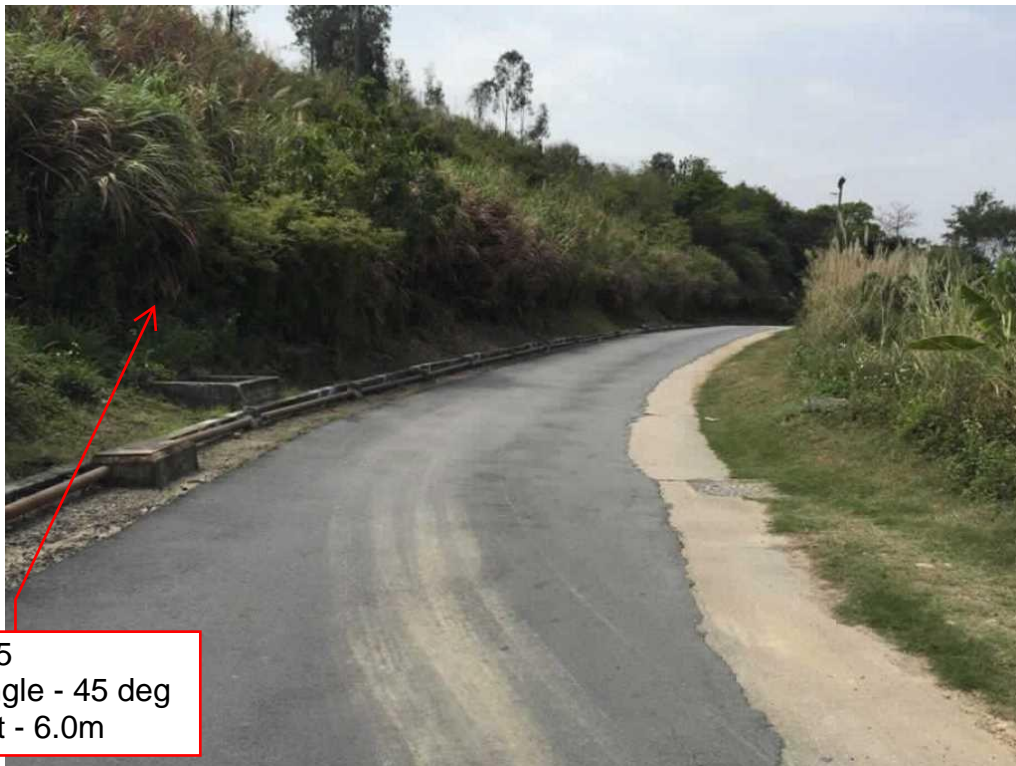
Photo 2: General View of 2SE-B/C305

2SE-B/C305
Average Angle - 45 deg
Max. Height - 6.0m

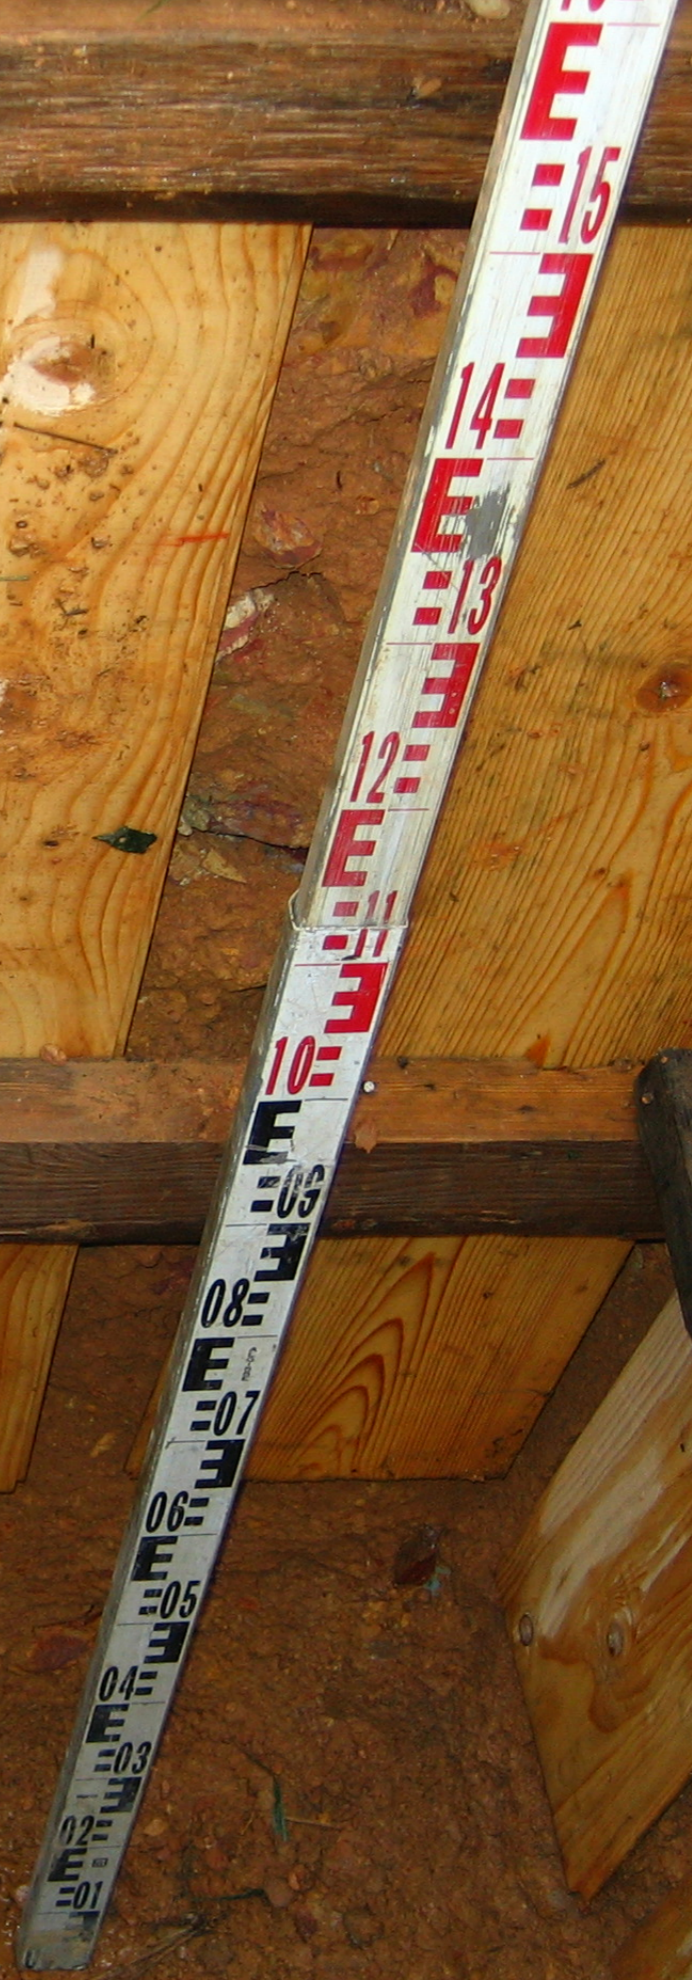
**GEOTECHNICS & CONCRETE ENGG (HK) LTD**
ASD CONTRACT NO TCN307
TERM CONTRACT
FOR
GROUND INVESTIGATION

CONSTRUCTION OF A SECONDARY
SITE: BOUNDARY FENCE - PHASE 1
WO NO: ASD010414 DATE: 13-4-2005
T.P. NO: TP40
FACE: C (LOWER)

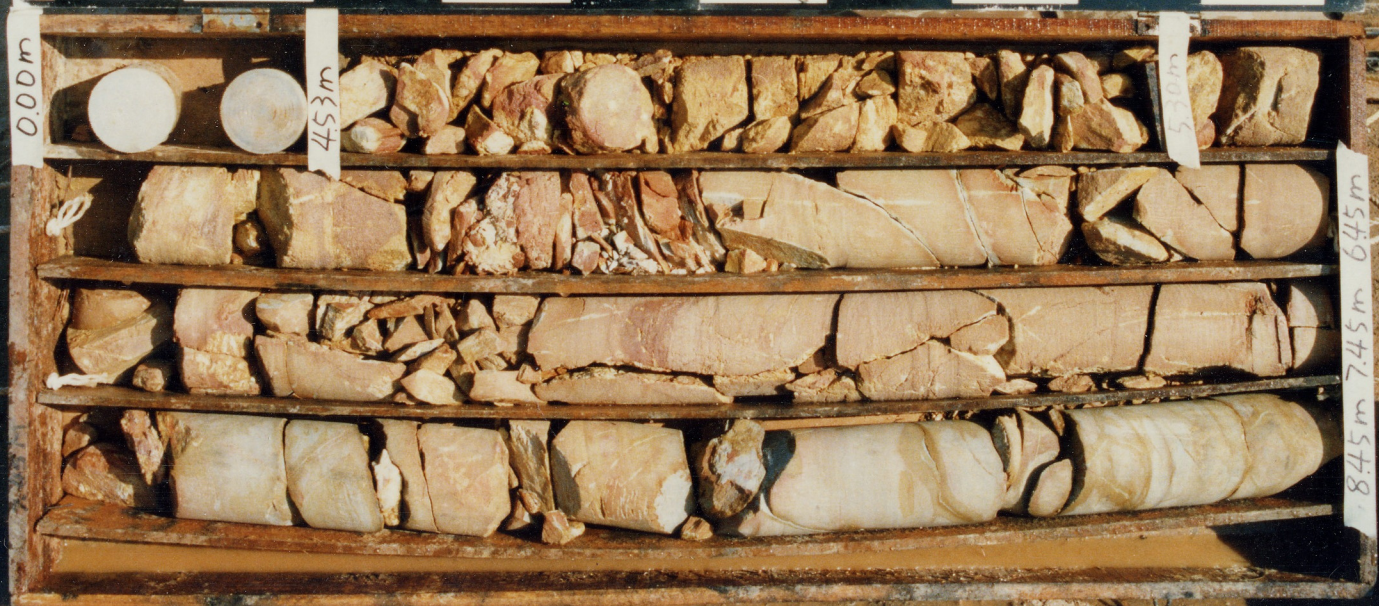
CLIENT	GEOTECHNICAL CONTROL OFFICE		
CONTRACT NO.	GC/85/09		
CONTRACTOR	LAM GEOTECHNICS LTD		
JOB NAME	LOK MA CHAU	W.O.NO.	PW7/2/16.75
HOLE NO.	BH-5	BOX'S NO.	1 OF 7
DEPTH	METRE FROM 0.00m TO 8.45m

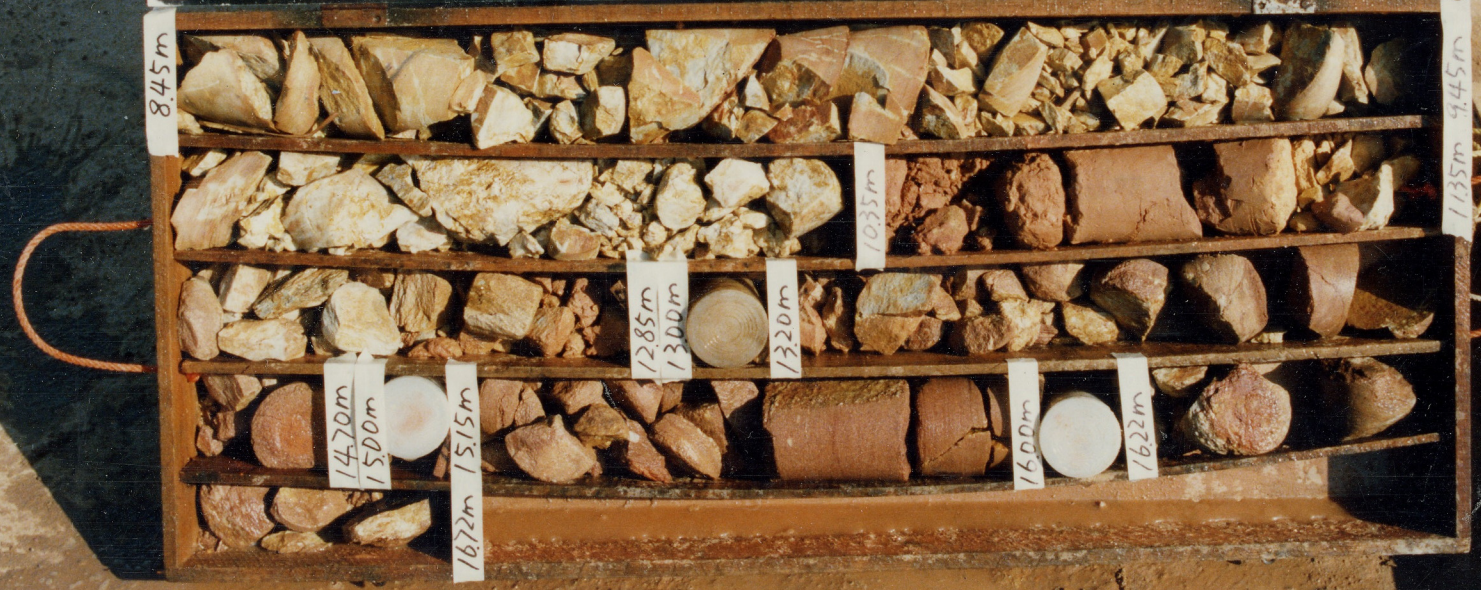
CLIENT	GEOTECHNICAL CONTROL OFFICE		
CONTRACT NO.	GC/85/09		
CONTRACTOR	LAM GEOTECHNICS LTD		
JOB NAME	LOK MA CHAU	W.O.NO.	PW7/2/16.75
HOLE NO.	BH-5	BOX'S NO.	2 OF 7
DEPTH	METRE FROM 8.45m TO 16.72m

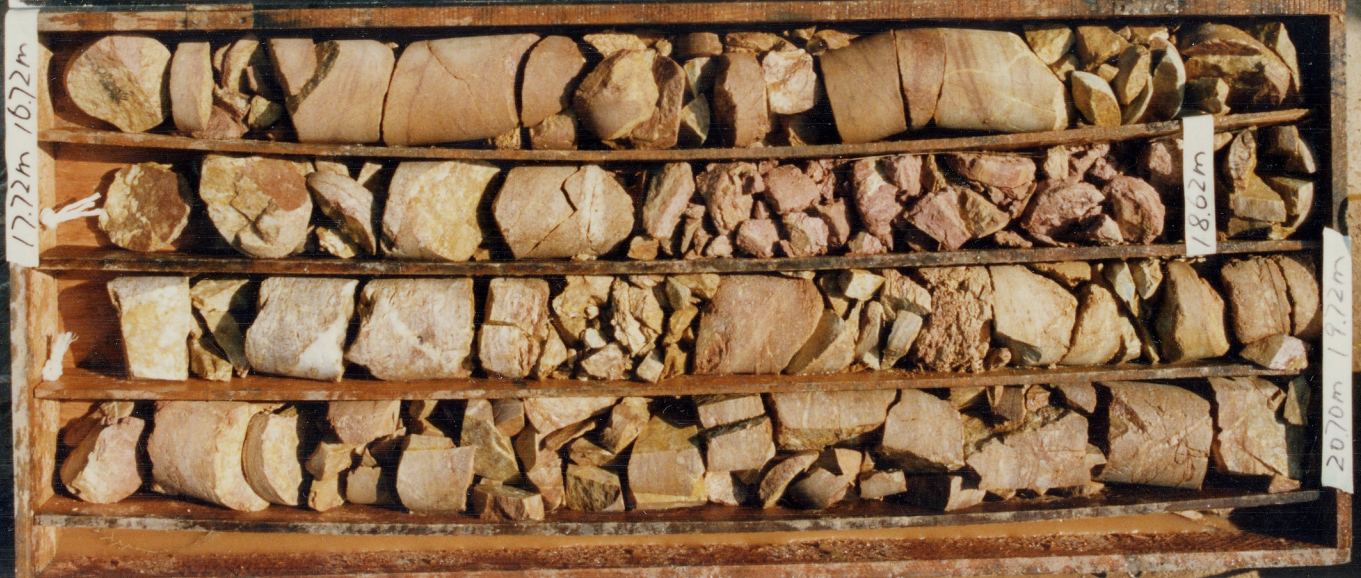
CLIENT	GEOTECHNICAL CONTROL OFFICE		
CONTRACT NO.	GC/85/09		
CONTRACTOR	LAM GEOTECHNICS LTD		
JOB NAME	LOK MA CHAU	W.O.NO.	PW7/2/16.75
HOLE NO.	BH-5	BOX'S NO.	3 OF 7
DEPTH	METRE FROM 16.72m TO 20.70m

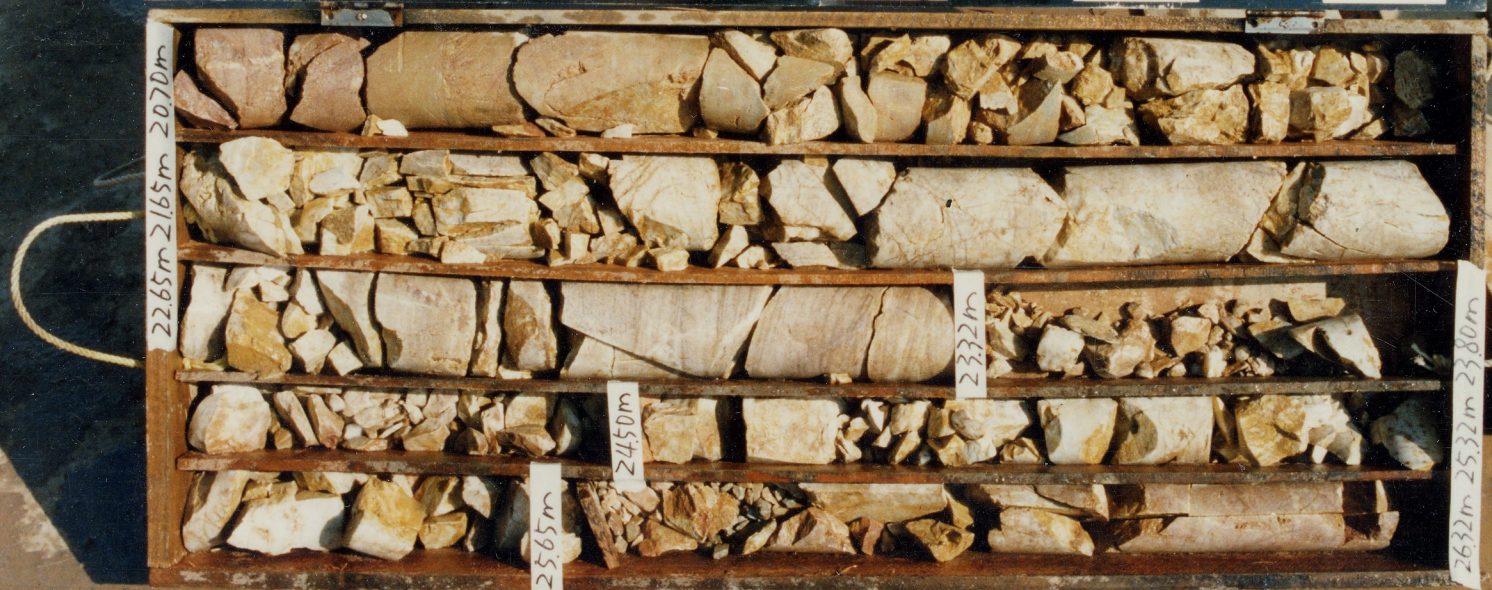
CLIENT	GEOTECHNICAL CONTROL OFFICE		
CONTRACT NO.	GC/85/09		
CONTRACTOR	LAM GEOTECHNICS LTD		
JOB NAME	LOK MA CHAU	W.O.NO.	PW7/2/16.75
HOLE NO.	BH-5	BOX'S NO.	4 OF 7
DEPTH	METRE FROM 20.70m TO 26.32m

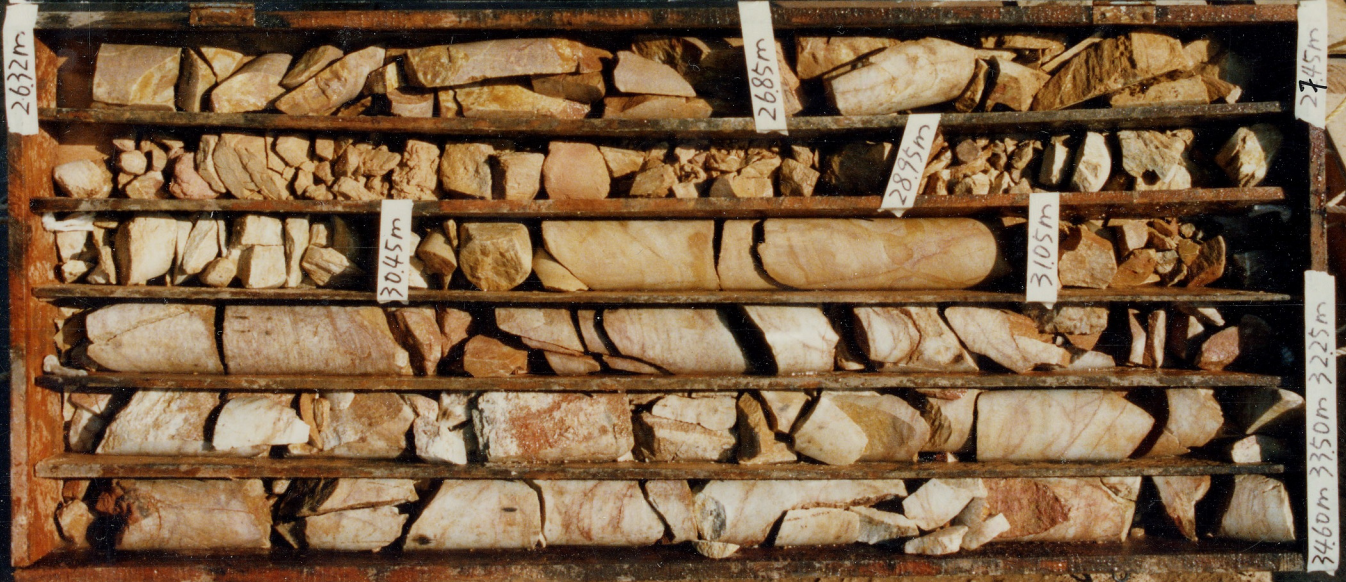
CLIENT	GEOTECHNICAL CONTROL OFFICE	
CONTRACT NO.	GC/85/09	
CONTRACTOR	LAM GEOTECHNICS LTD	
JOB NAME	LOK MA CHAU	W.O.NO. PW7/2/16.75
HOLE NO.	BH-5	BOX'S NO. 5 OF 7
DEPTH	METRE FROM 26.32m TO 34.60m.

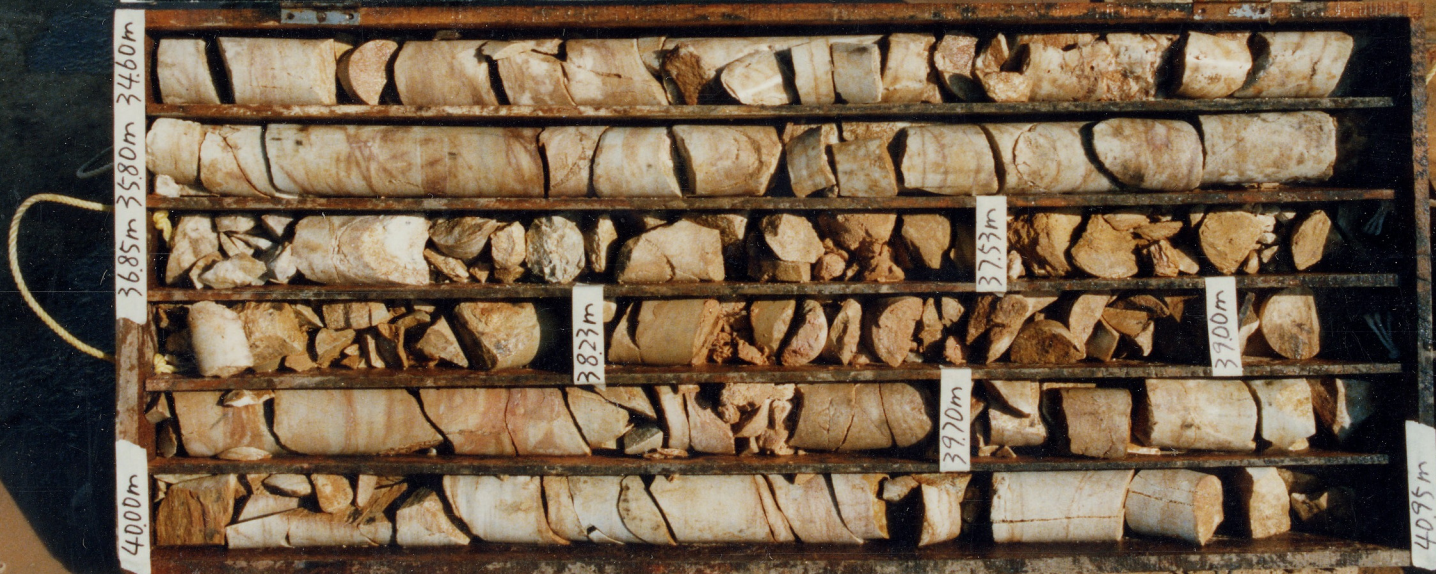
CLIENT	GEOTECHNICAL CONTROL OFFICE		
CONTRACT NO.	GC/85/09		
CONTRACTOR	LAM GEOTECHNICS LTD		
JOB NAME	LOK MA CHAU	W.O.NO.	PW7/2/16.75
HOLE NO.	BH-5	BOX'S NO.	6 OF 7
DEPTH	METRE FROM 34.60m TO 40.95m

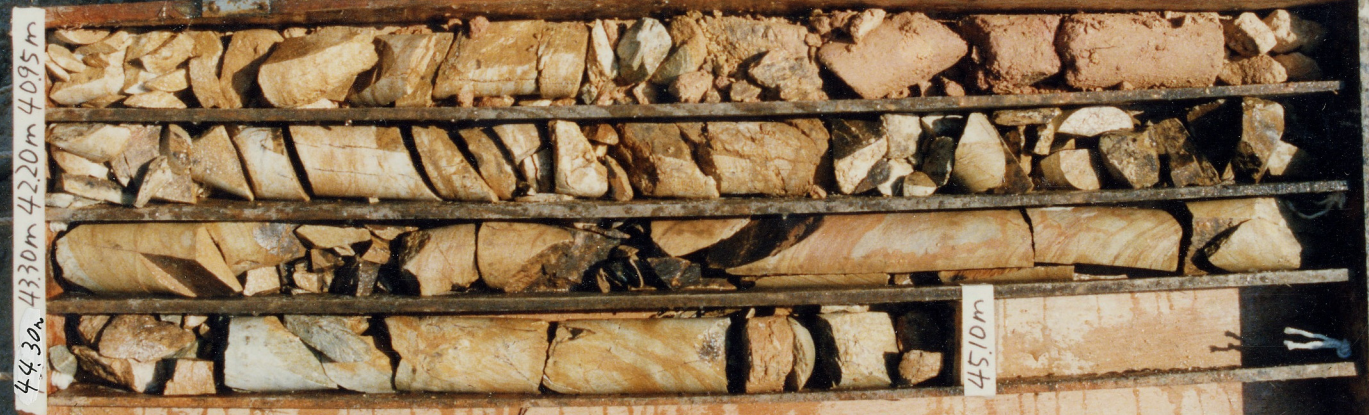
CLIENT	GEOTECHNICAL CONTROL OFFICE		
CONTRACT NO.	GC/85/09		
CONTRACTOR	LAM GEOTECHNICS LTD		
JOB NAME	LOK MA CHAU	W.O.NO.	PW7/2/16.75
HOLE NO.	BH-5	BOX'S NO.	7 OF 7
DEPTH	METRE FROM 40.95m TO 45.10m

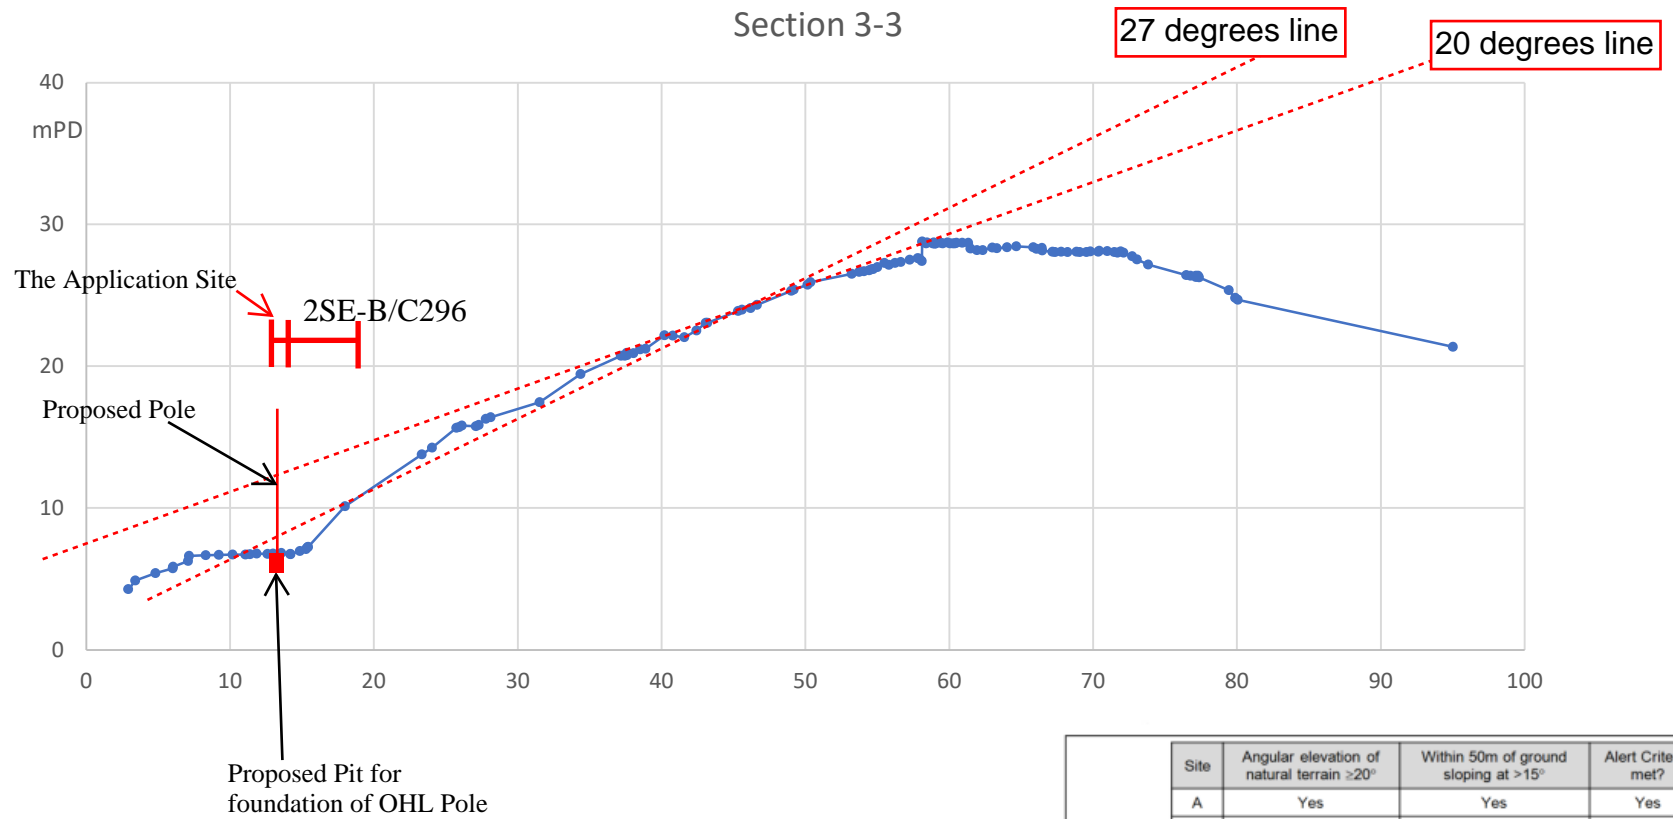
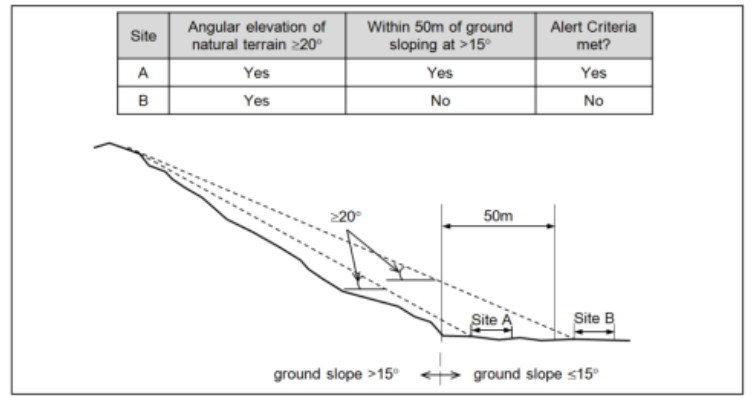
Figure 2.5 Application of Alert Criteria

Comparing Figure 2.5 and Section 3, the site for proposed OHL Pole meets alert criteria of natural terrain hazard.

Comparing Figure 2.5 and Section 1, the site for proposed OHL Pole meets alert criteria of natural terrain hazard.

Comparing Figure 2.5 and Section 2, the site for proposed OHL Pole meets alert criteria of natural terrain hazard.

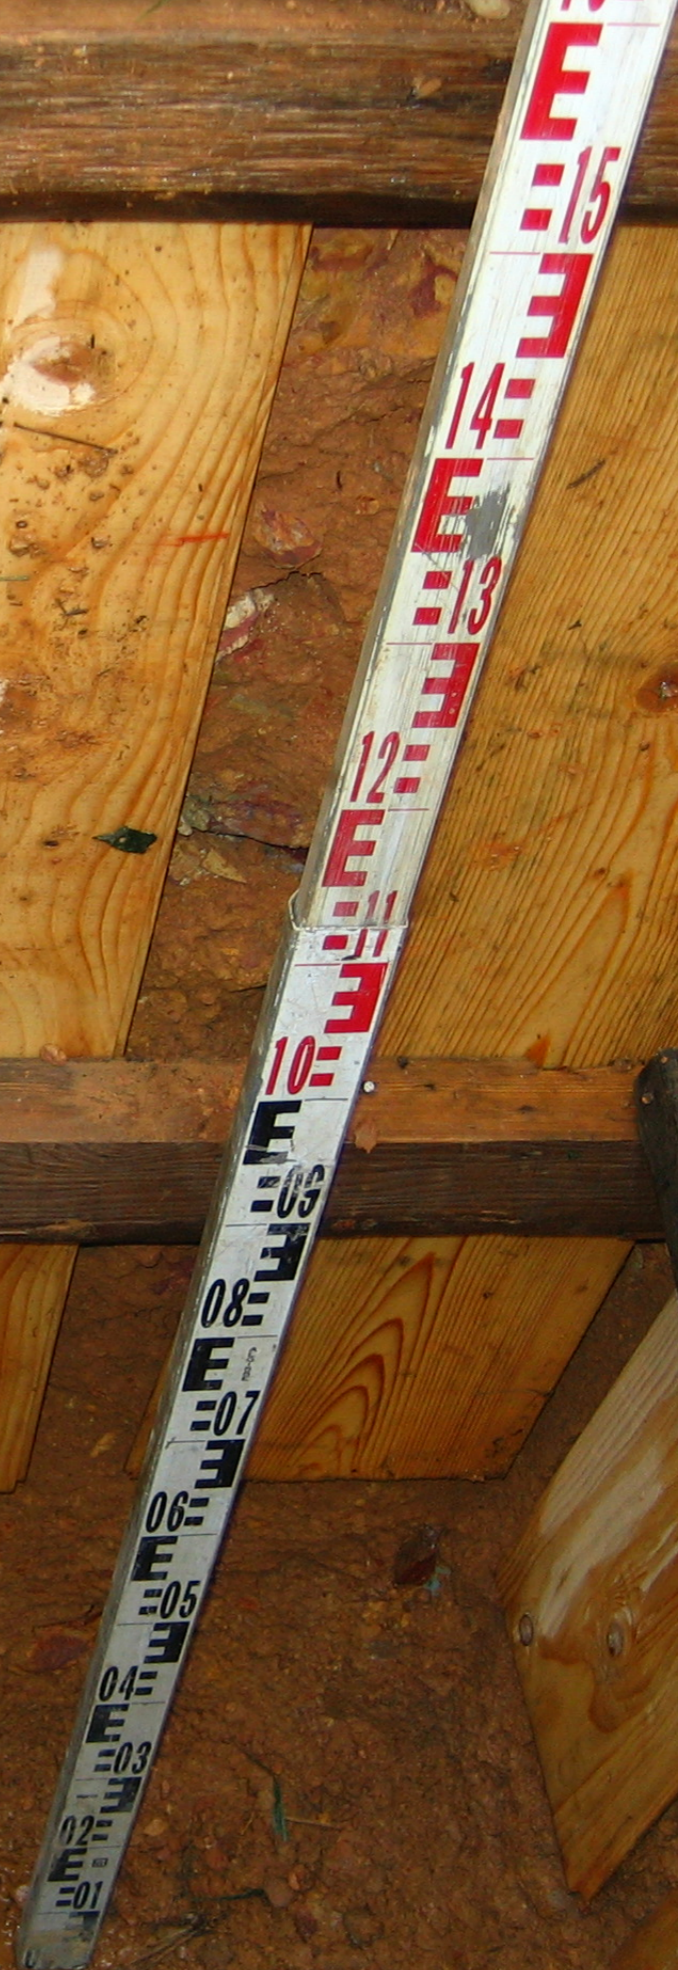
**GEOTECHNICS & CONCRETE ENGG (HK) LTD**
ASD CONTRACT NO TCN307
TERM CONTRACT
FOR
GROUND INVESTIGATION
CONSTRUCTION OF A SECONDARY
SITE: BOUNDARY FENCE - PHASE 1
WO NO: ASD010414 DATE: 13-4-2005
T.P. NO: TP40
FACE: C (LOWER)

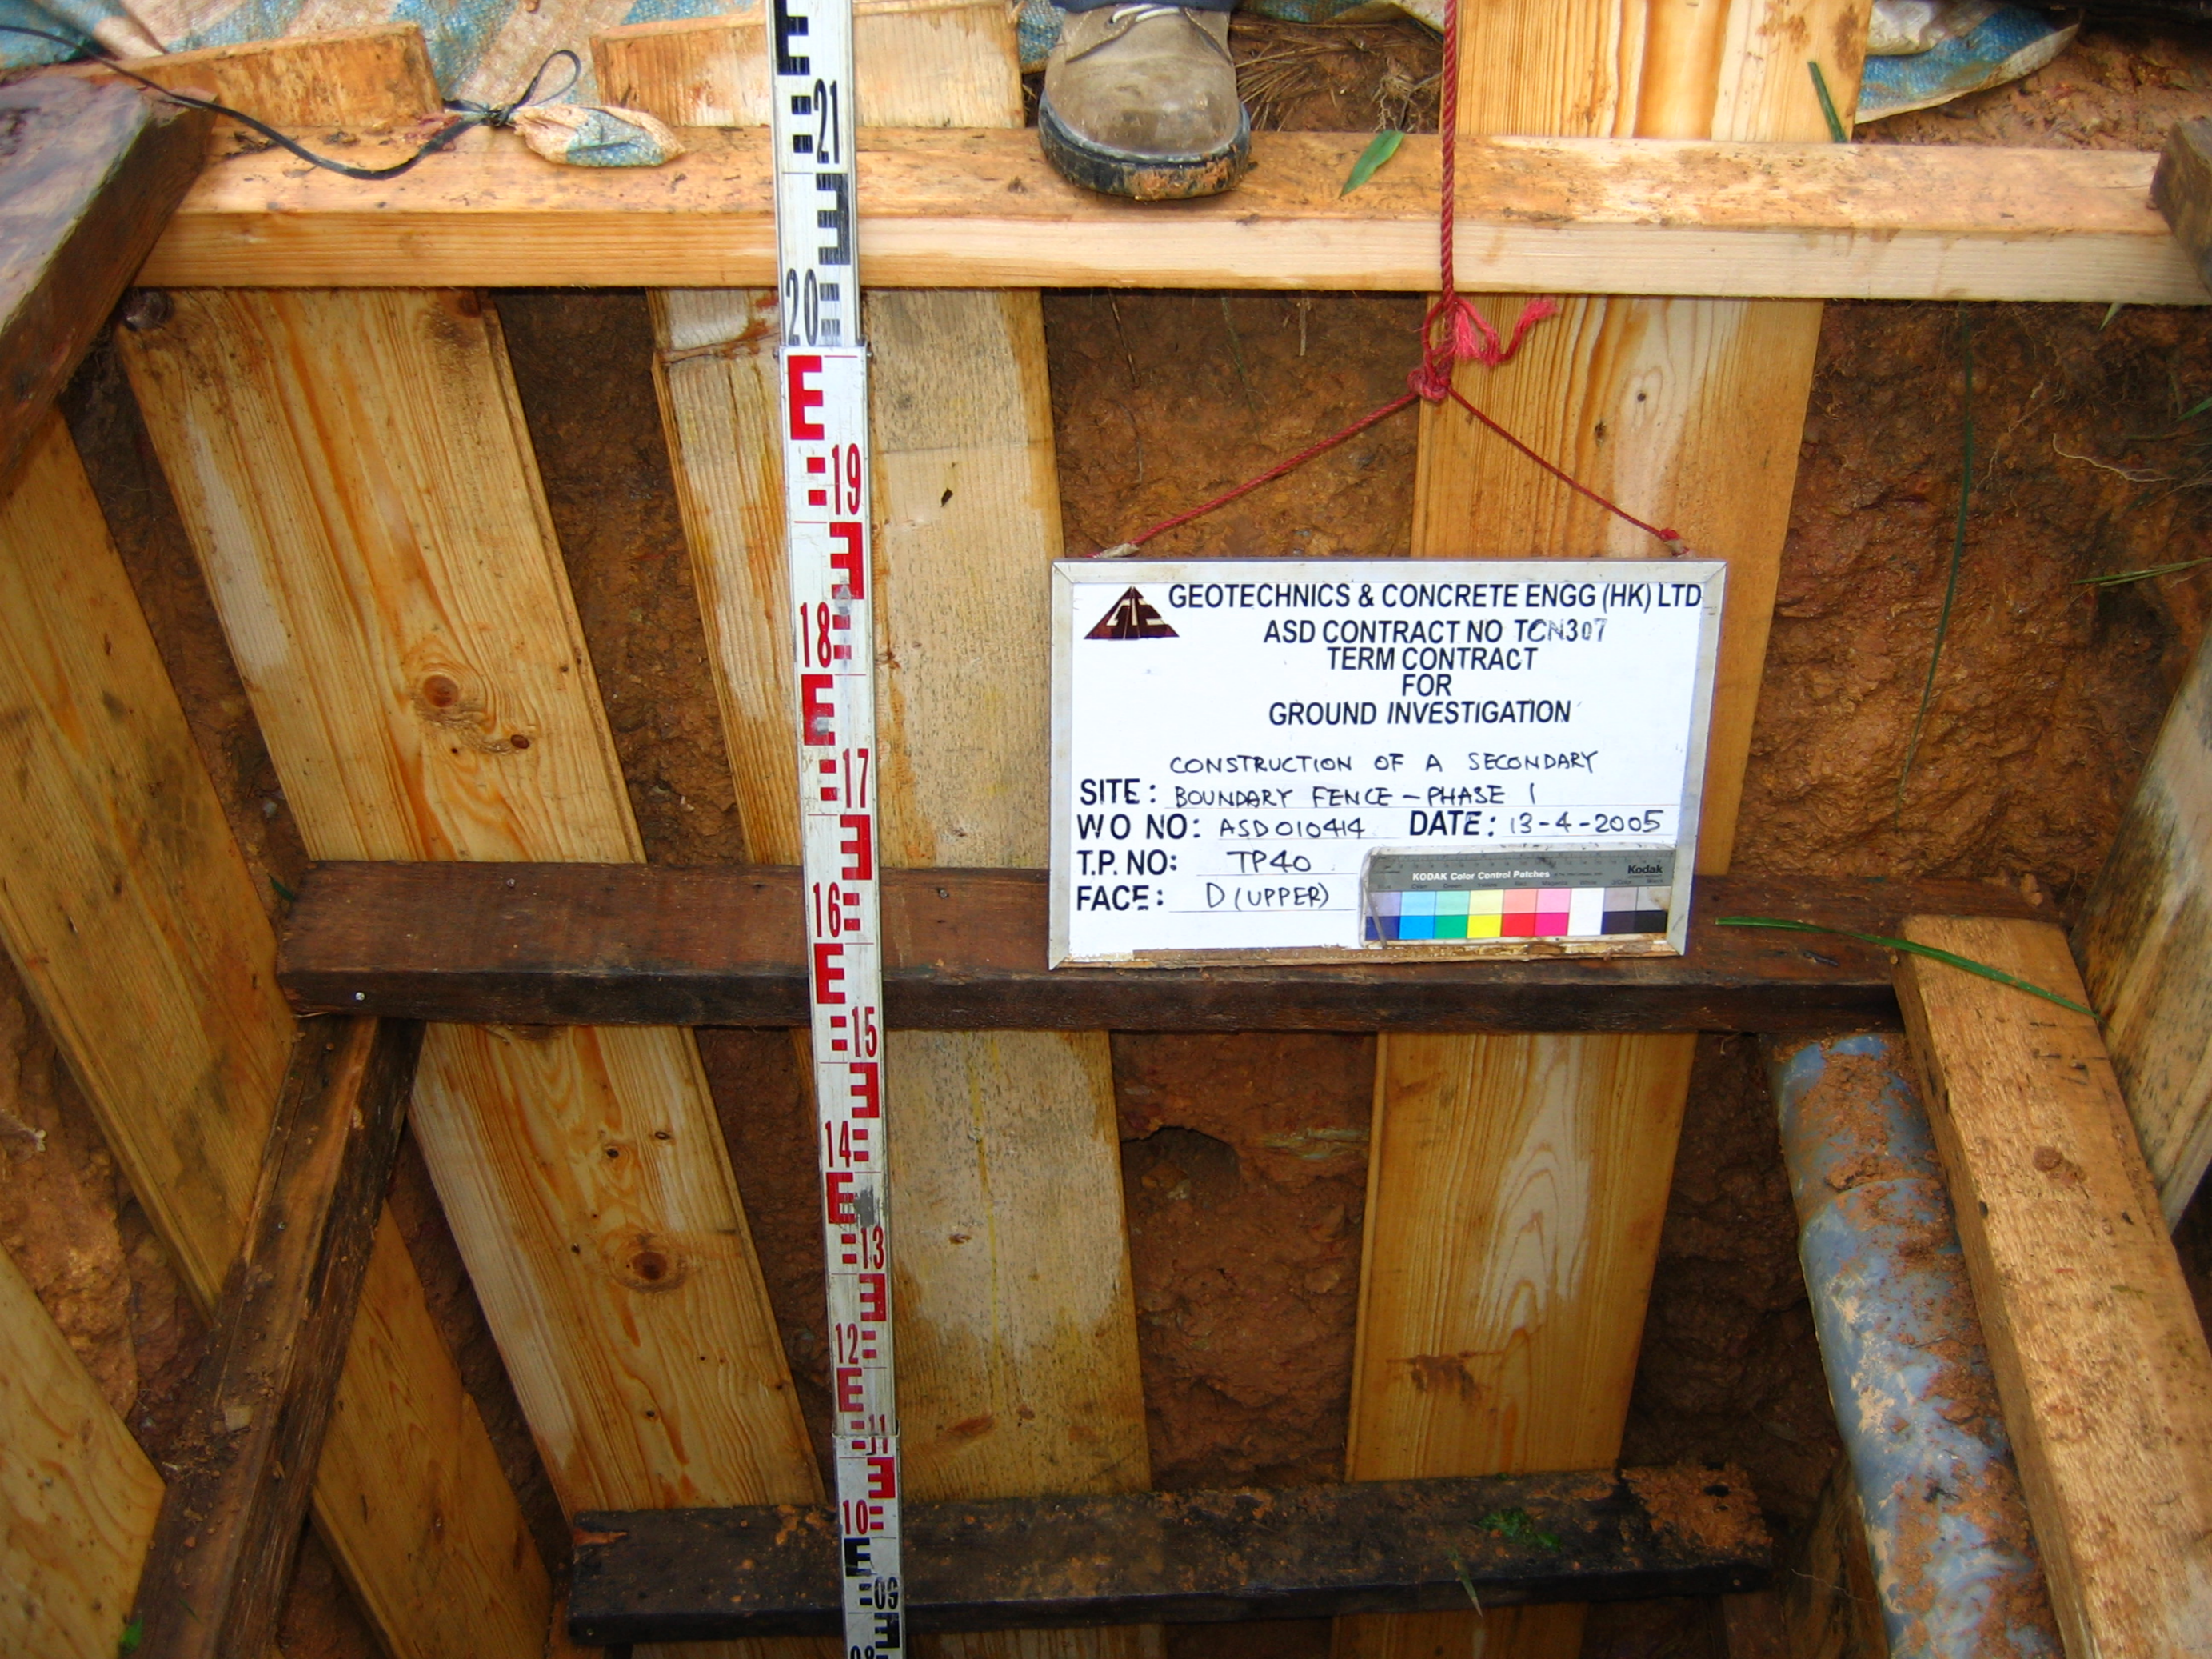
GEOTECHNICS & CONCRETE ENGG (HK) LTD
ASD CONTRACT NO TCN307
TERM CONTRACT
FOR
GROUND INVESTIGATION
SITE: CONSTRUCTION OF A SECONDARY
WO NO: BOUNDARY FENCE - PHASE I
T.P. NO: ASD 010414
FACE: TP40 DATE: 13-4-2005
