Geotechnical Planning Review Report for Installation of Proposed Public Utility Installation and Associated Filling and Excavation of Land (OHL Pole & Stay Erection)

Geotechnical Planning Review | Government Land in D.D. 96, San Tin, Yuen Long

B190011.051.01 | 8 August 2022

CLP Power Hong Kong Limited

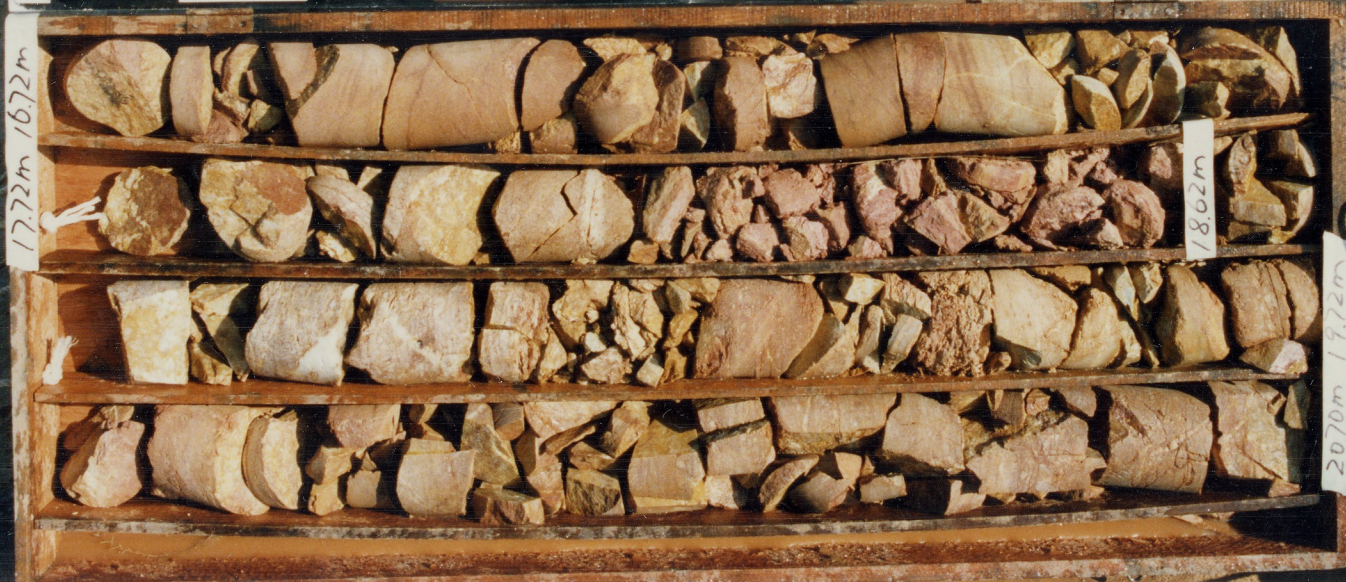
CLIENT	GEOTECHNICAL CONTROL OFFICE		
CONTRACT NO.	GC/85/09		
CONTRACTOR	LAM GEOTECHNICS LTD		
JOB NAME	LOK MA CHAU	W.O.NO.	PW7/2/16.75
HOLE NO.	BH-5	BOX'S NO.	3 OF 7
DEPTH	METRE FROM 16.72m TO 20.70m

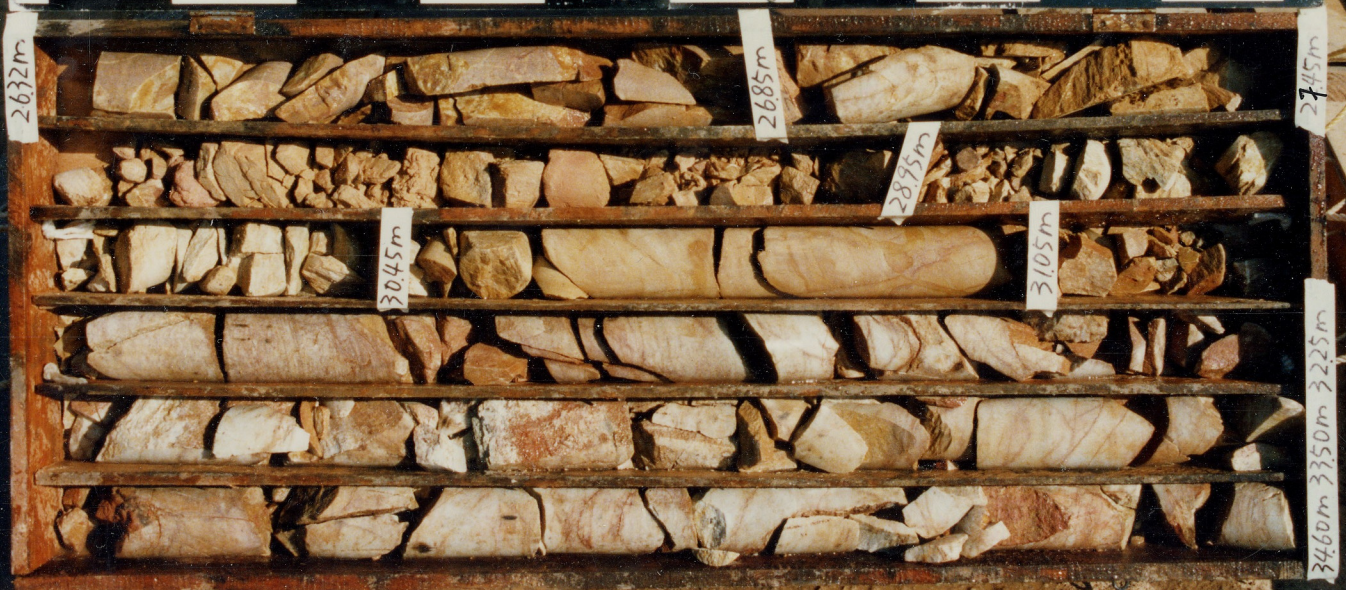
CLIENT	GEOTECHNICAL CONTROL OFFICE	
CONTRACT NO.	GC/85/09	
CONTRACTOR	LAM GEOTECHNICS LTD	
JOB NAME	LOK MA CHAU	W.O.NO. PW7/2/16.75
HOLE NO.	BH-5	BOX'S NO. 5 OF 7
DEPTH	METRE FROM 26.32m TO 34.60m.

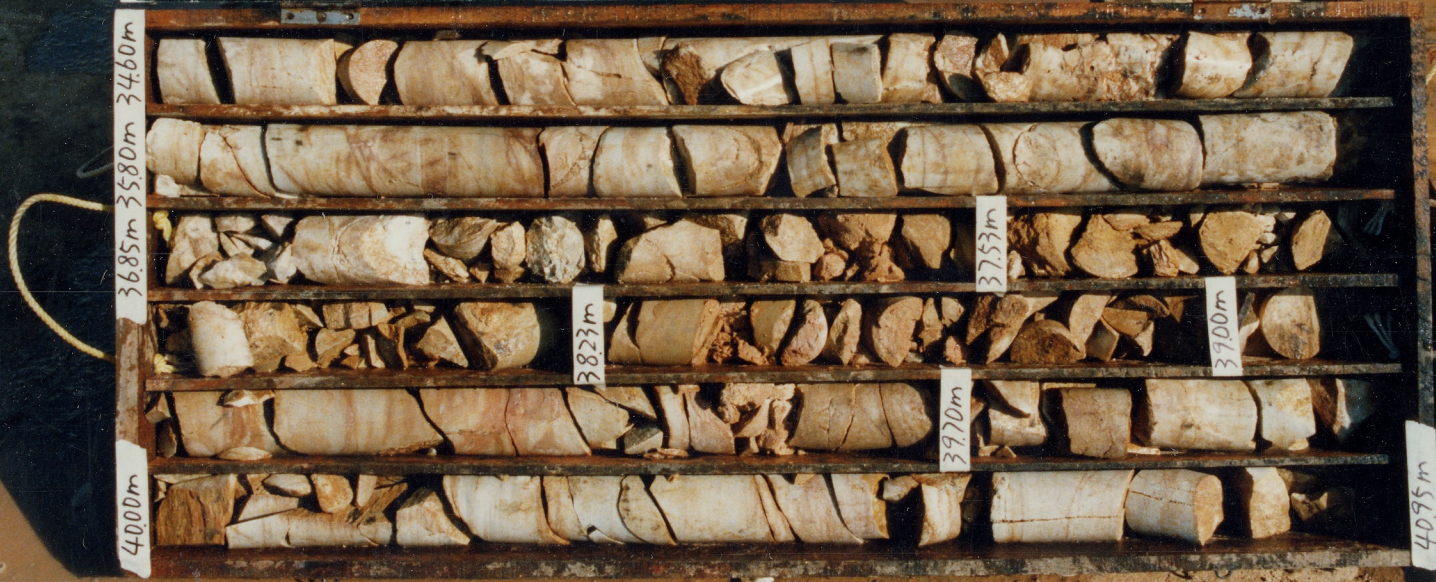
CLIENT	GEOTECHNICAL CONTROL OFFICE		
CONTRACT NO.	GC/85/09		
CONTRACTOR	LAM GEOTECHNICS LTD		
JOB NAME	LOK MA CHAU	W.O.NO.	PW7/2/16.75
HOLE NO.	BH-5	BOX'S NO.	6 OF 7
DEPTH	METRE FROM 34.60m TO 40.95m

34.60m
35.80m
36.85m
40.00m

37.53m
37.00m
39.70m
40.95m

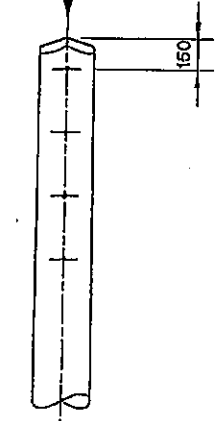
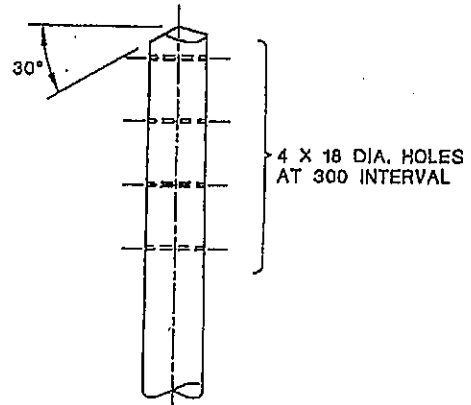
VIEW A'

Pole 10m high above ground

GOUGE MARK

GROUND LEV.
