**Project Title** : Drainage Improvement in Tsuen Wan and Kwai Chung-Tsuen Wan Drainage Tunnel  
**工程項目名稱**: 荃灣及葵涌雨水排放系統改善工程荃灣雨水排放隧道

**Environmental Permit No.** : FEP-01/275/2007  
**環境許可證編號** : FEP-01/275/2007

**Figure 2** : Works of Intake I-2 at Sam Dip Tam Stream  
**圖2**: 位於三疊潭河道的收水口I-2工程圖

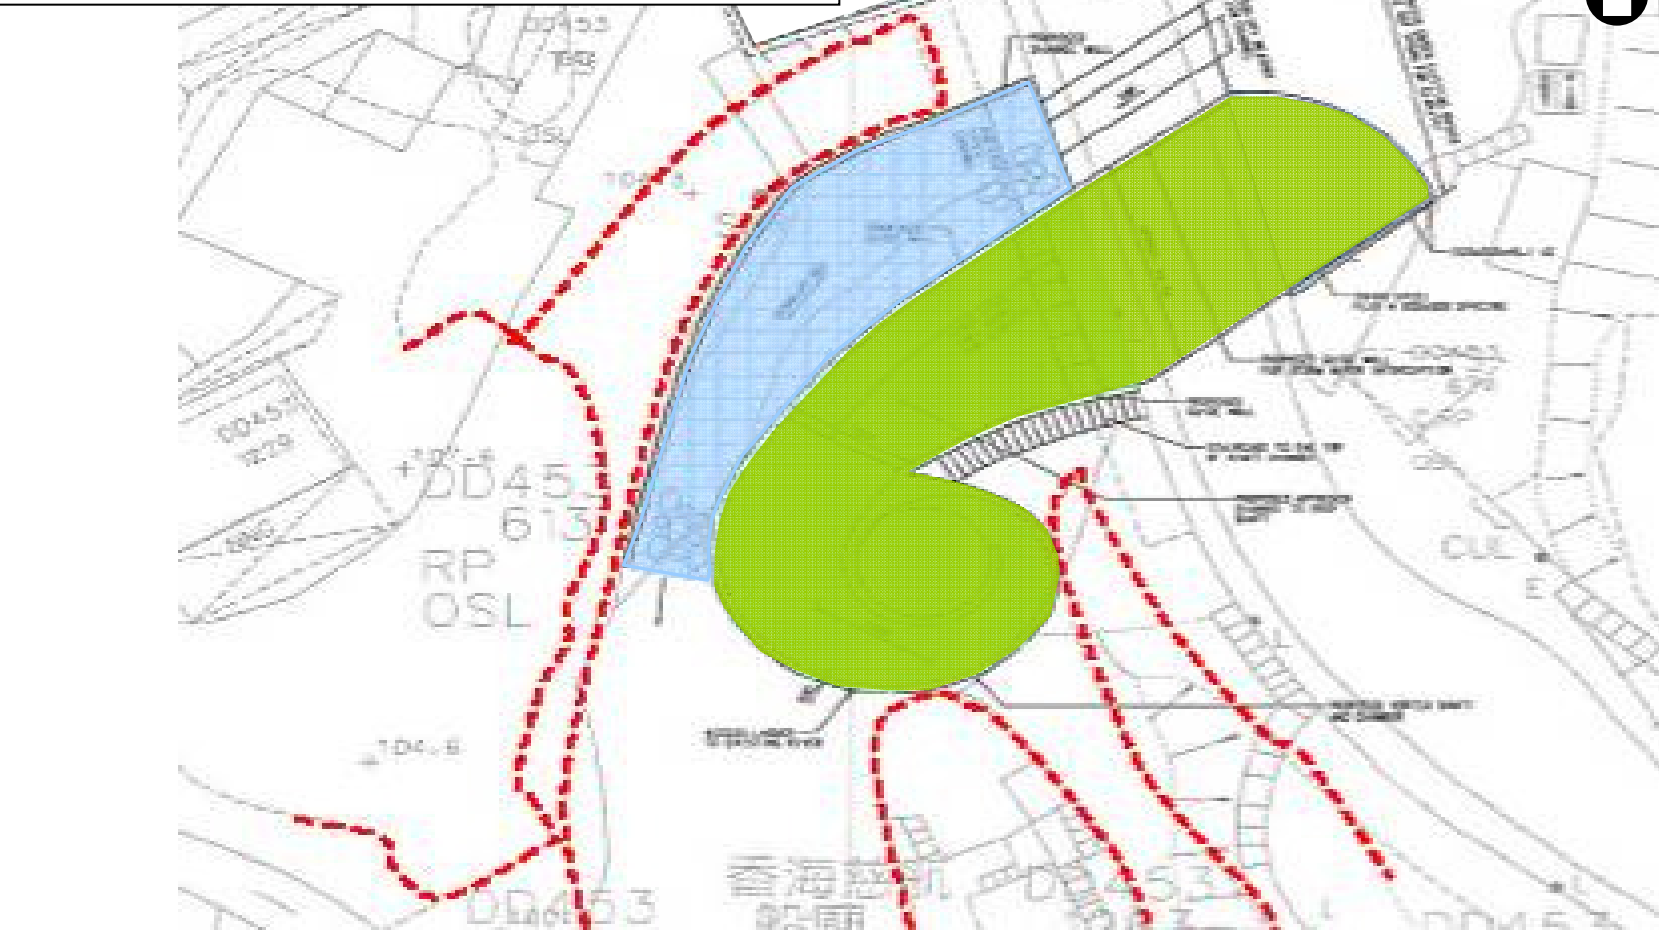
Area to be restored to natural stream bed
-

Area to be formed as man-made structures
-

Private lot boundaries near the intake structure (not all boundaries are shown for clarity)

(This figure is prepared based on Figure 7.7 of the EIA Report (Register No. AEIAR-088/2005)  
(本圖是根據環境影響評估報告(登記冊編號: AEIAR-088/2005)圖7.7編制)
