Agreement No. CE 45/93
Lantau Port Development - Stage 1
Reclamation for Shipyard at To Kau Wan
North Lantau
EIA for Operational Phase

FINAL ENVIRONMENTAL IMPACT ASSESSMENT REPORT

October 1995

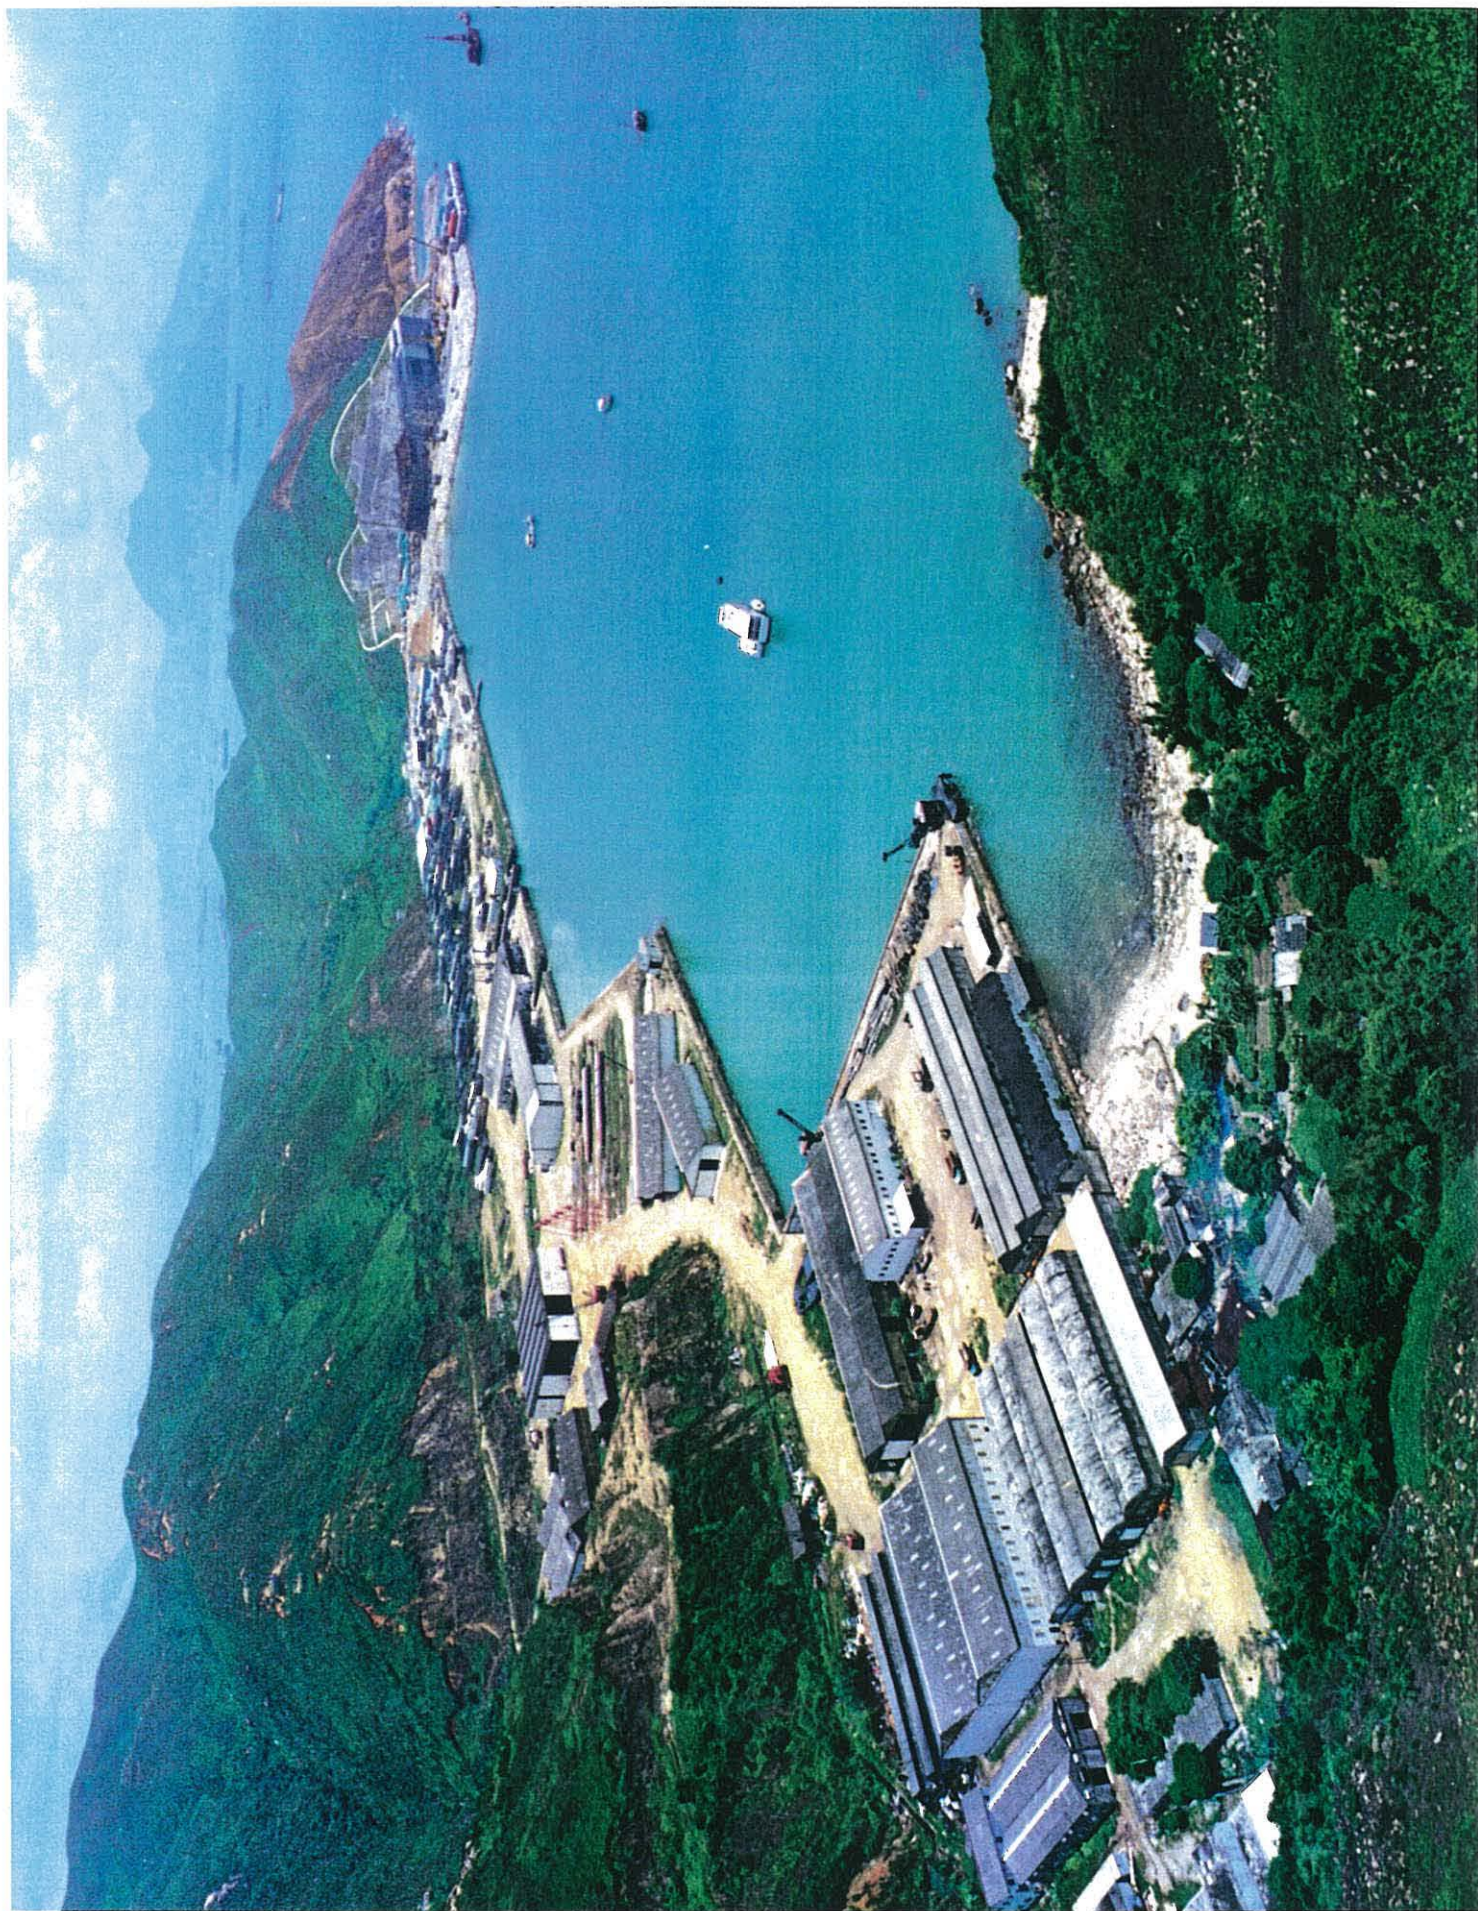
Plate 2.1

- 2.5 To retain flexibility over time, the Penny's Bay Shipyard layout has evolved and has been modified to suit changing demand. Cheoy Lee increased the Shipyard land area by further reclamation: the hillside being quarried to provide the materials for reclamation. The reclaimed area currently being used by Cheoy Lee Shipyard totals approximately 14 ha; of which about 4.2 ha is occupied by buildings, 2.1 ha for the storage of fibreglass boat moulds and 7.5 ha which comprises general open areas and roads for access, cranes, storage, manoeuvring, slipways and open-air boat fabrication. A photograph overlooking the Penny's Bay Shipyard is given in Plate 2.1. Penny's Bay Power Station can be seen in the upper right hand corner.

2.6 The layout of the Shipyard is shown on Figure 2.1, together with building sizes and areas by type of use. Two views of the Shipyard are shown in Plates 2.1 and 2.2. To give an initial broad impression of land usage, generalised building areas by use are shown below in Table 2.1.

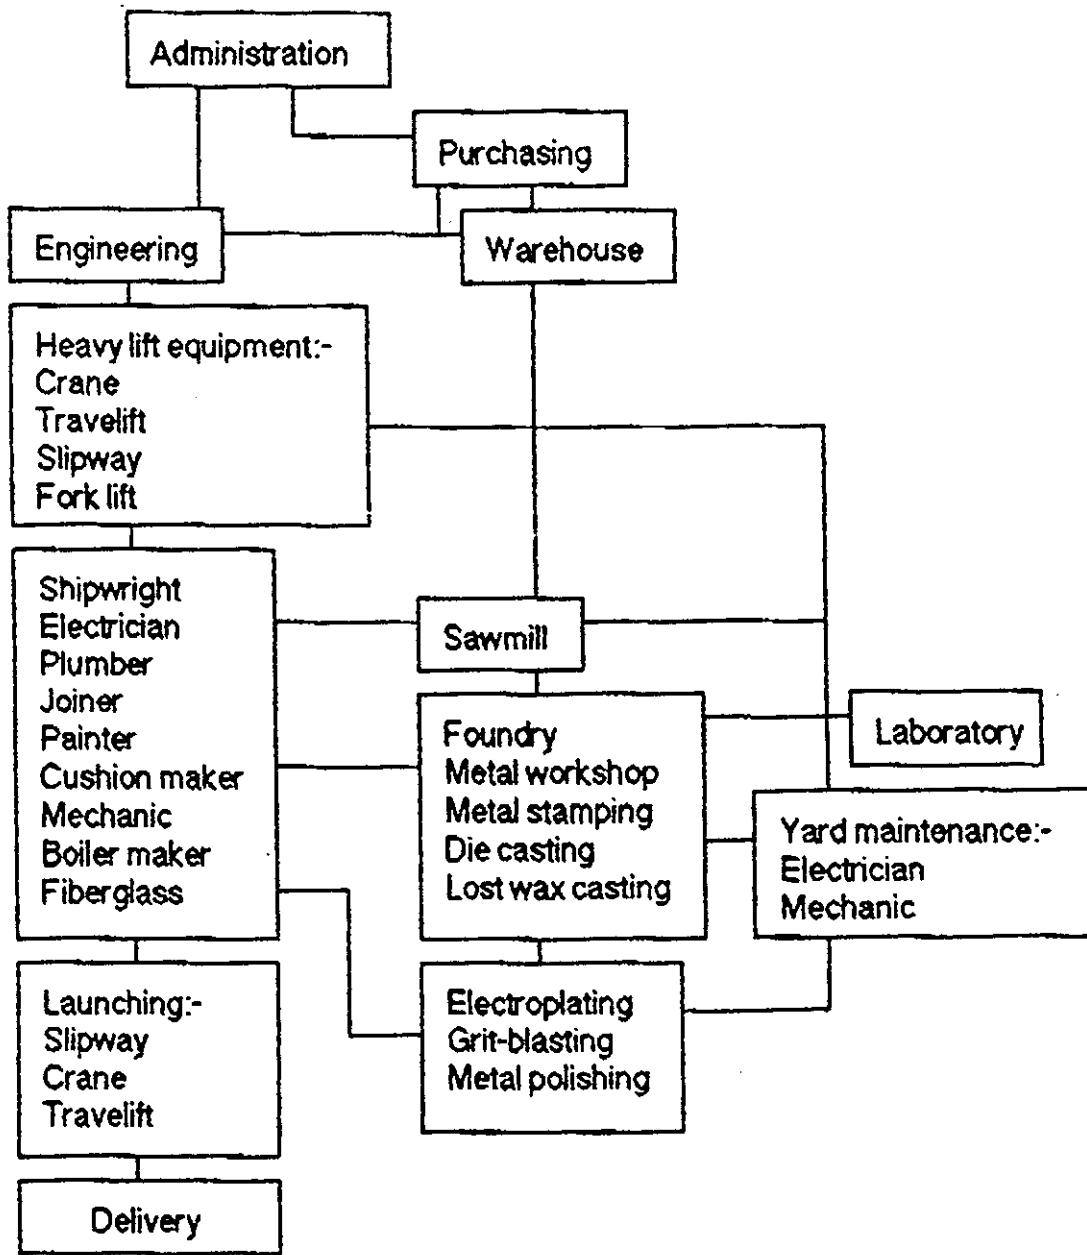
Scale
 Figure No.
 2.2

TO KAU WAN OPERATIONAL EIA
 VESSEL REPAIR / SERVICE
 FLOW CHART
 (provided by Cheoy Lee Shipyards Ltd.)

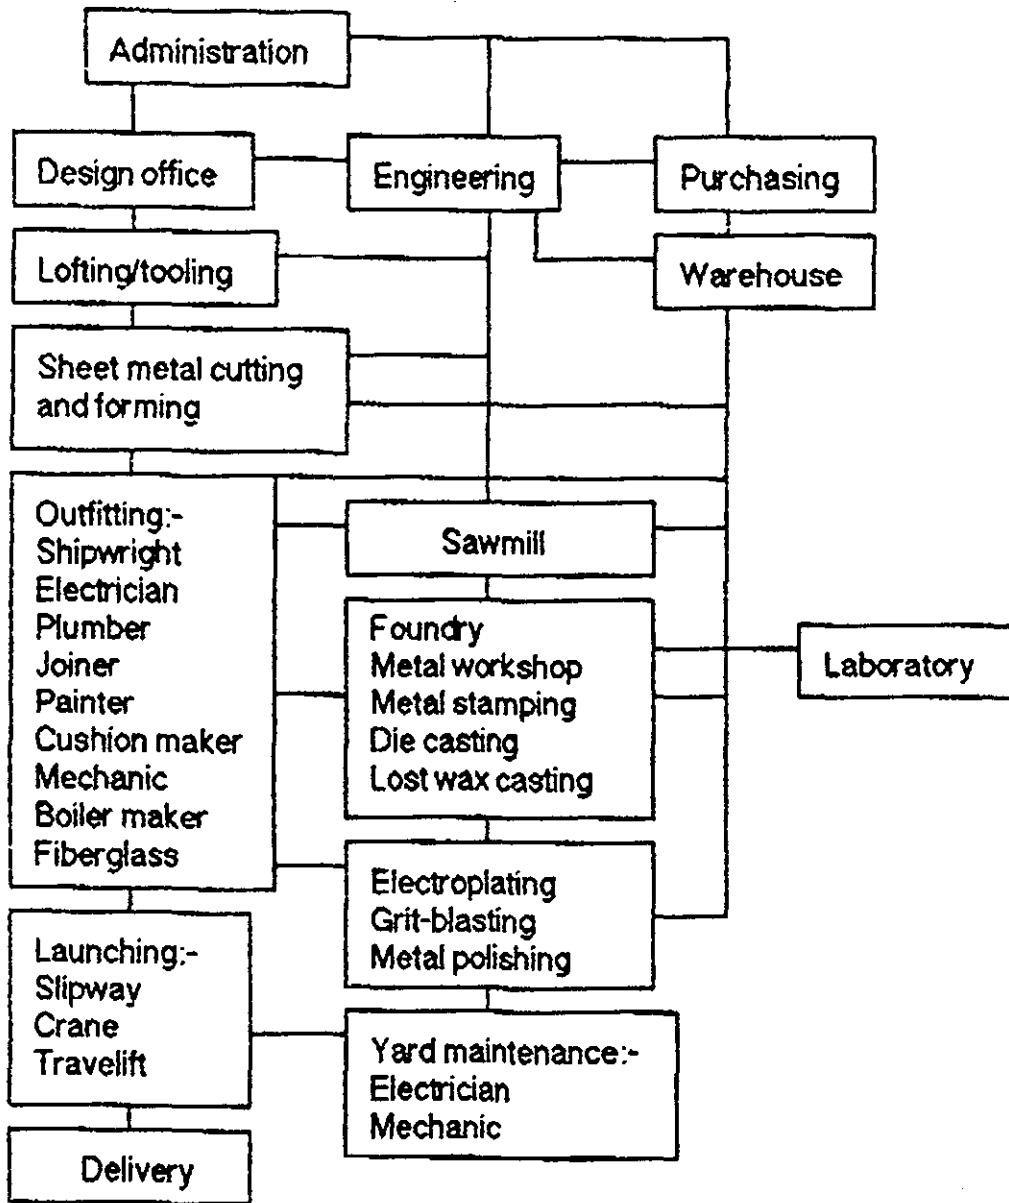
Figure No.
 2.3

Note: All scrap metal will be returned to foundry for recycling.

TO KAU WAN OPERATIONAL EIA
 TYPICAL STEEL VESSEL
 PRODUCTION FLOW CHART
 (provided by Cheoy Lee Shipyards Ltd.)

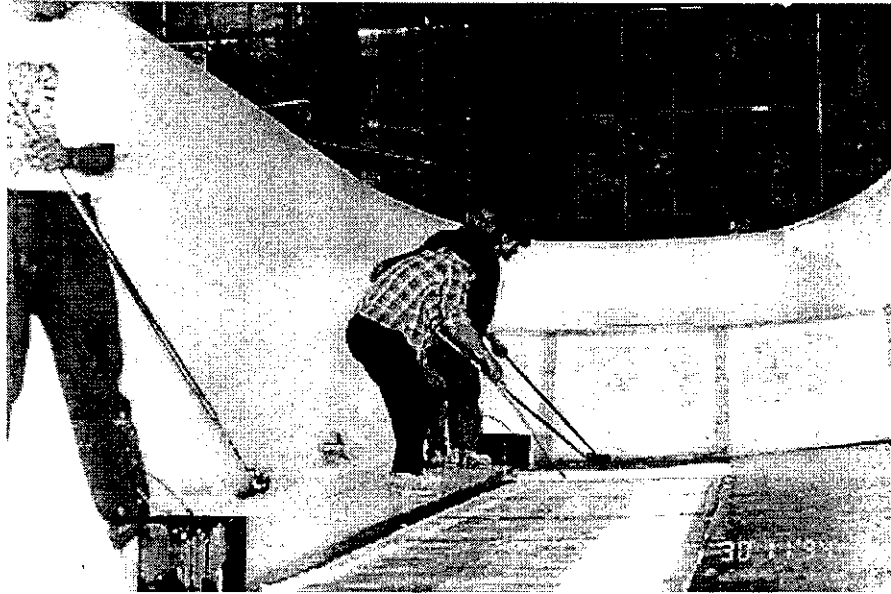
Plate 3.1 : GRP Ship Making Process

- 3.19 GRP ships are made in a very similar way to that used to produce the moulds. First a layer of resin is applied to the mould, called a Gel Coat, which provides a smooth protective layer for the GRP laminate. For decorative purposes, this gel coat usually has a coloured dye added. Next, fibreglass cloth is layered into the mould and resin applied to produce a laminate in a process called Hand Layup. The materials are then compressed or densified with a roller to eliminate entrapped air and to spread the resin evenly. This process is illustrated in Plate 3.1. Many layers may be needed to produce the finished ship. During this process, the GRP may also be coloured by using different resins which have had a coloured dye mixed into them. Reinforcing structures may need to be added, especially for the superstructure, and this is accomplished by using a process called Encapsulation. Blocks of high density polyurethane foam or plywood are placed in strategic areas of the hull or superstructure where additional strength is required and GRP layered over the top forming a box like structure. This results in a very strong structure which also provides additional flotation in the event of hull rupture. The chemicals and hence the environmental and health hazards are the same as for the mould building described above.

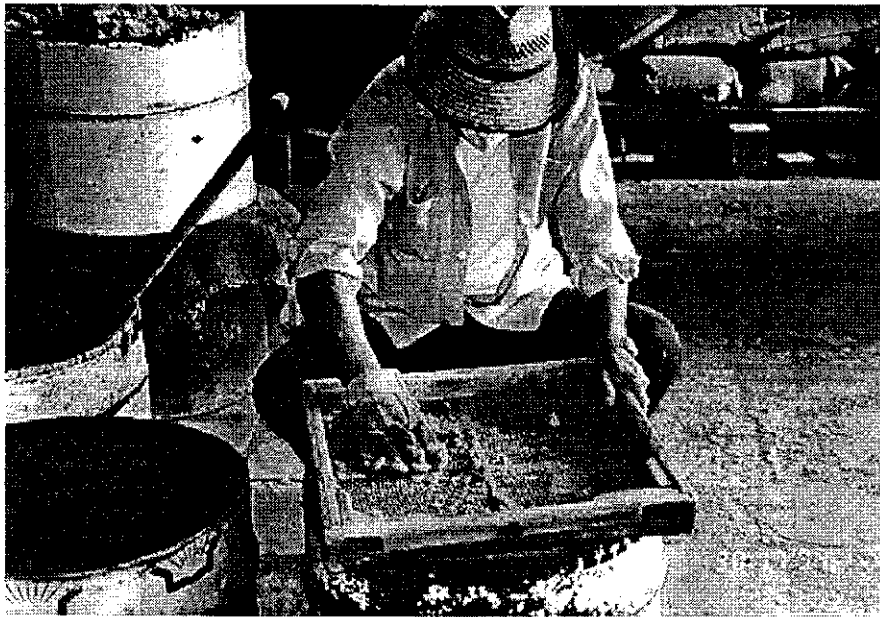
Plate 3.6 : Sand Recycling

3.25 As can be seen from Plate 3.4, the area around the crucible and furnaces is very clean. Plate 3.5 shows two workers forming sand moulds. The whole area appeared to be very well maintained and cleaned. All slag from the steel furnace is collected in large steel drums until sufficient quantity has been collected for disposal. Slag from other metals, such as copper, is collected and sold for recycling to China. All spilt sand is swept up and recycled as is the sand used for the moulds. Plate 3.6 shows a worker cleaning the sand ready for re-use.

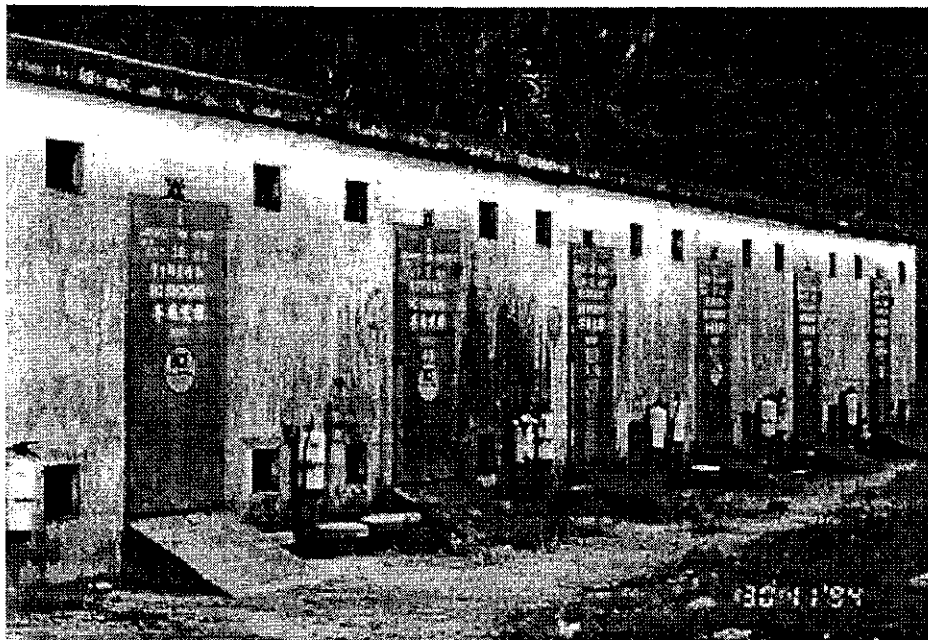
Plate 3.12 : Dangerous Goods Storage

- 3.64 All dangerous goods are currently stored in a special locked, ventilated and environment controlled storage facility separated from other buildings (see Plate 3.12). There are five separate rooms for MEKP, paints, xylene, sulphuric acid and acetylene respectively. This storage facility is separated from all other buildings and appropriate (powder) fire extinguishers are on hand.
