ROUTE 3 TAI LAM TUNNEL & YUEN LONG
APPROACH - SOUTHERN SECTION

FINAL DETAILED ENVIRONMENTAL
IMPACT ASSESSMENT

Volume 2 - The Conveyor System

August 1995

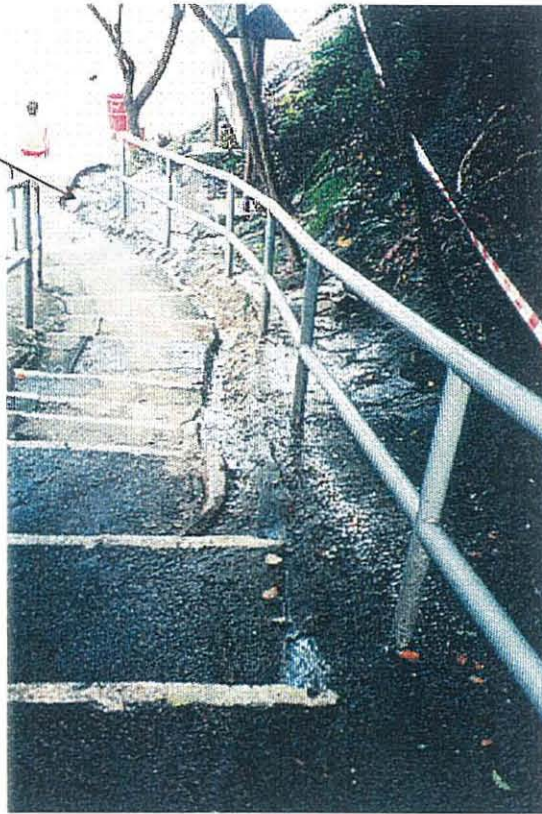
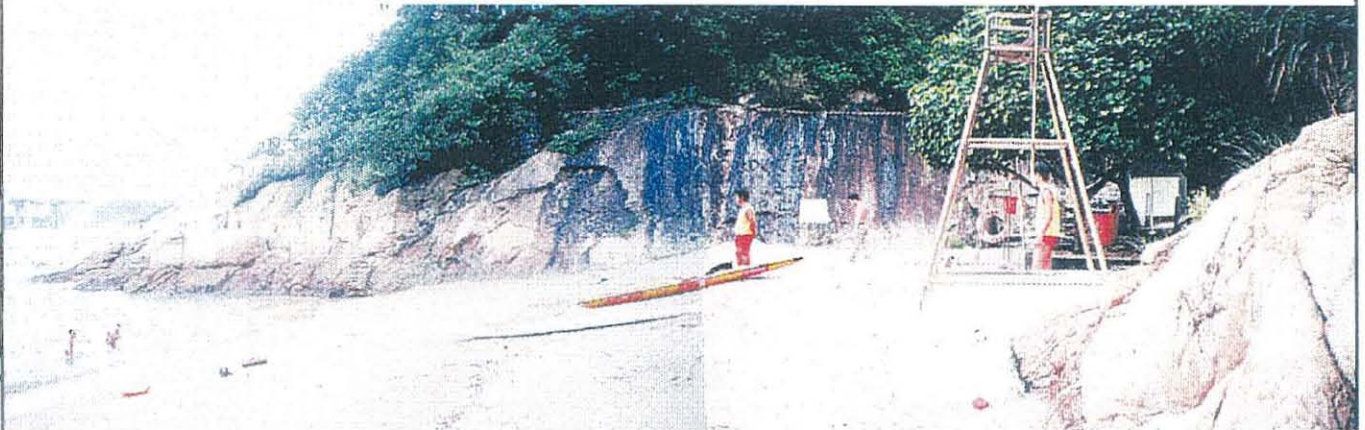
Figure 5.3 Site Visit (16/7/95) Photos at Eastern Gemini Beach

Temporary surface water
draining into eastern
Gemini Beach

Eastern Gemini Beach

The effect of the proposed stockpile platform on *E. coli* levels at Gemini Beaches has not been quantitatively modelled. As previously described the extension of the existing headland south may reduce the flushing capacity of the eastern Gemini Beach and subsequently affect existing *E. coli* levels. High *E. coli* levels at the beach are, however, a regional problem rather than a local problem. A site visit was carried out on 13 June 1995 and the only water flowing into the east Gemini Beach is a small temporary water stream which is rather clean and silt free (Figure 5.3).
