KEY VIEW 3 (KV 3)

AGREEMENT No. CE 75/2002 (WS)
EXTENSION OF SIU HO WAN WATER TREATMENT WORKS — INVESTIGATION

MITIGATION MEASURES - PUI O

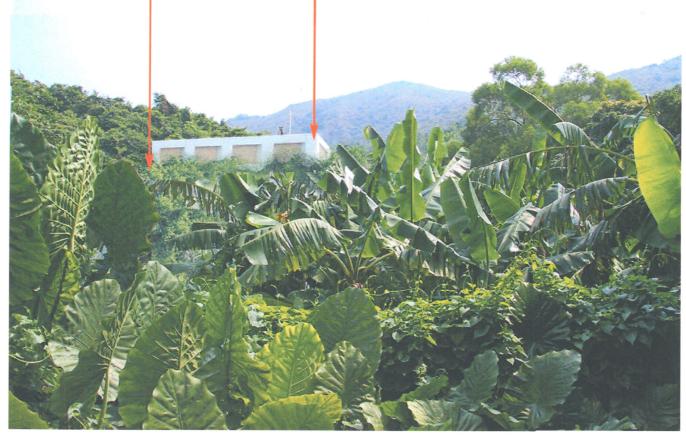
KV 3 - PROPOSED RECONSTRUCTION OF PUI O RAW WATER PUMPING STATION. DAY 1 OF THE OPERATION WITH MITIGATION MEASURES

Photomontage of KV 3 without Mitigation Measures

LMM 4 **Compensatory Planting of trees** for visual screening

LMM₂ Surface finishes of the Reconstruction of Pui O Raw Water Pumping Station would be visually compatible with that of the existing Pui O No. 2 Raw Water Pumping Station
